## REGULAR MEETING

THE REGULAR MEETING OF THE CITY COMMISSION OF THE CITY OF TRUTH OR CONSEQUENCES, NEW MEXICO, TO BE HELD IN THE COMMISSION CHAMBERS, 405 W. 3RD ST., ON WEDNESDAY, MARCH 27, 2024; TO START AT 9:00 A.M.

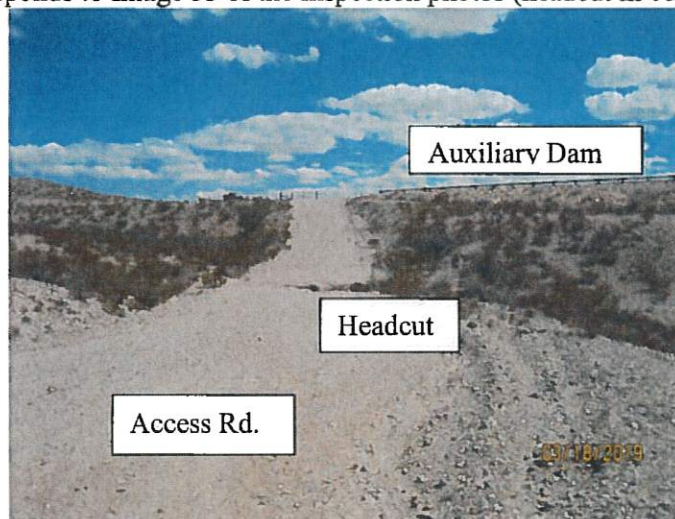
1. Repair the large erosion gully at the south end of the auxiliary spillway and curtail future erosion by redirecting surface runoff. The gully is large and if left unaddressed could result in a potential failure mode at the left abutment of the auxiliary spillway.
2. Repair the large headcut and erosion gully that is present across the access road to the flood detention pool from the north end of the earthen auxiliary dam. See image below which corresponds to Image 53 of the inspection photos (headcut in center of image).

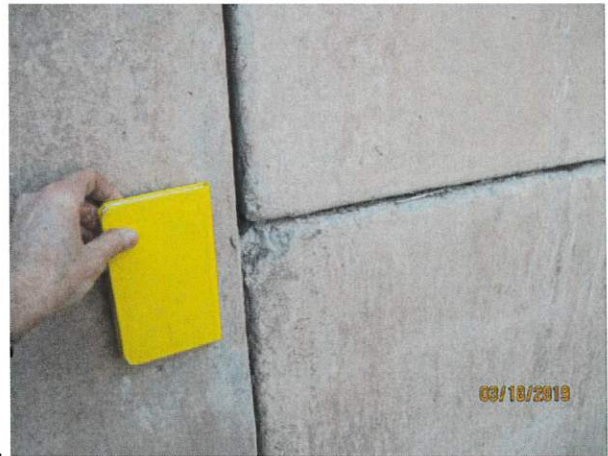
49.

**Images 47 through 50:** Examples of concrete defects requiring patching at several locations on the main dam.

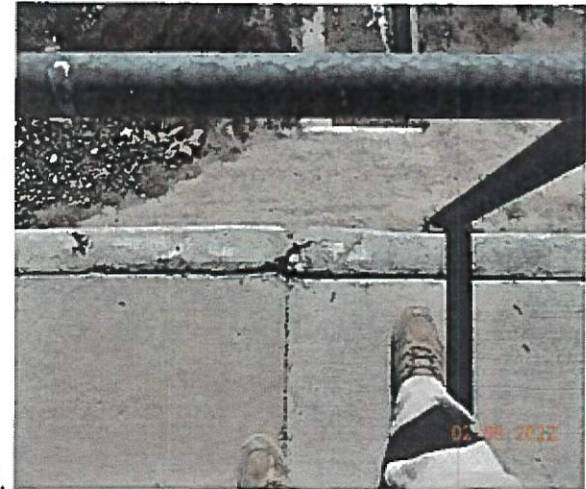
21.

**Images 20 through 22:** Westerly view along the primary spillway crest (Image 20), southerly view along the left side primary spillway training wall (Image 21), and view of the lower portion of the left downstream groin of the main dam and spalled concrete at a contraction joint (Image 22).

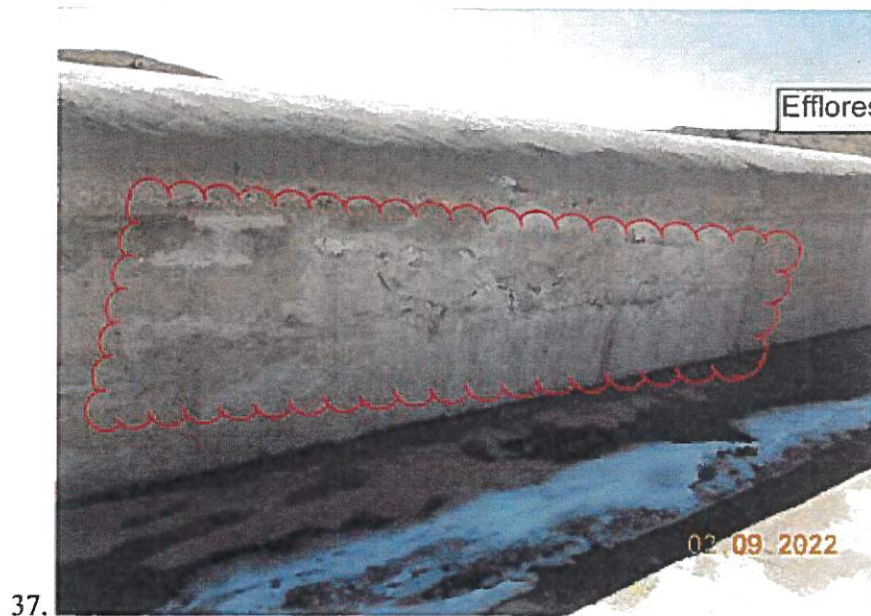
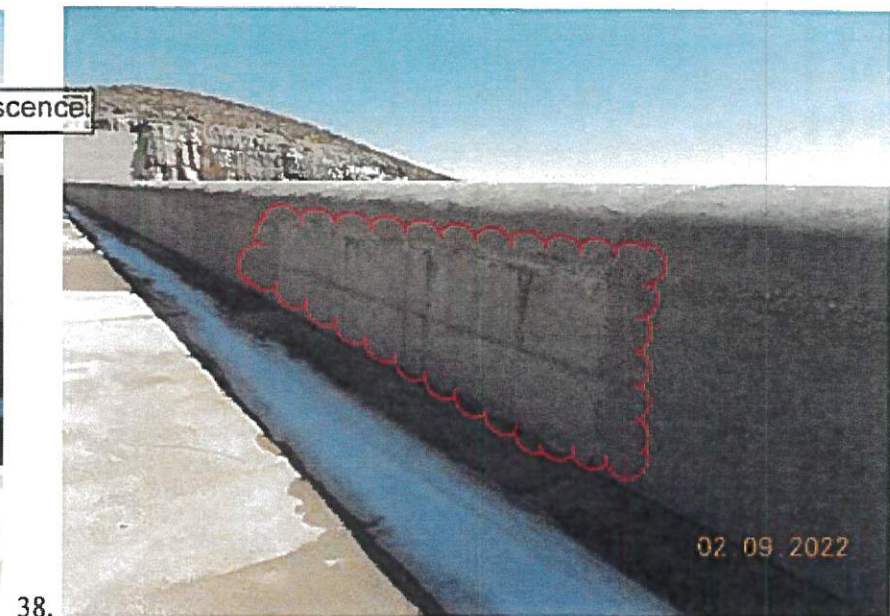
**Images 37 and 38:** Examples of concrete efflorescence and spalling on the upstream face of the emergency spillway ogee weir.

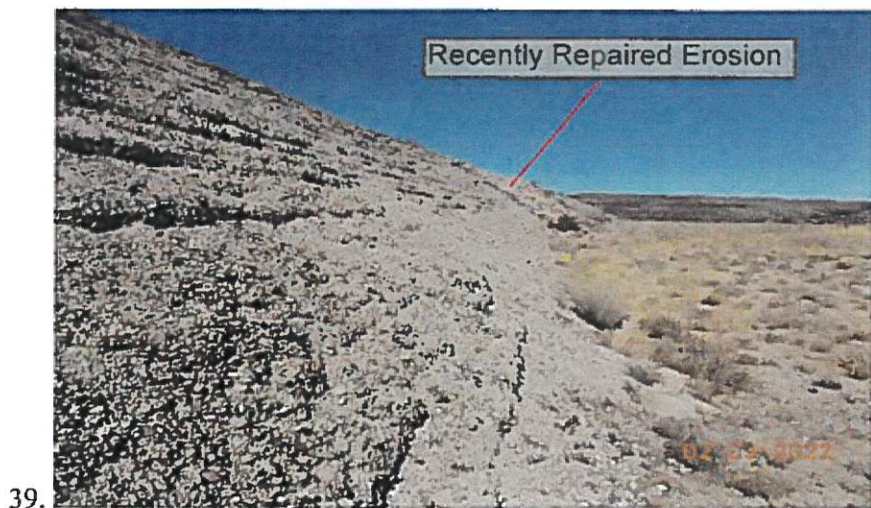
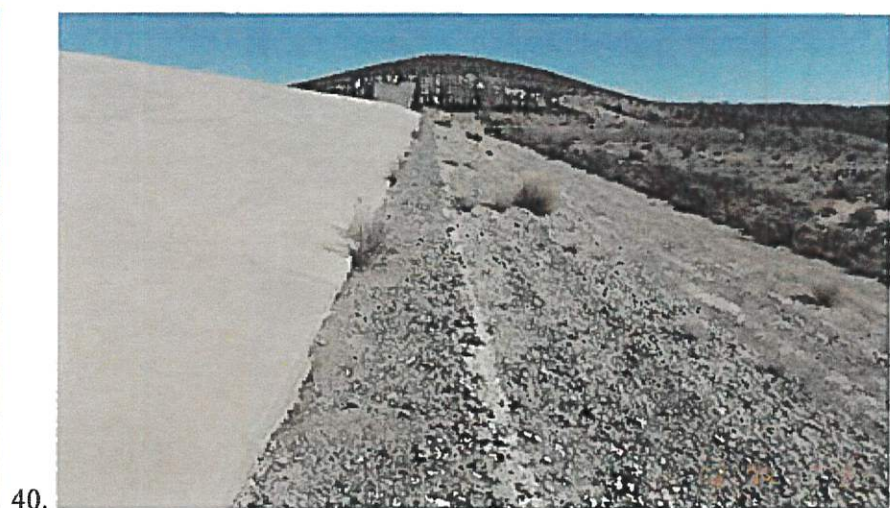
**Images 39 and 40:** Views of soil cement armoring on right side slope of emergency spillway approach channel (Image 39) and armoring on the downstream slope of the emergency spillway ogee section.

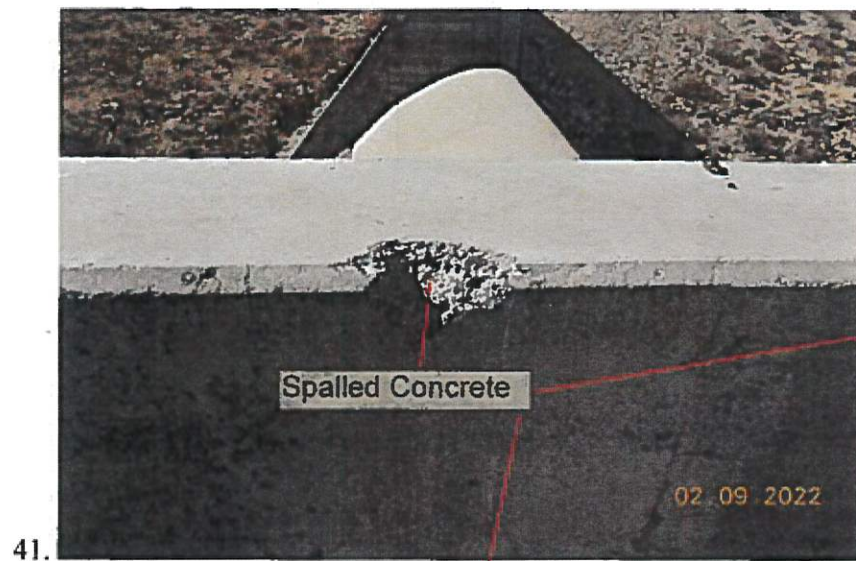
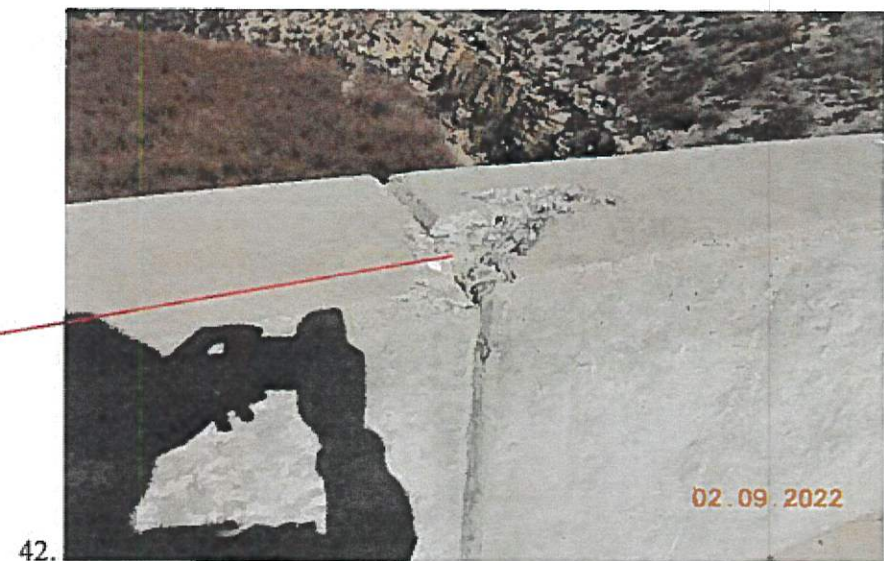
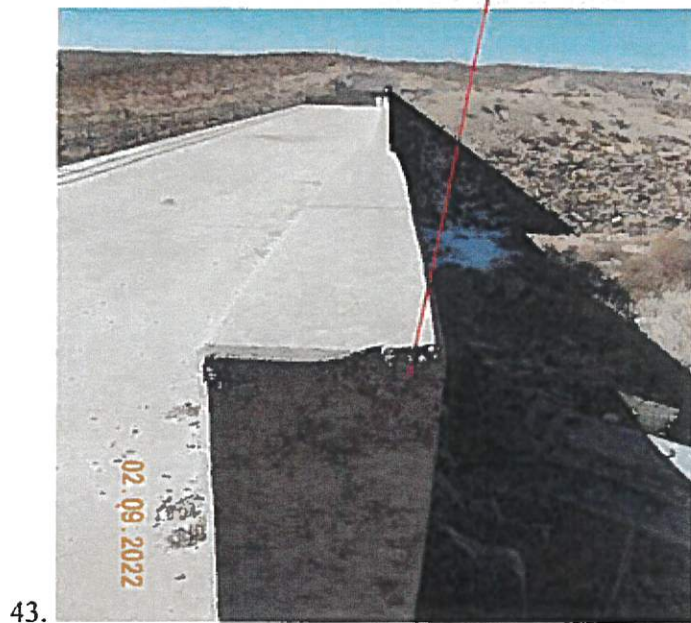
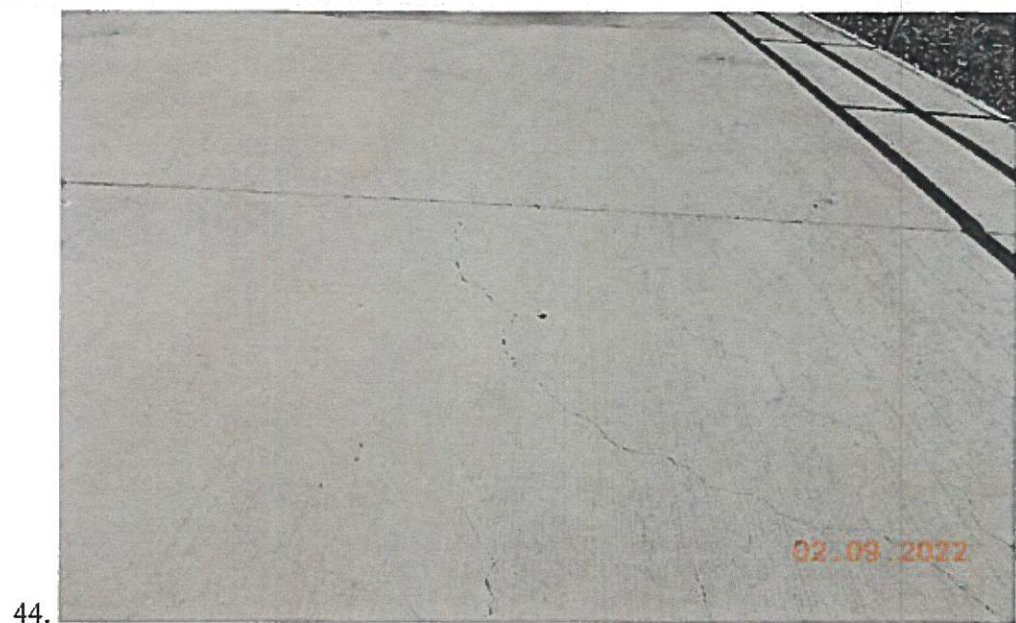
**Images 41 through 44:** Examples of damaged (spalled) concrete on the parapet walls of the main dam and shrinkage cracking on the crest of the main dam. Repair of the spalled concrete is required along with monitoring and documentation of the shrinkage cracks over time.

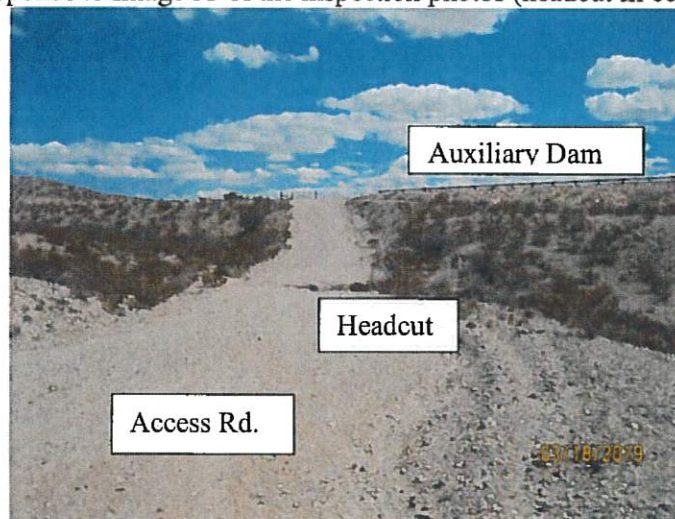
1. Repair the large erosion gully at the south end of the auxiliary spillway and curtail future erosion by redirecting surface runoff. The gully is large and if left unaddressed could result in a potential failure mode at the left abutment of the auxiliary spillway.
2. Repair the large headcut and erosion gully that is present across the access road to the flood detention pool from the north end of the earthen auxiliary dam. See image below which corresponds to Image 53 of the inspection photos (headcut in center of image).

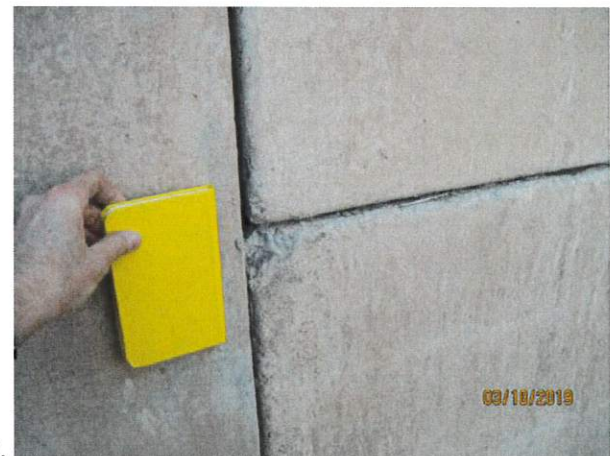
49.

**Images 47 through 50:** Examples of concrete defects requiring patching at several locations on the main dam.

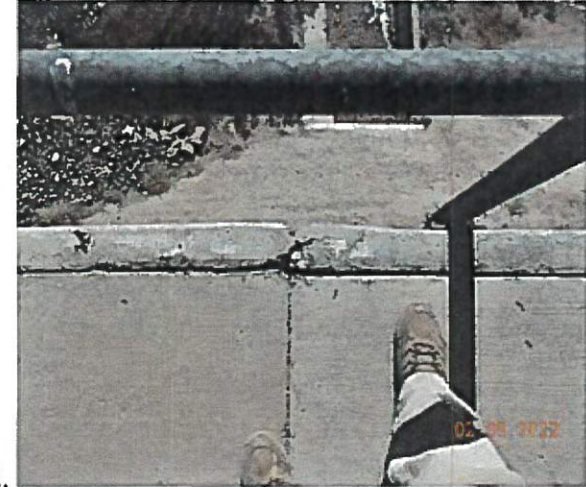
21.

**Images 20 through 22:** Westerly view along the primary spillway crest (Image 20), southerly view along the left side primary spillway training wall (Image 21), and view of the lower portion of the left downstream groin of the main dam and spalled concrete at a contraction joint (Image 22).

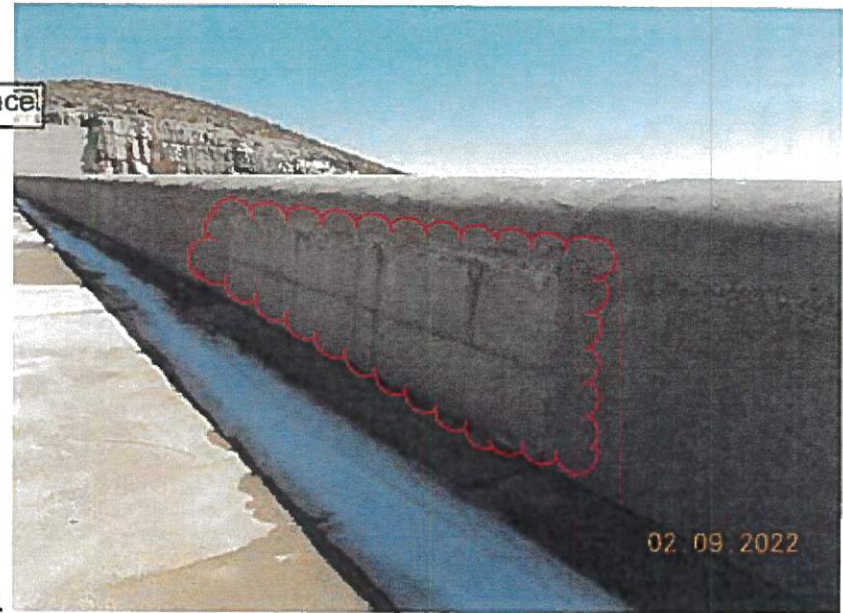
37.

**Images 37 and 38:** Examples of concrete efflorescence and spalling on the upstream face of the emergency spillway ogee weir.

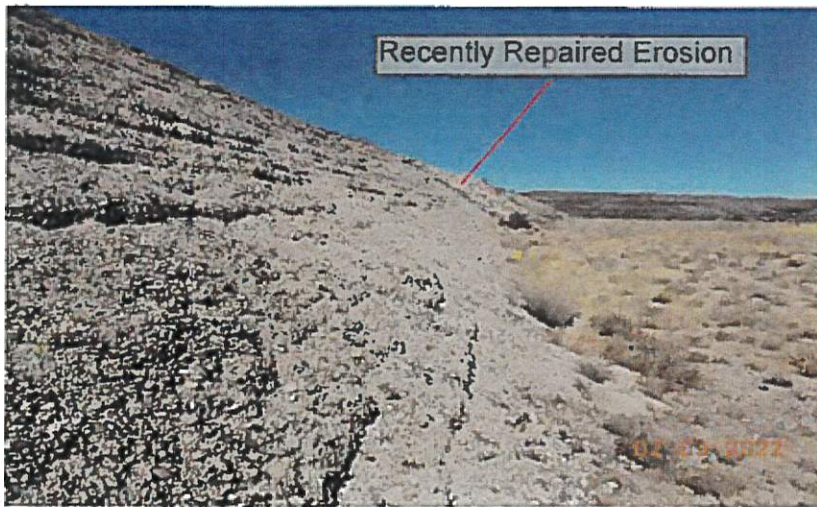
**Images 39 and 40:** Views of soil cement armoring on right side slope of emergency spillway approach channel (Image 39) and armoring on the downstream slope of the emergency spillway ogee section.

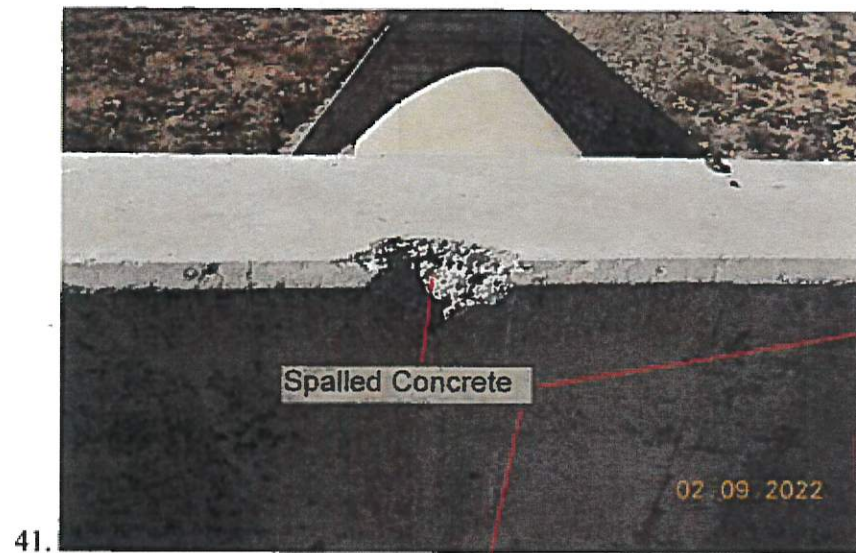
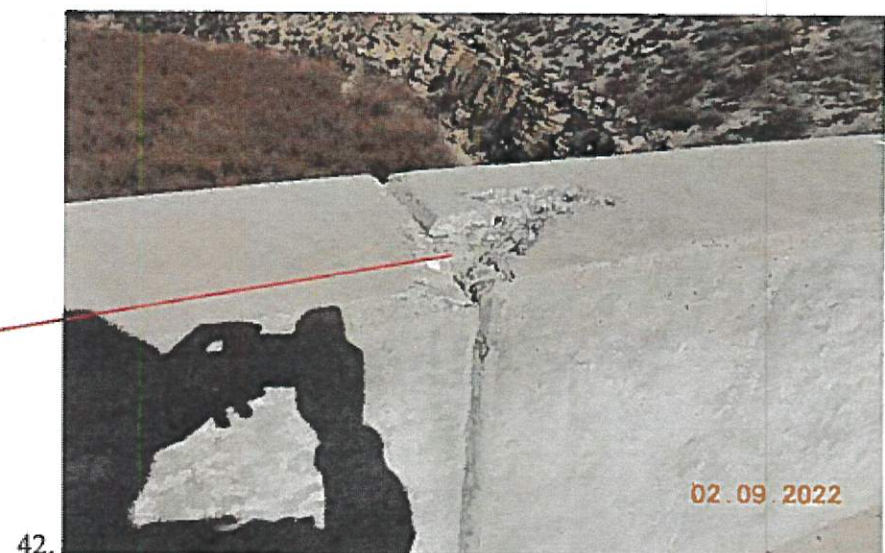
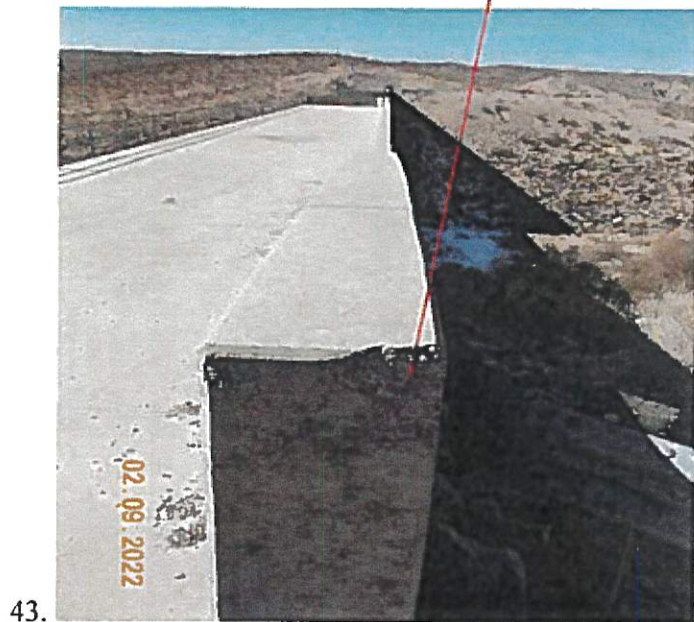
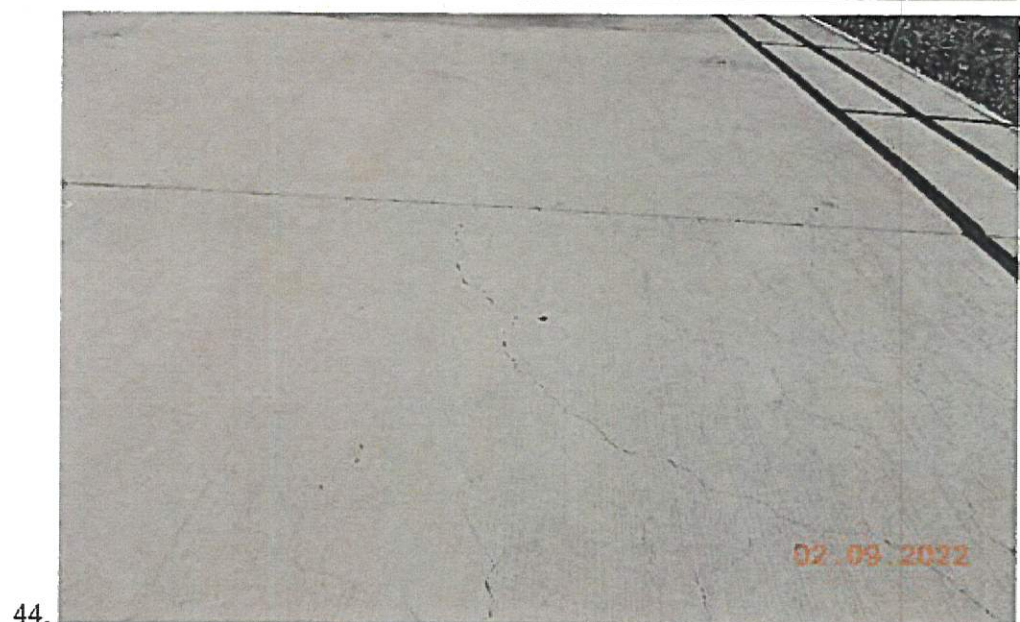
**Images 41 through 44:** Examples of damaged (spalled) concrete on the parapet walls of the main dam and shrinkage cracking on the crest of the main dam. Repair of the spalled concrete is required along with monitoring and documentation of the shrinkage cracks over time.

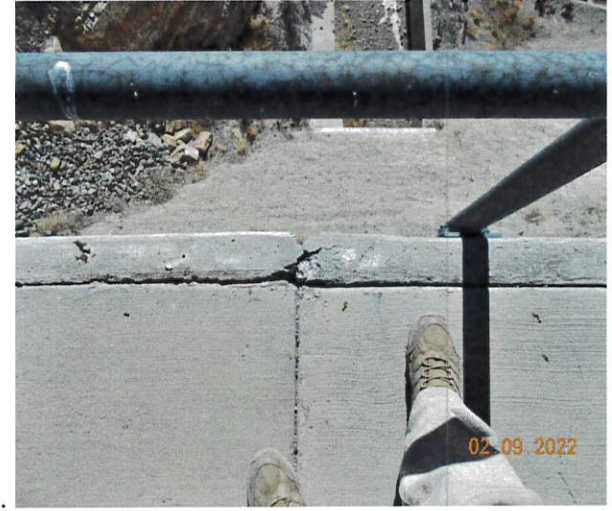
21.

**Images 20 through 22:** Westerly view along the primary spillway crest (Image 20), southerly view along the left side primary spillway training wall (Image 21), and view of the lower portion of the left downstream groin of the main dam and spalled concrete at a contraction joint (Image 22).

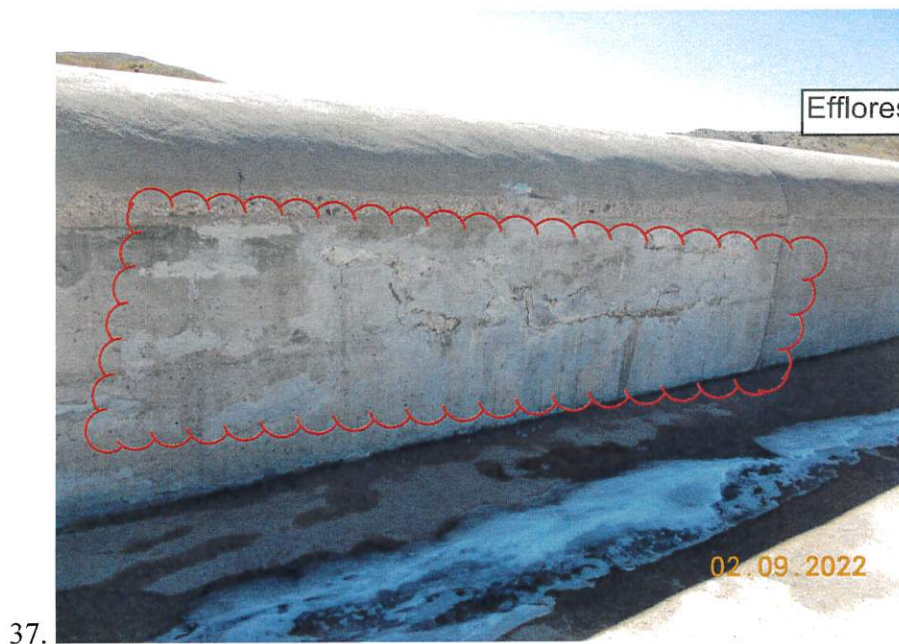
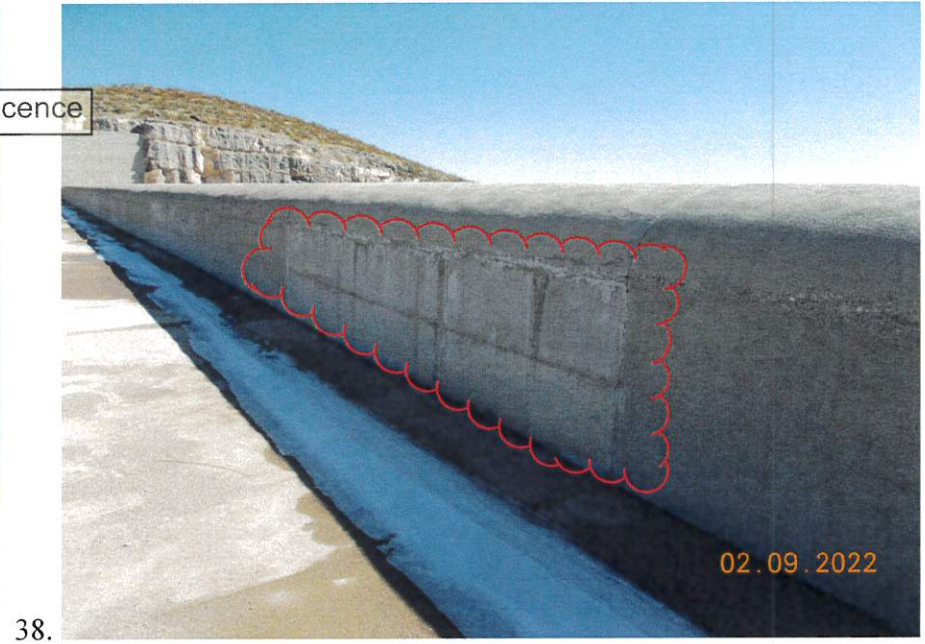
**Images 37 and 38:** Examples of concrete efflorescence and spalling on the upstream face of the emergency spillway ogee weir.

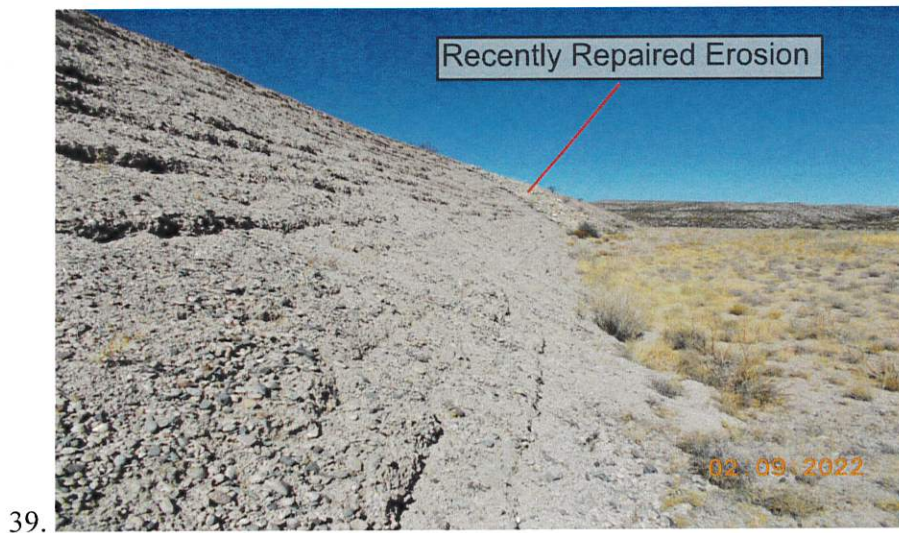
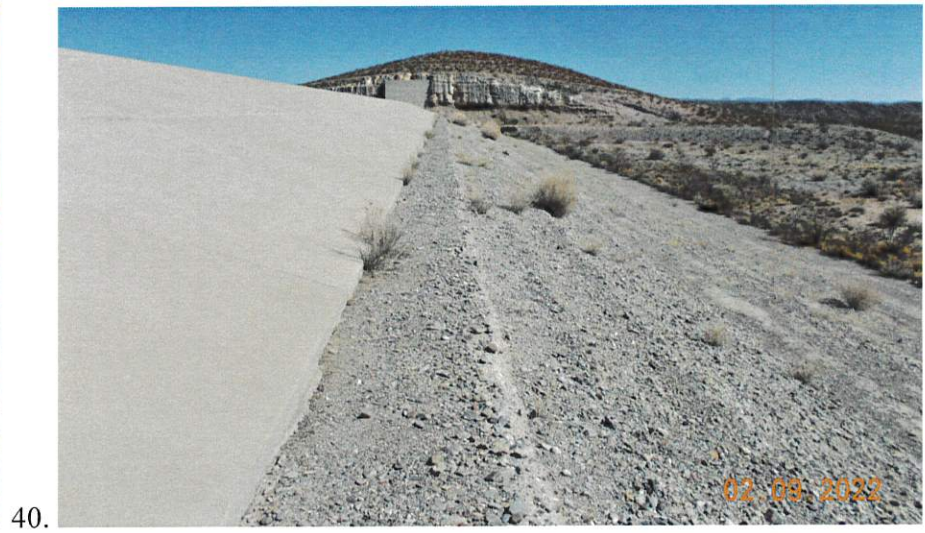
**Images 39 and 40:** Views of soil cement armoring on right side slope of emergency spillway approach channel (Image 39) and armoring on the downstream slope of the emergency spillway ogee section.

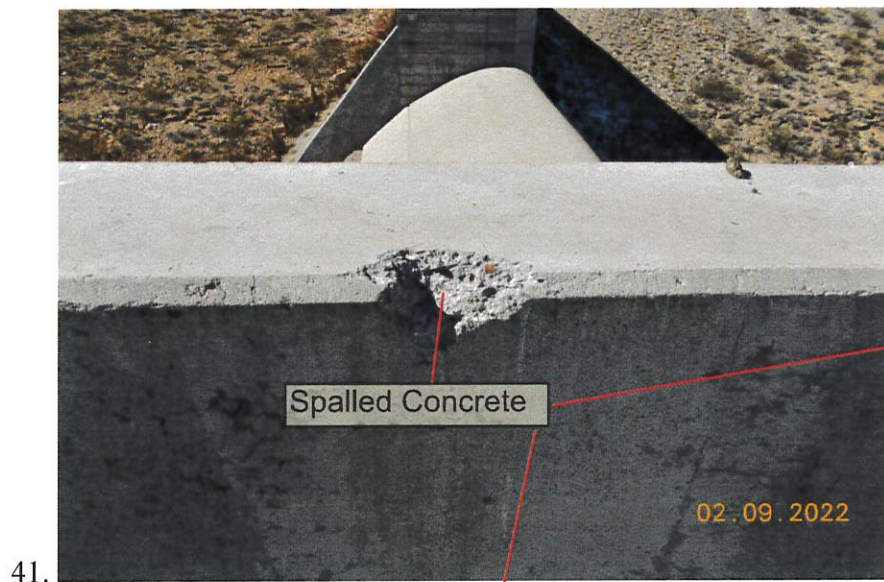
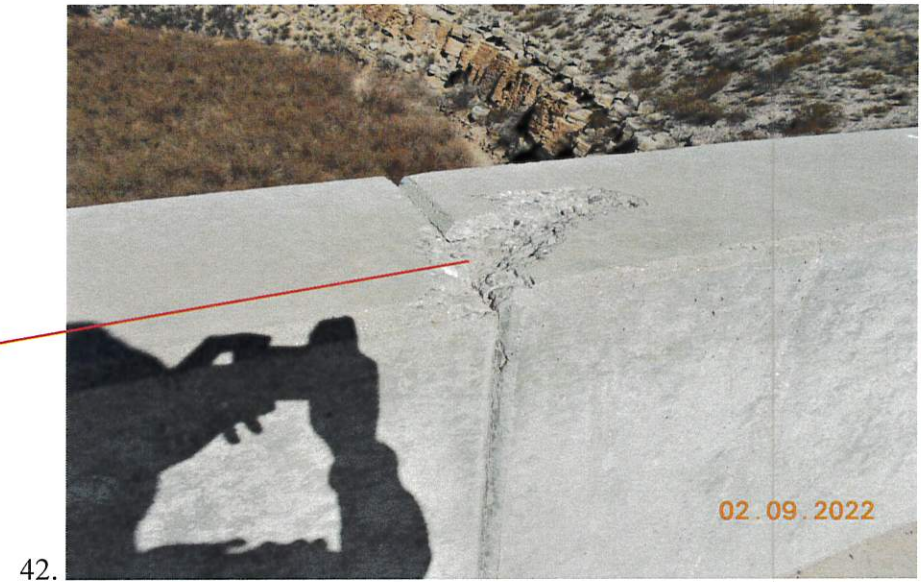
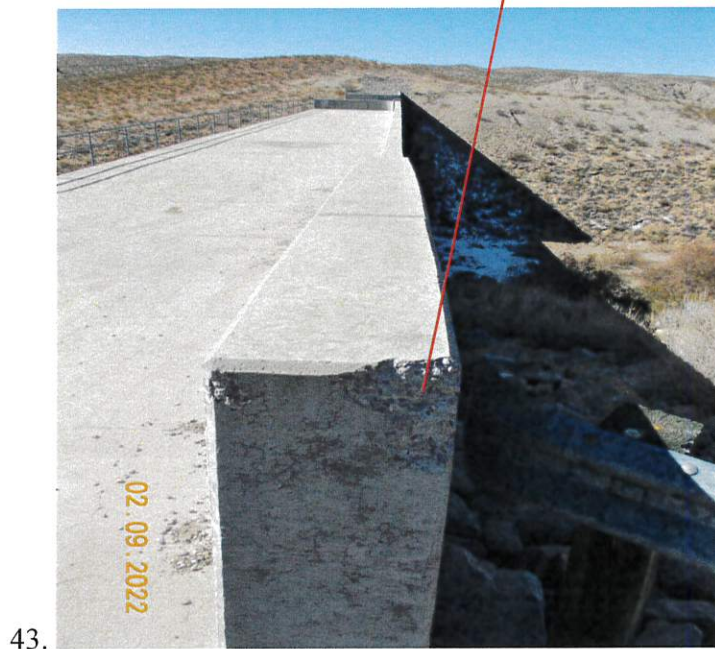
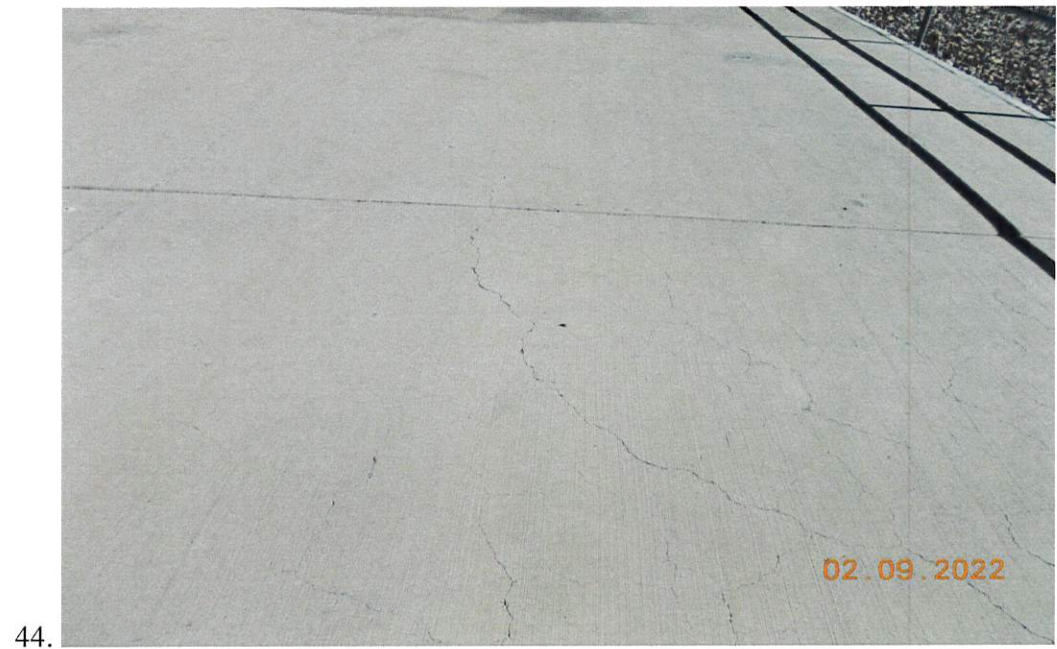
**Images 41 through 44:** Examples of damaged (spalled) concrete on the parapet walls of the main dam and shrinkage cracking on the crest of the main dam. Repair of the spalled concrete is required along with monitoring and documentation of the shrinkage cracks over time.

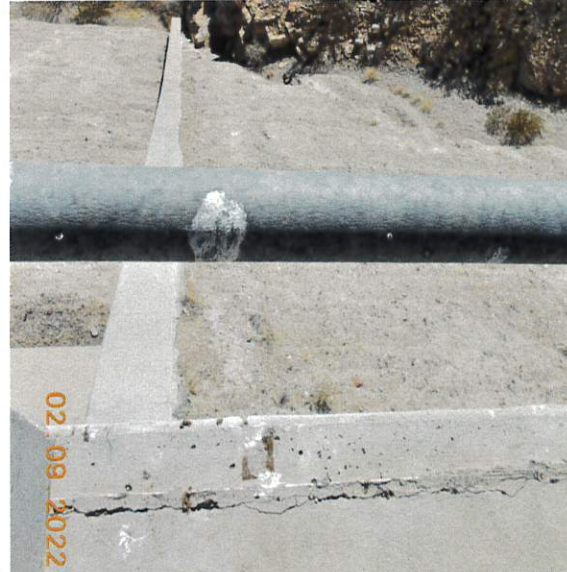
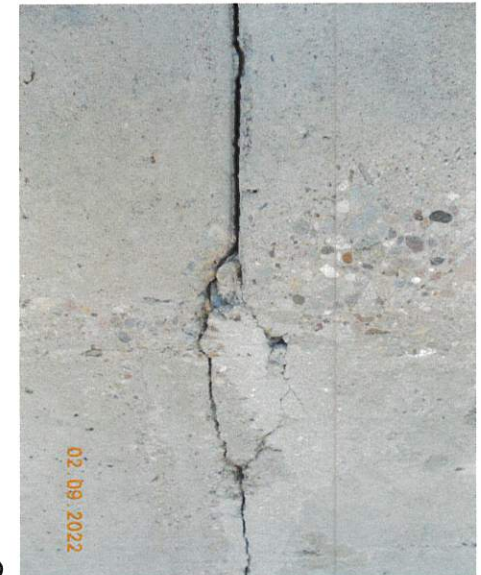
47. 48. 49. **Images 47 through 49:** Examples of offset joints and cracks on the upstream face, crest of the main dam and upstream face of the emergency spillway ogee section that should be monitored over time.

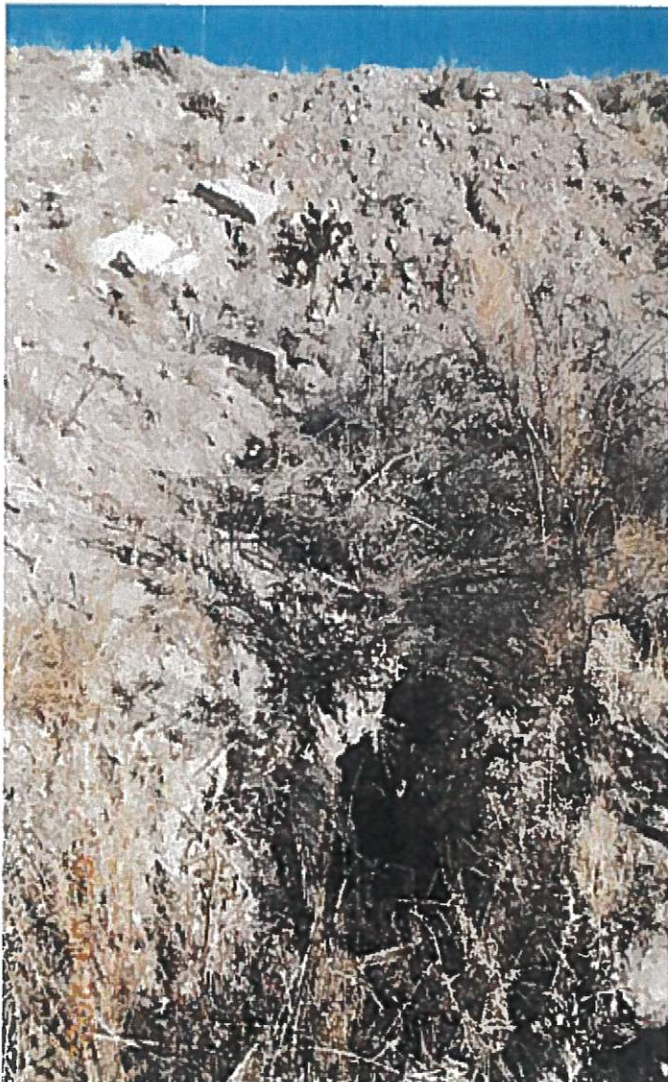
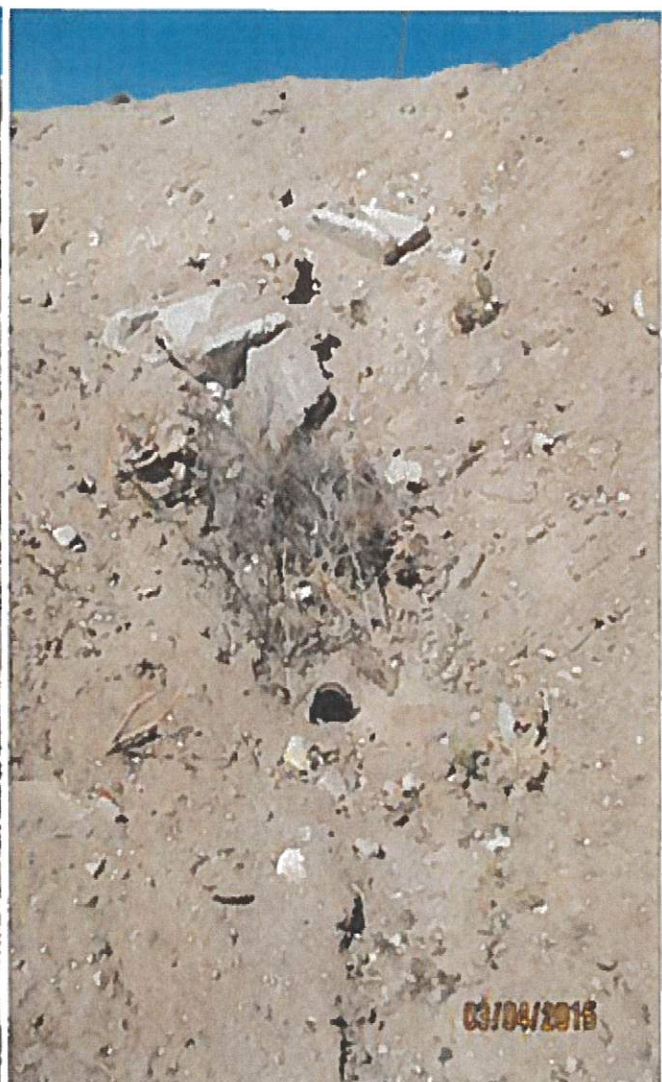
| Notes: | Interior inspections of both outlet conduits (8-inch and 36-inch) are required. The outfall (downstream end) of the 8-inch dia. Conduit was either buried or obscured by vegetation and not seen during this inspection (the 8-inch dia. outfall needs to be maintained as exposed). For reference, see the photographs below, the outfall is obscured in the 2022 image and exposed in the 2015 image. | | | |

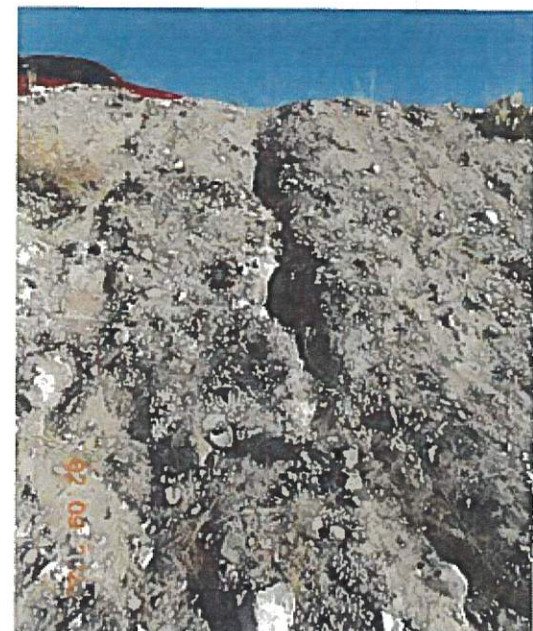
22.

**Images 21 through 23:** Erosion gullies in need of repair on the upstream slope (Images 21 and 22) and more of the same on the downstream slope (Image 23).

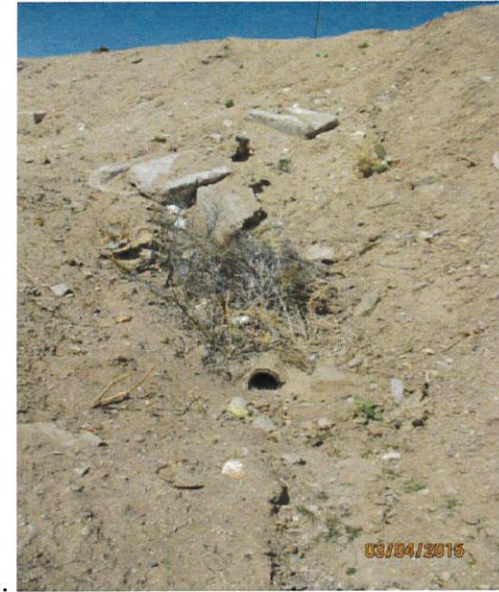
13.

**Images 13 and 14:** Upstream views of the lower level outlet outfall in 2022 and 2015, respectively. The outfall is currently obscured and needs to be maintained in an exposed condition.

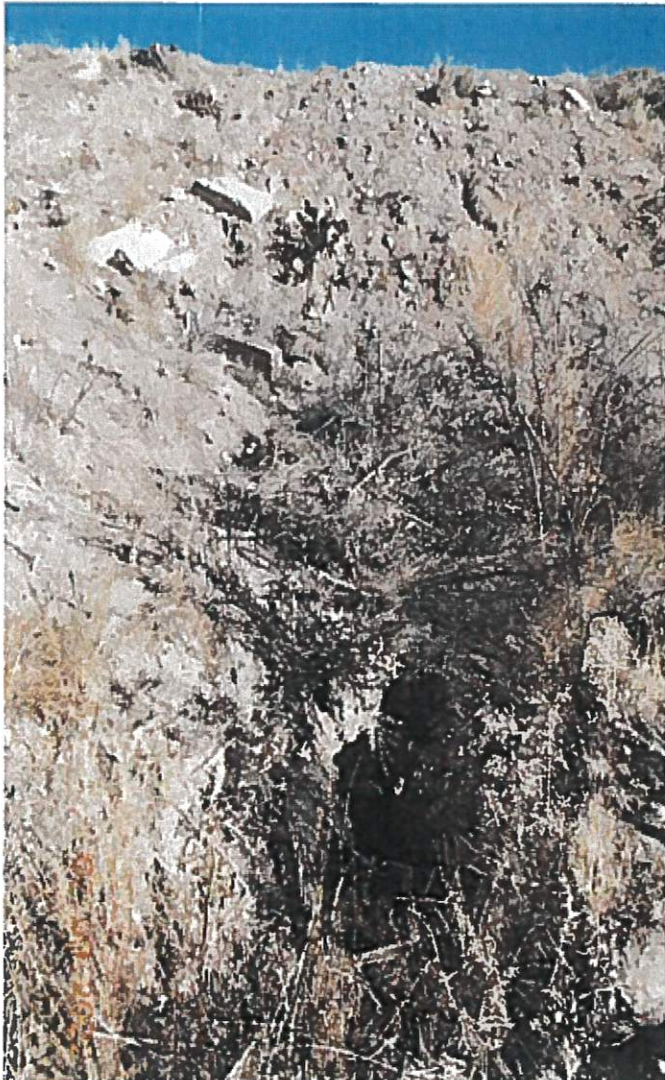
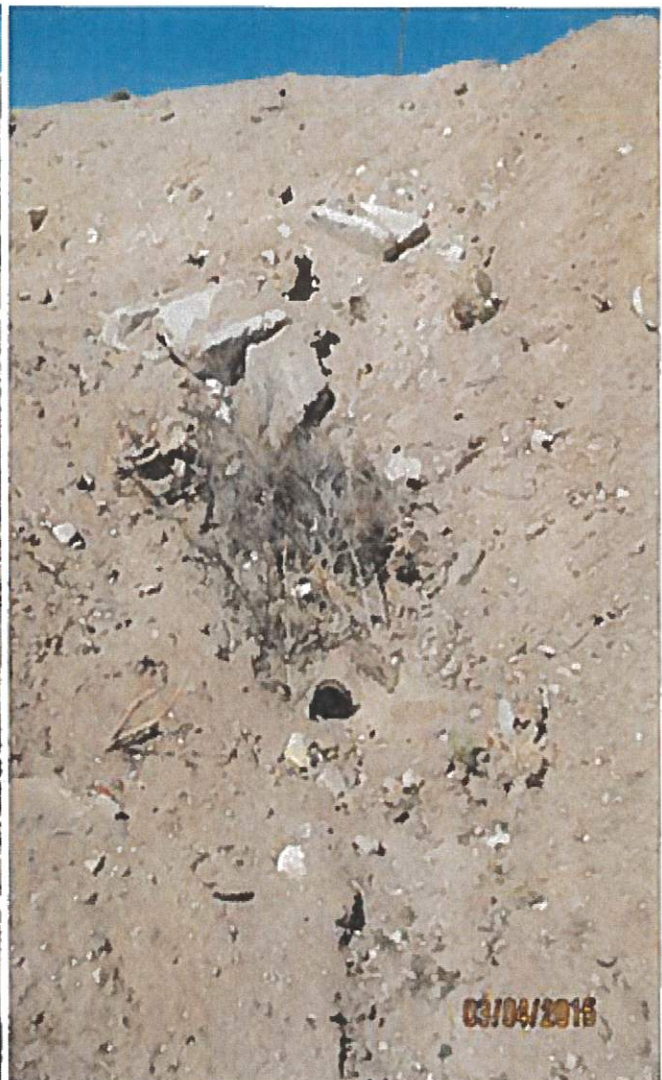
| Notes: | Interior inspections of both outlet conduits (8-inch and 36-inch) are required. The outfall (downstream end) of the 8-inch dia. Conduit was either buried or obscured by vegetation and not seen during this inspection (the 8-inch dia. outfall needs to be maintained as exposed). For reference, see the photographs below, the outfall is obscured in the 2022 image and exposed in the 2015 image. | | | |

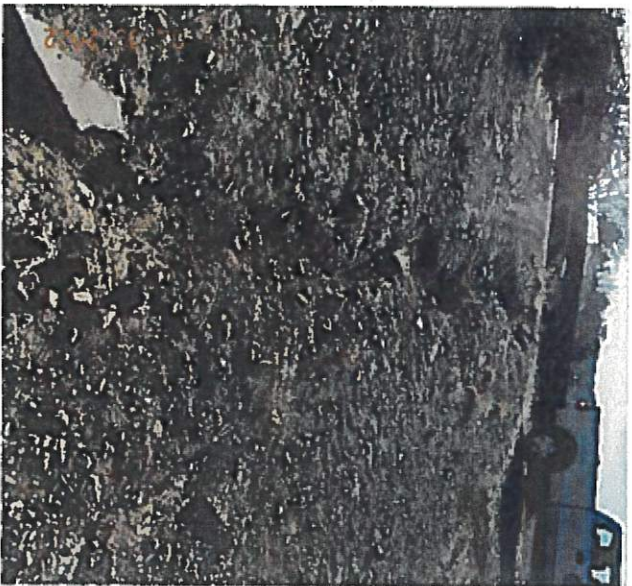
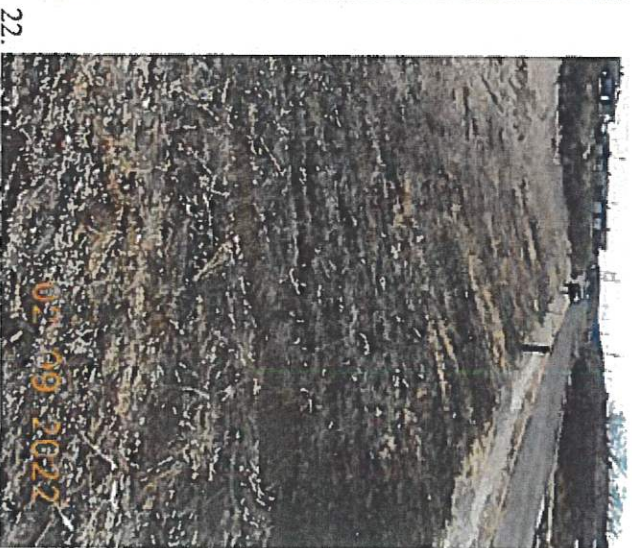
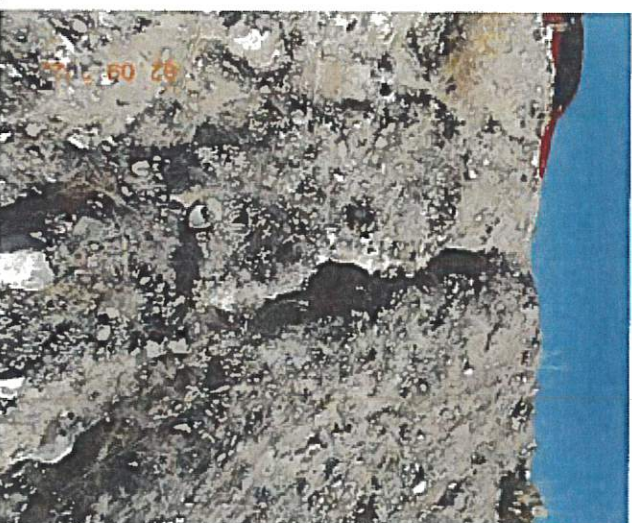
21. Images 21 through 23: Erosion gullies in need of repair on the upstream slope (Images 21 and 22) and more of the same on the downstream slope (Image 23).

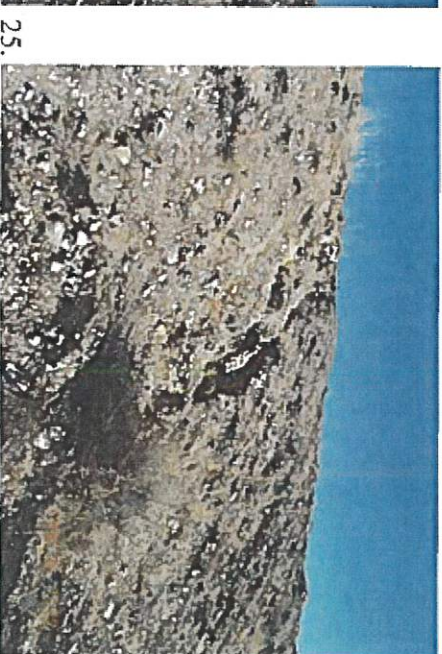
24. Images 24 through 26: Additional views of erosion on the downstream slope. A gravel/cobble mulch placed on the embankment slopes and abutment contacts at the upstream and downstream groins of the dam would serve well towards diminishing erosion.

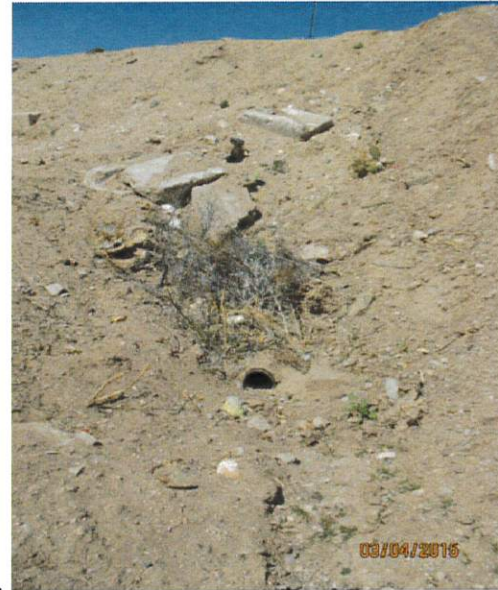
13.

**Images 13 and 14:** Upstream views of the lower level outlet outfall in 2022 and 2015, respectively. The outfall is currently obscured and needs to be maintained in an exposed condition.

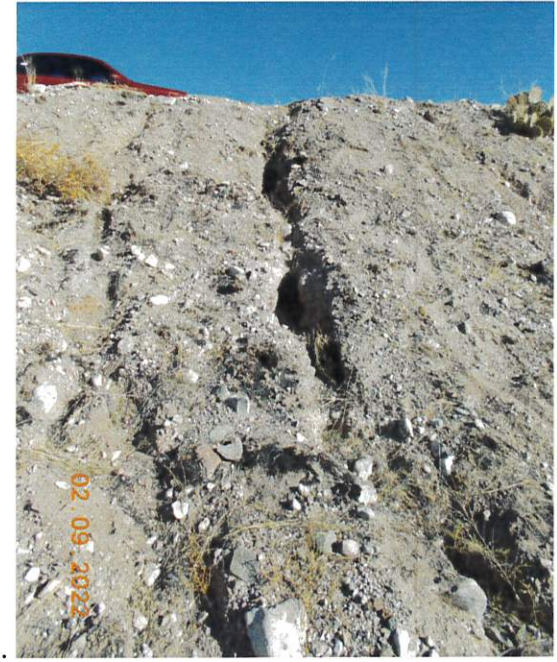
22.

**Images 21 through 23:** Erosion gullies in need of repair on the upstream slope (Images 21 and 22) and more of the same on the downstream slope (Image 23).

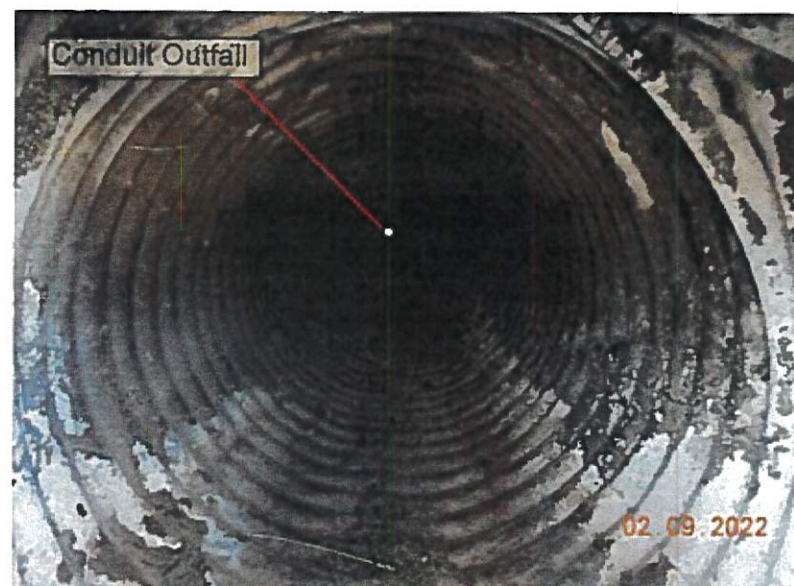
16.

**Images 16 and 17:** Downstream (southerly) views of the outlet works intake. The steel orifice plate significantly limits the capacity of the outlet conduit and is highly susceptible to clogging during a flood event. The orifice plate needs to be removed and replaced with a properly designed NRCS type ported riser. The CMP asphalt liner is deteriorated, an interior inspection of the conduit is required to verify the overall condition of the conduit.

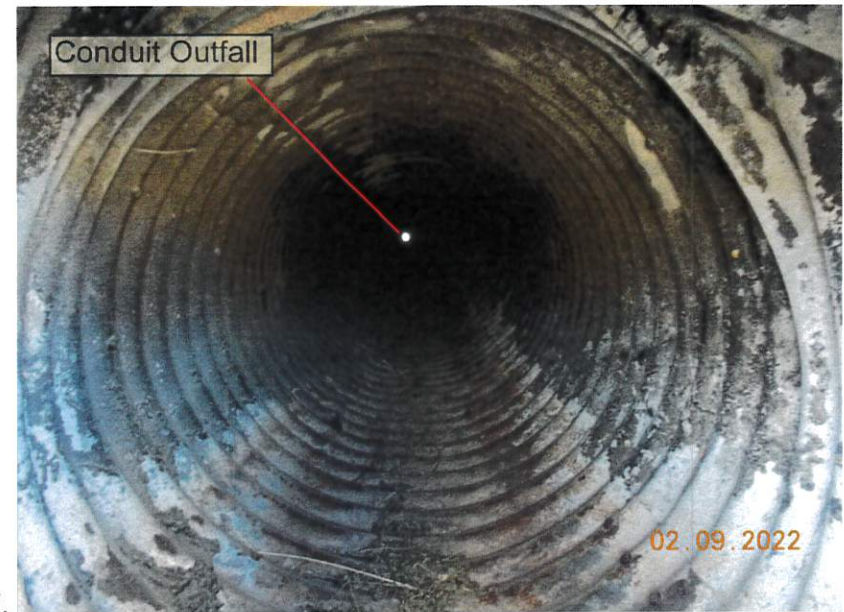
16.

**Images 16 and 17:** Downstream (southerly) views of the outlet works intake. The steel orifice plate significantly limits the capacity of the outlet conduit and is highly susceptible to clogging during a flood event. The orifice plate needs to be removed and replaced with a properly designed NRCS type ported riser. The CMP asphalt liner is deteriorated, an interior inspection of the conduit is required to verify the overall condition of the conduit.
