## REGULAR MEETING

THE REGULAR MEETING OF THE CITY COMMISSION OF THE CITY OF TRUTH OR CONSEQUENCES, NEW MEXICO, TO BE HELD IN THE COMMISSION CHAMBERS, 405 W. 3RD ST., ON WEDNESDAY, MARCH 27, 2024; TO START AT 9:00 A.M.

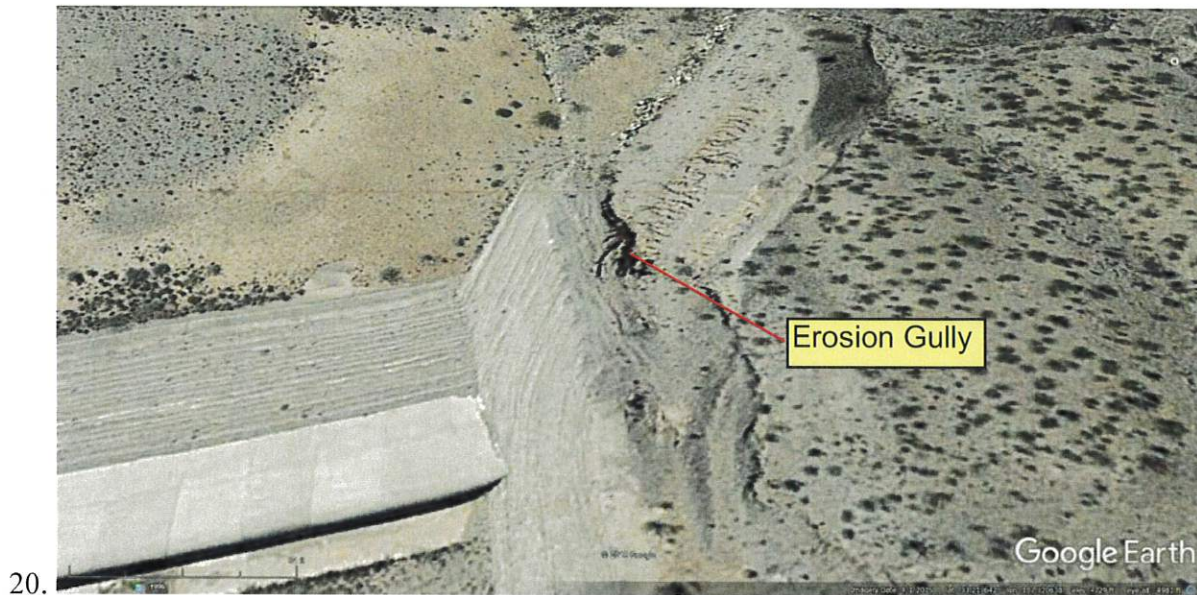
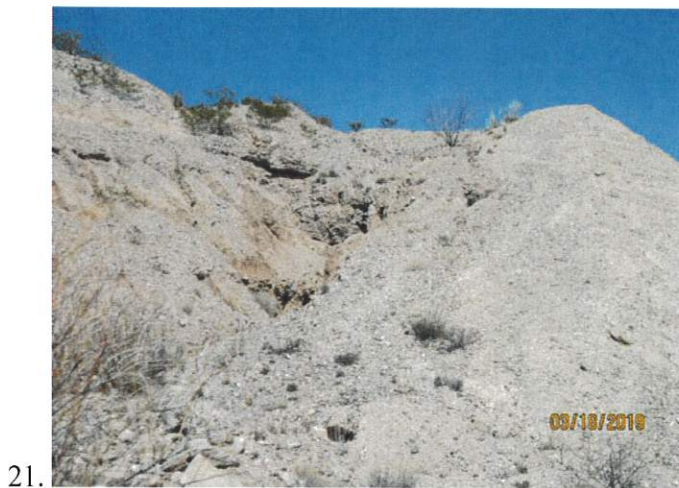
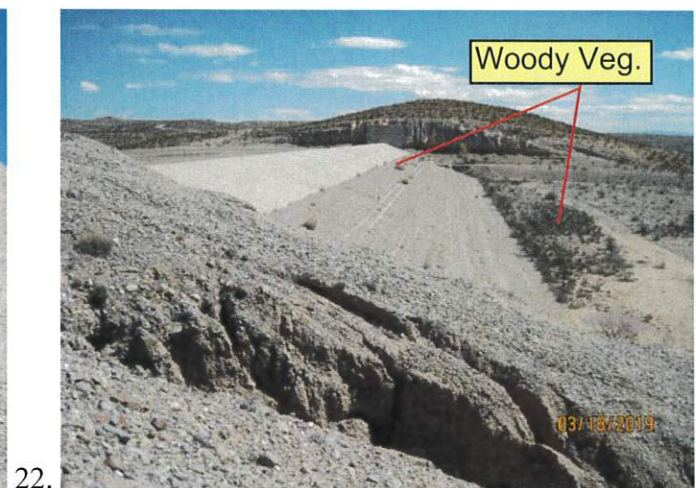
**Images 20 through 22:** Aerial view from GoogleEarth (Image 20) of large erosion gully located along the soil cement armored right abutment of the auxiliary spillway; additional views of the same erosion gully seen from ground level (Images 21 and 22).

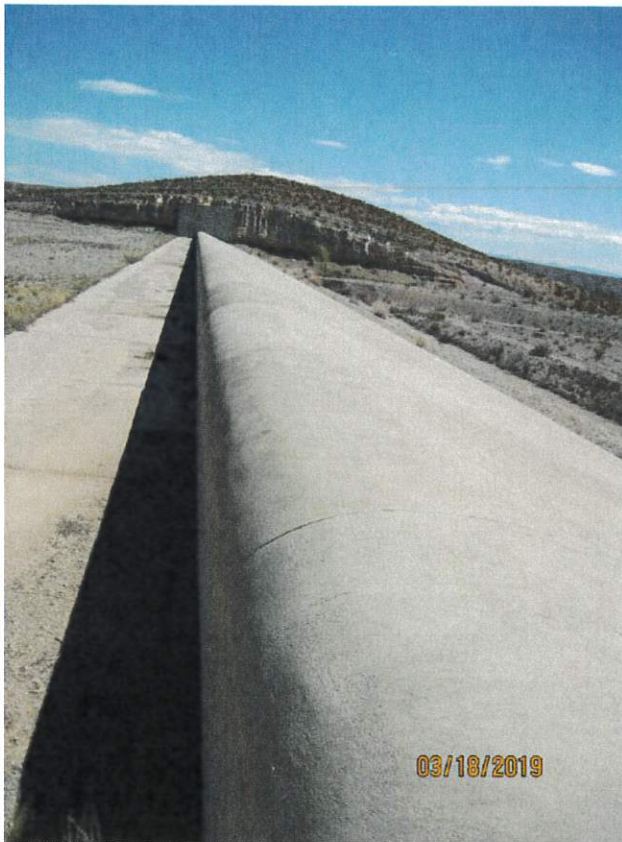
25.

**Images 25 through 29:** Various views of the auxiliary spillway with defects as indicated.

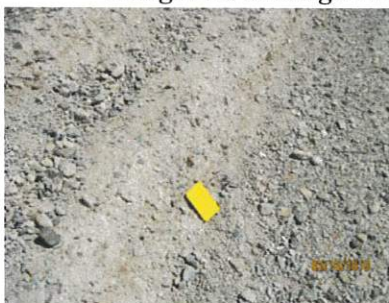
30.

**Images 30 through 32:** Typical views of details pertaining to the auxiliary spillway; RCC degradation on the downstream stepped section of the spillway (Image 30), deterioration of one of several patched portions of upstream face of the ogee section (Image 31), one of several daylighted drain outfalls on the downstream face auxiliary spillway (Image 32).

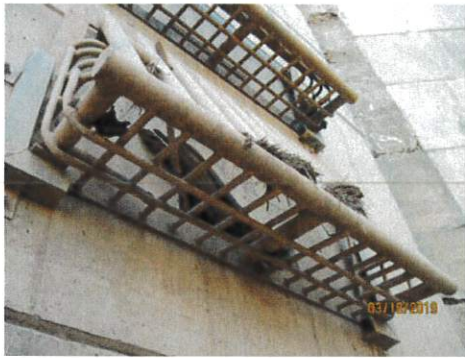
36.

**Images 36 through 38:** Examples of several partially plugged ports on the outlet works lower-level intake.

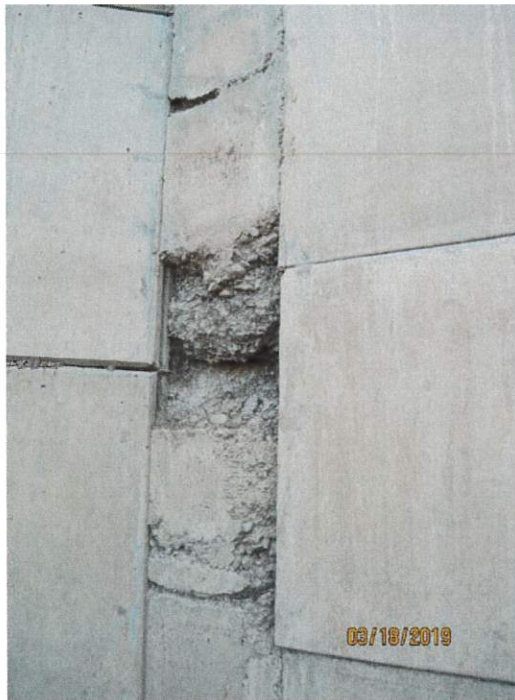
47.

**Images 47 through 50:** Examples of concrete defects requiring patching at several locations on the main dam.

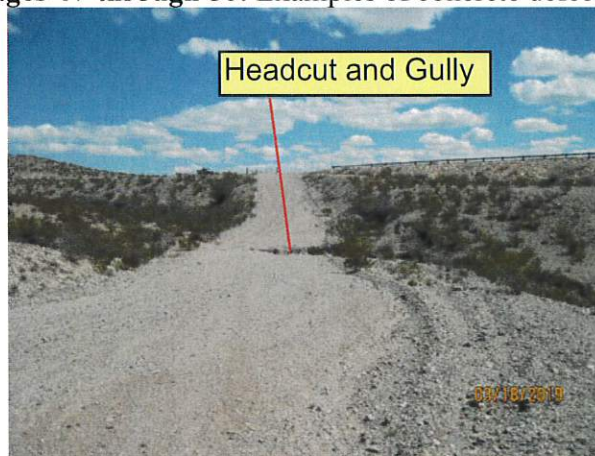
51.

**Image 51:** Headcut and erosion across access road to the detention basin. **Image 52:** Emerging woody vegetation emerging on the downstream face of the dam.

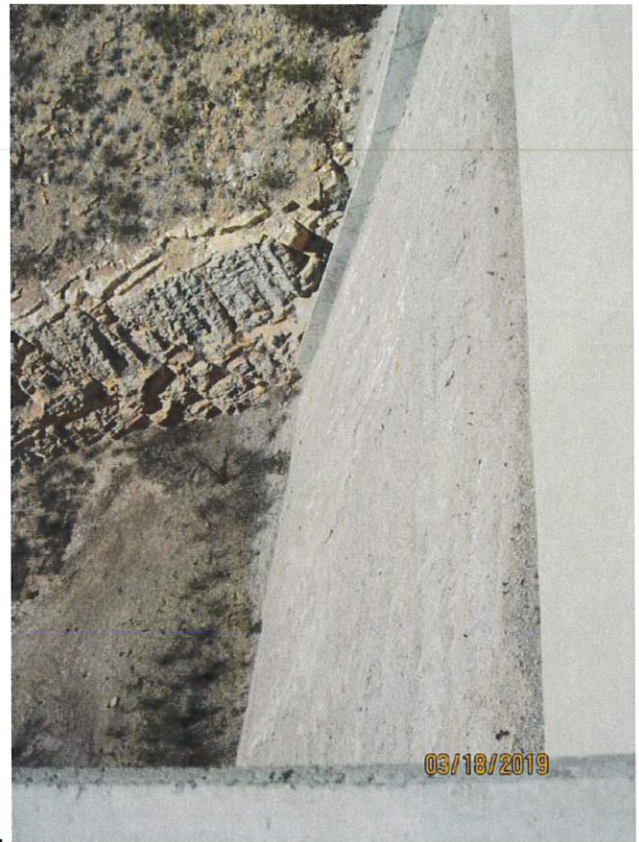
8.

**Images 8 through 10:** Southwesterly view across the service spillway (Image 8), view of the service spillway discharge chute (Image 9), and northeasterly view of the main dam / service spillway (Image 10).

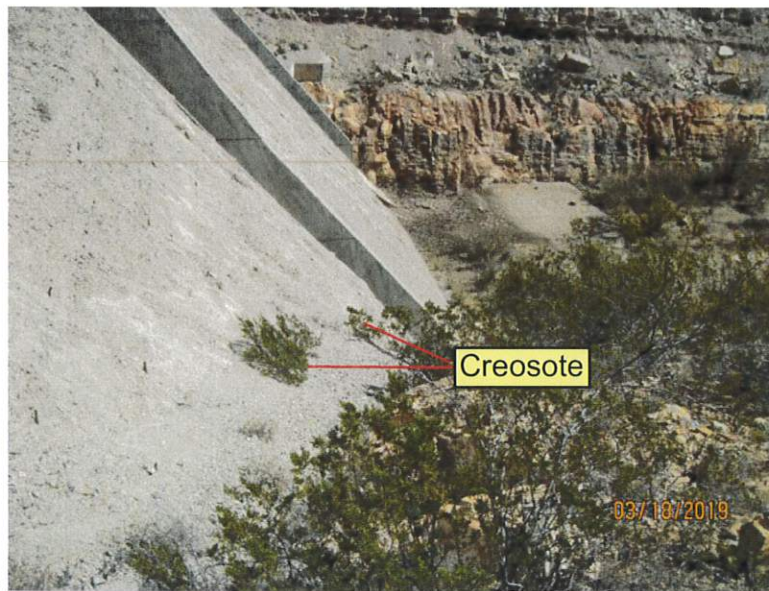
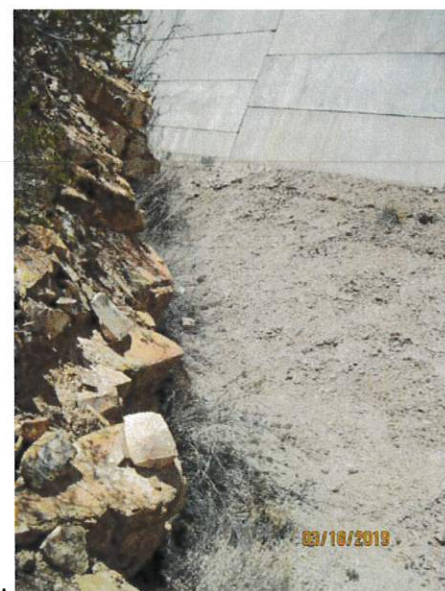
**Images 11 and 12:** Partial views of the right downstream groin of the main dam as seen from the vicinity of the right abutment contact.

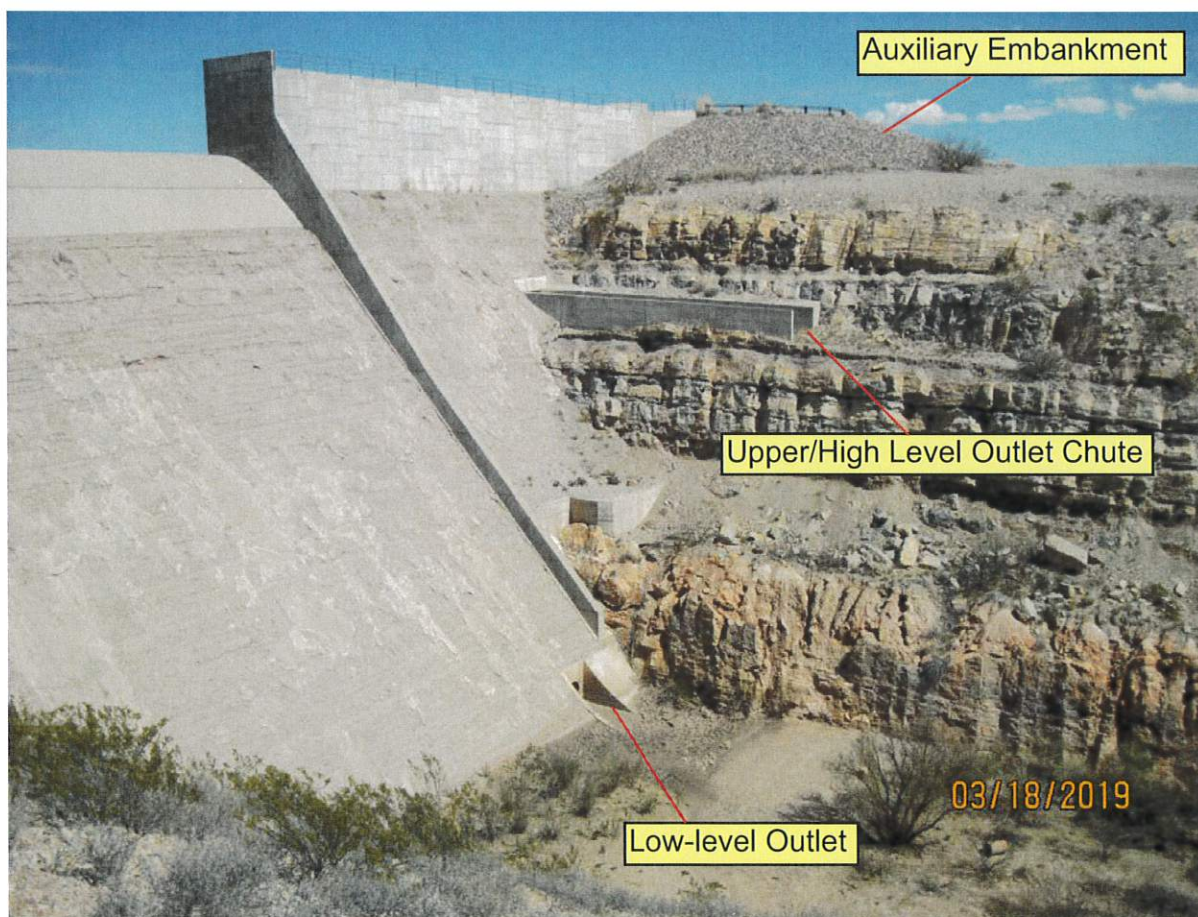
13.

**Image 13:** Easterly view of the left downstream groin with low-level and high-level outlet works features as indicated.

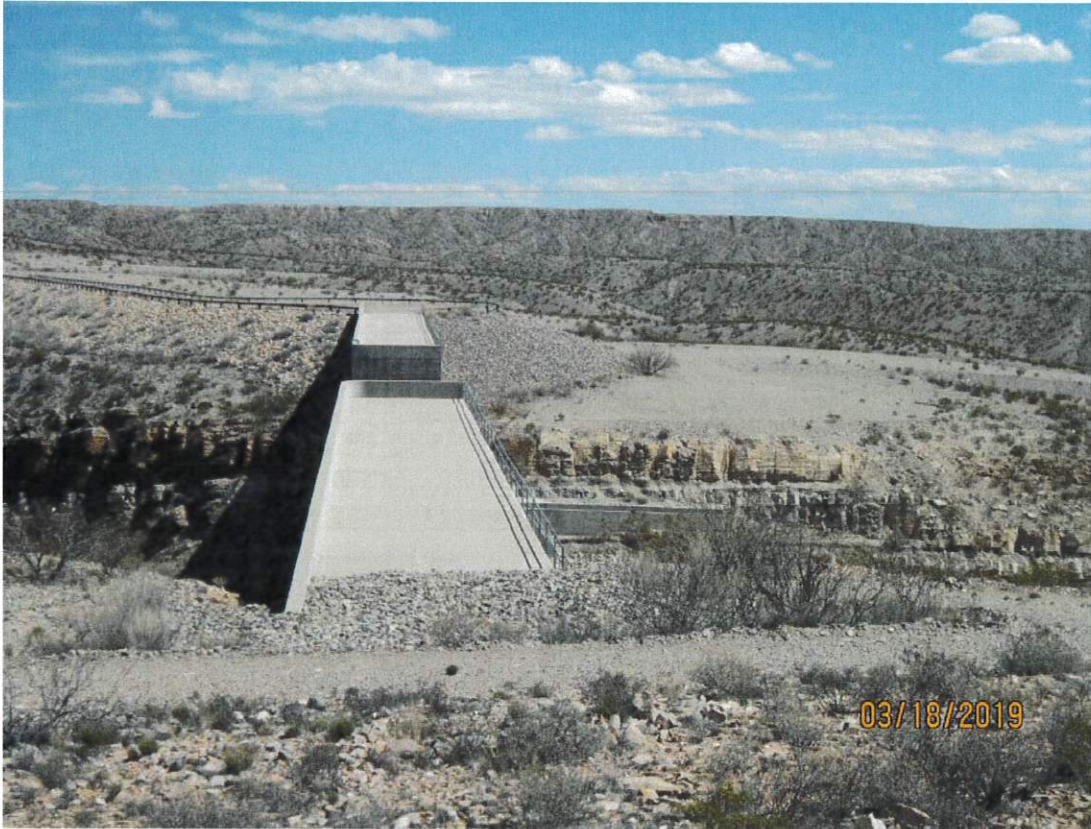
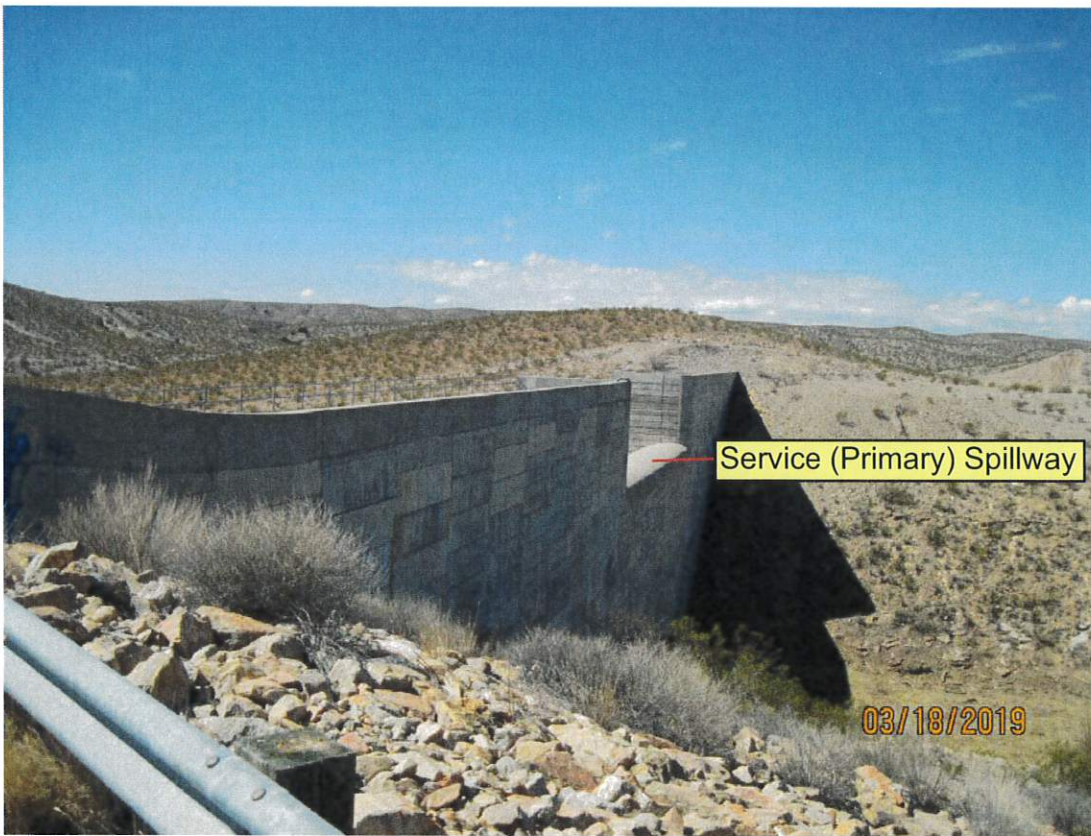
**Images 14 and 15:** Northeasterly and southwesterly views, respectively, along the longitudinal axis of the main dam and the upstream face of the main dam with additional features as indicated.

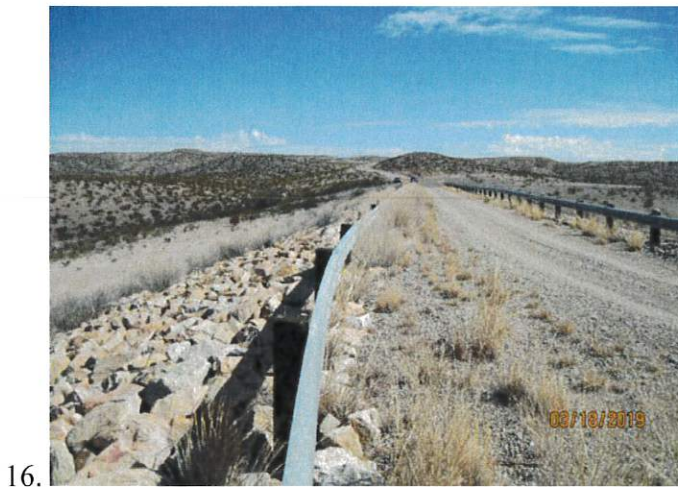
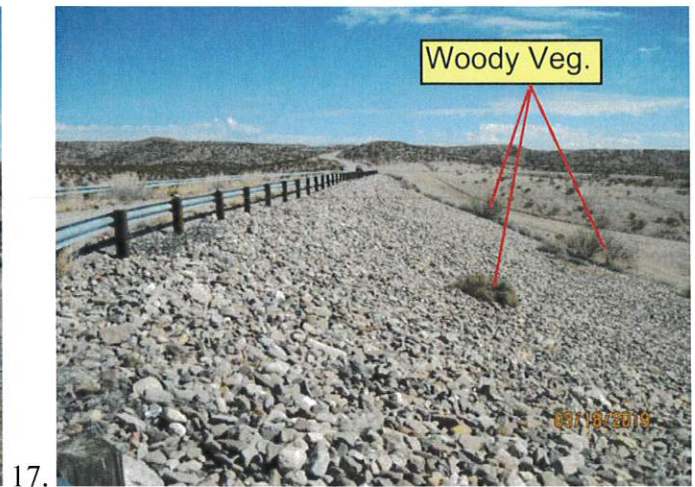
**Images 16 and 17:** Easterly views along the upstream slope and crest, and downstream slope of the auxiliary embankment, respectively. Images captured from the vicinity of the right abutment contact of the main dam with the auxiliary embankment.

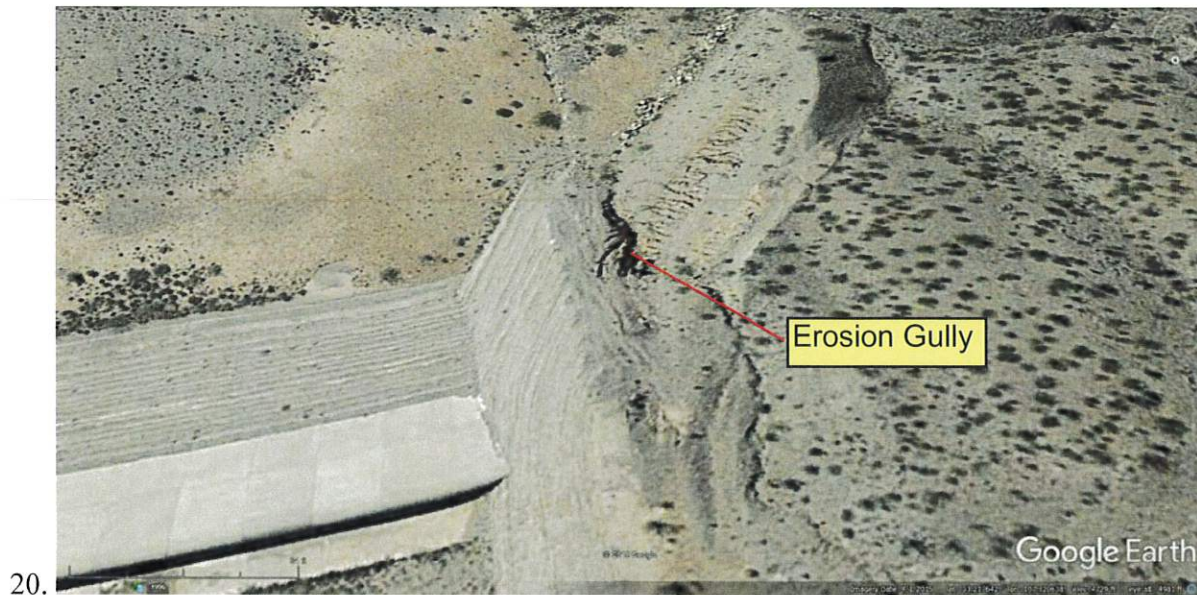
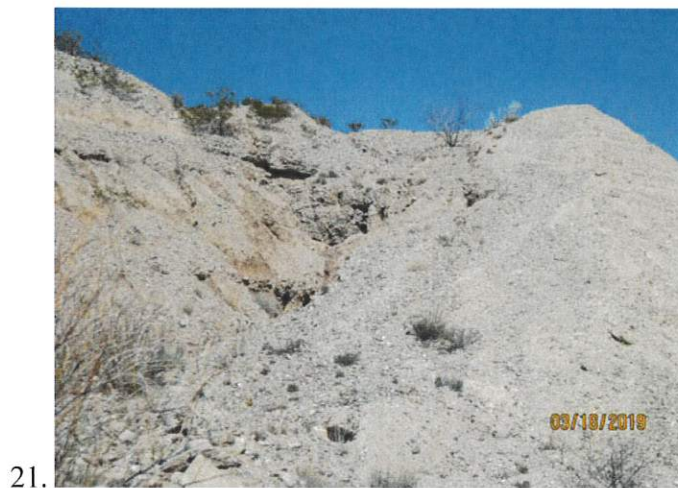
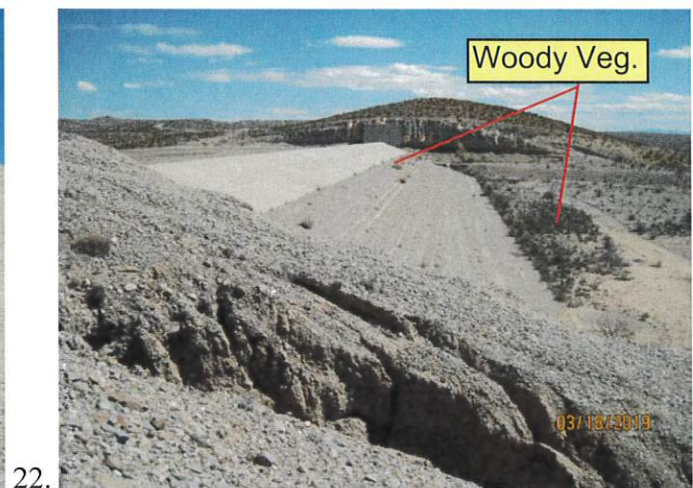
**Images 20 through 22:** Aerial view from GoogleEarth (Image 20) of large erosion gully located along the soil cement armored right abutment of the auxiliary spillway; additional views of the same erosion gully seen from ground level (Images 21 and 22).

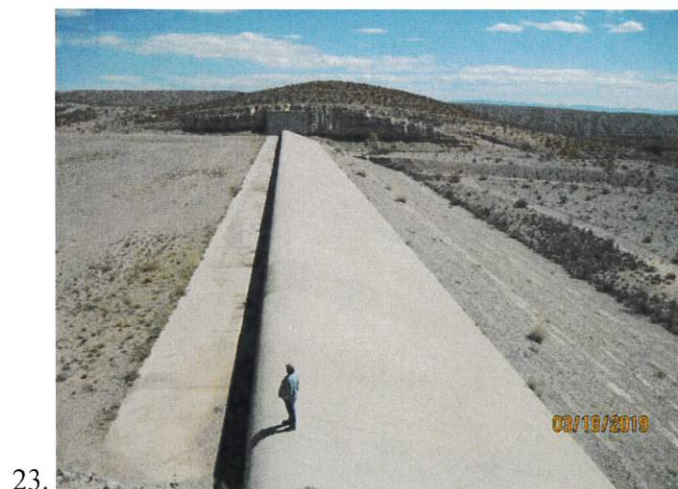
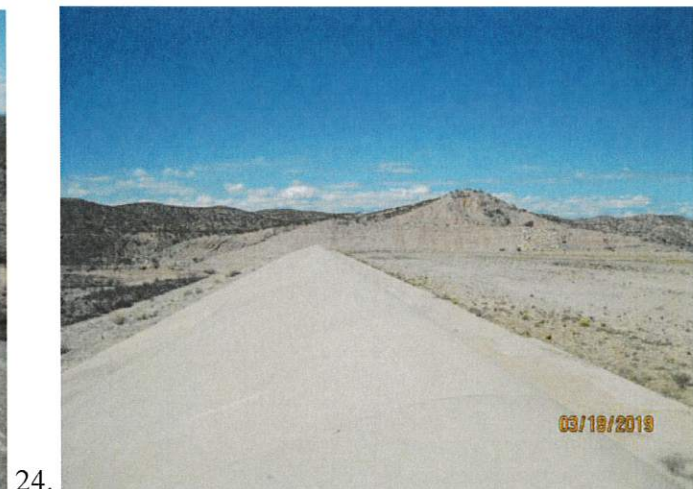
**Images 23 and 24:** Easterly and westerly views along the ogee crest of the auxiliary spillway, respectively.

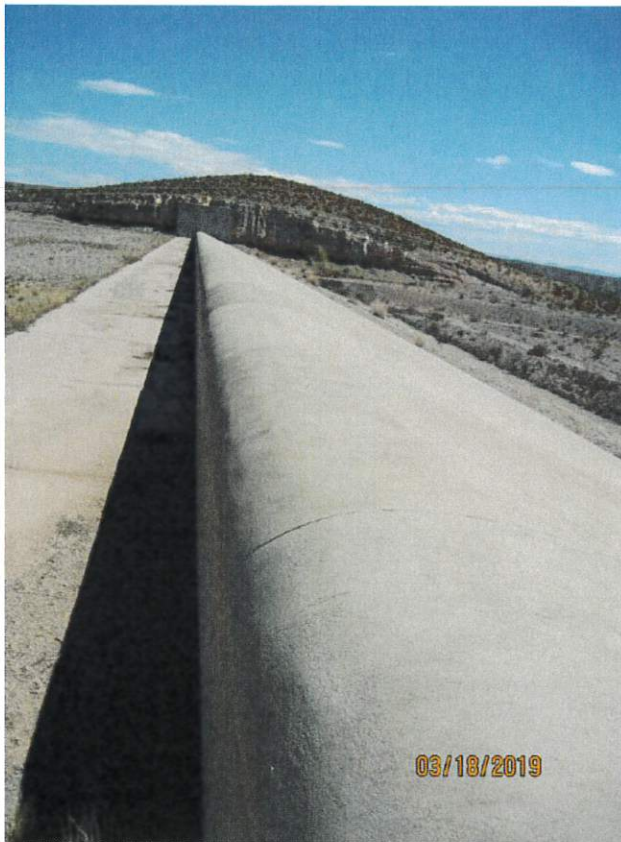
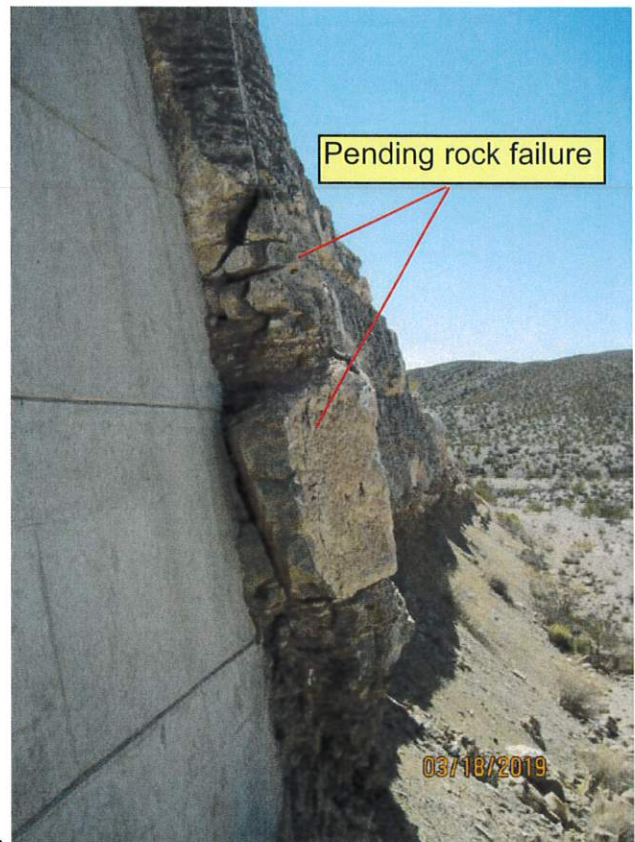
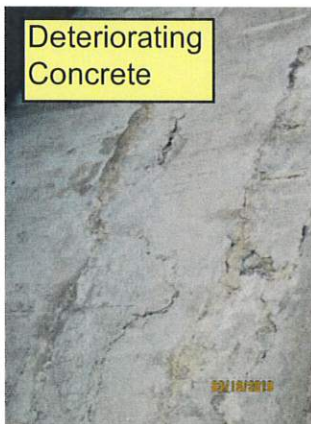
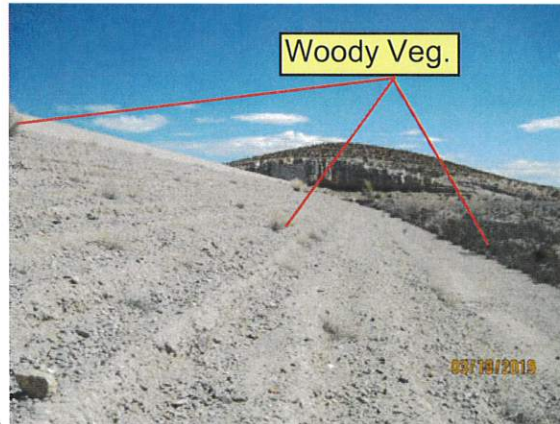
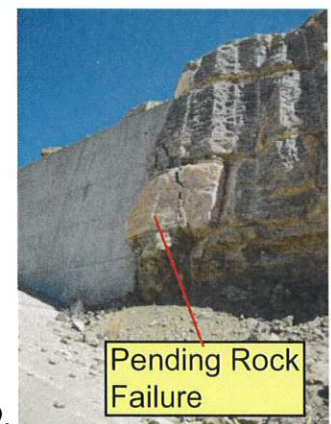
**Images 25 through 29:** Various views of the auxiliary spillway with defects as indicated.

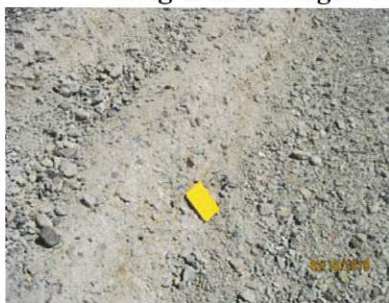
30.

**Images 30 through 32:** Typical views of details pertaining to the auxiliary spillway; RCC degradation on the downstream stepped section of the spillway (Image 30), deterioration of one of several patched portions of upstream face of the ogee section (Image 31), one of several daylighted drain outfalls on the downstream face auxiliary spillway (Image 32).

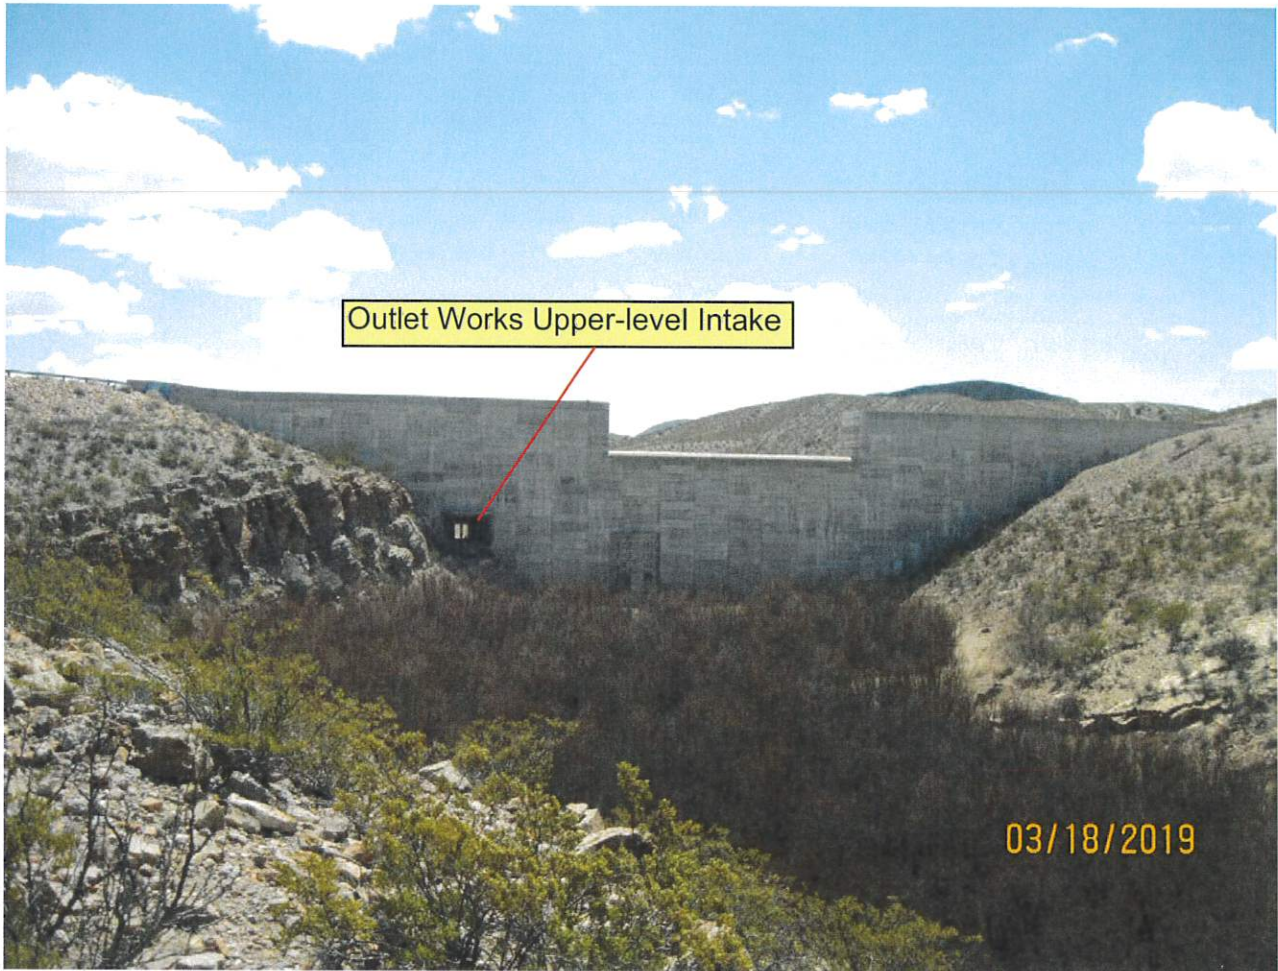
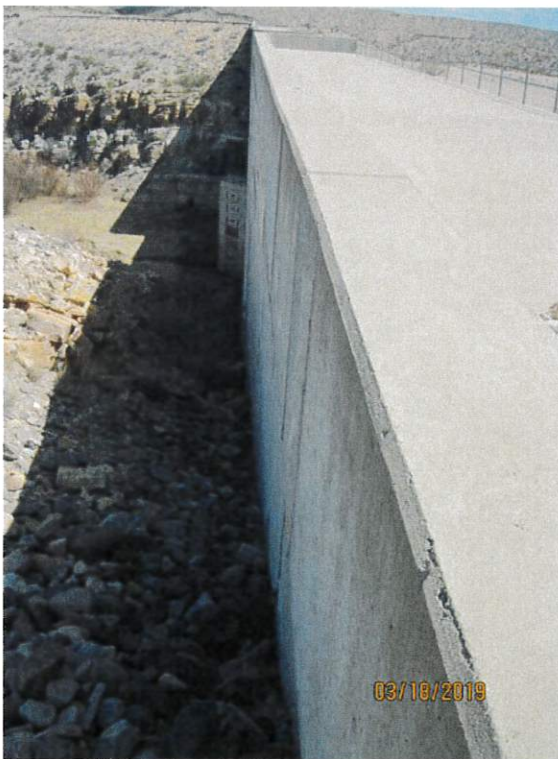
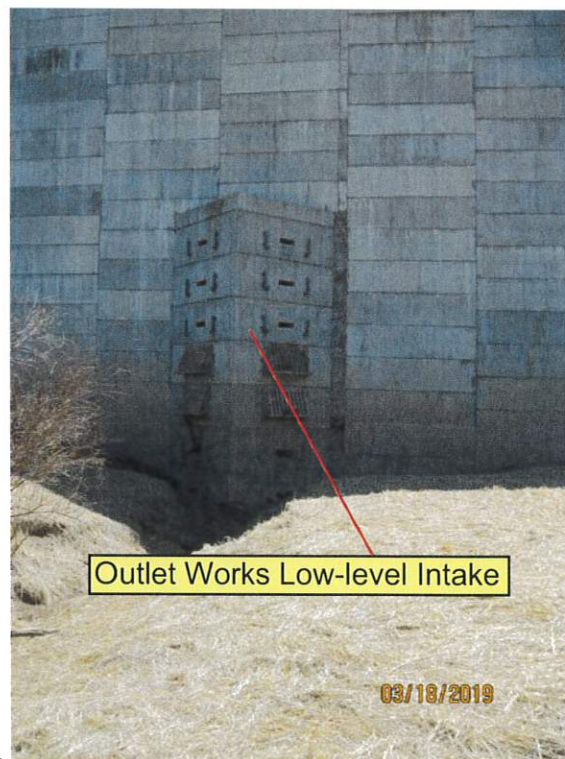
**Images 33 through 35:** Views emphasizing the lower-level and upper-level outlet works intakes

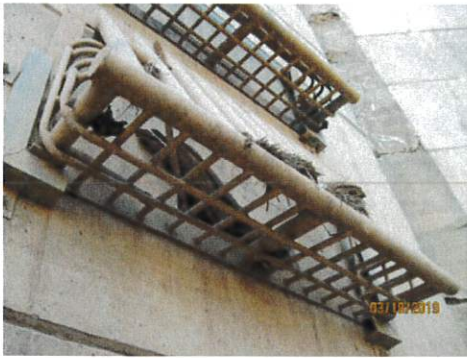
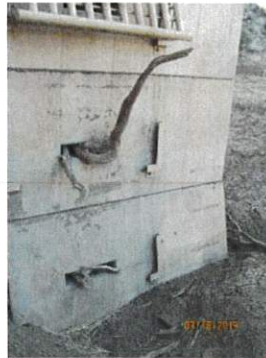
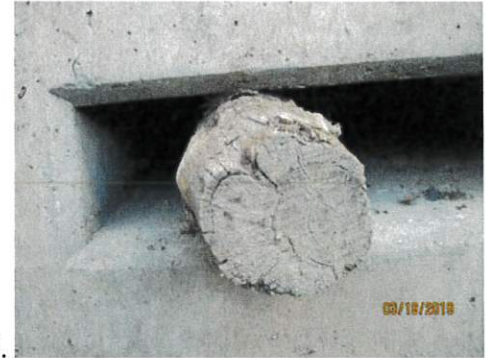
**Images 36 through 38:** Examples of several partially plugged ports on the outlet works lower-level intake.

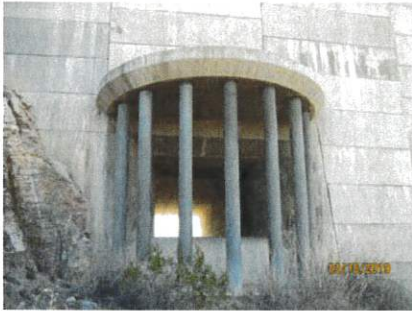
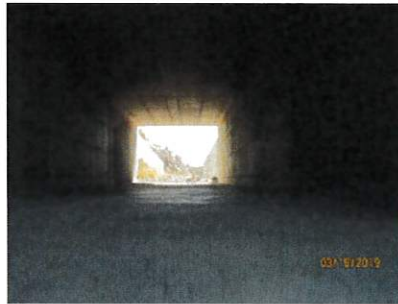
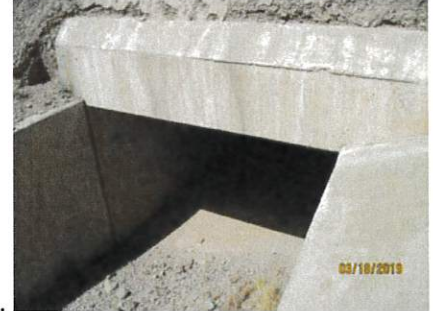
**Images 39 through 41:** Views of the outlet works upper-level intake, the upper-level outlet conduit, and the discharge end of the upper-level outlet conduit.

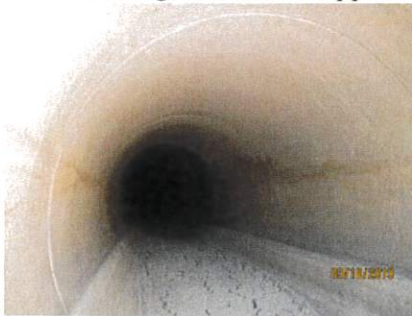
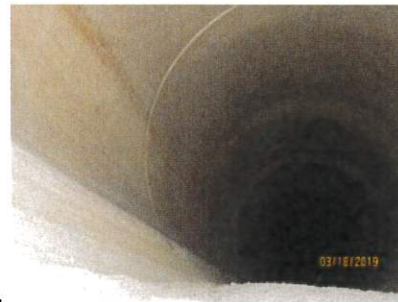
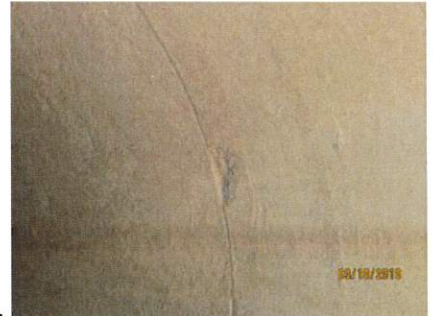
**Images 42 through 44:** Views of the downstream (discharge) end of the outlet works low-level conduit.

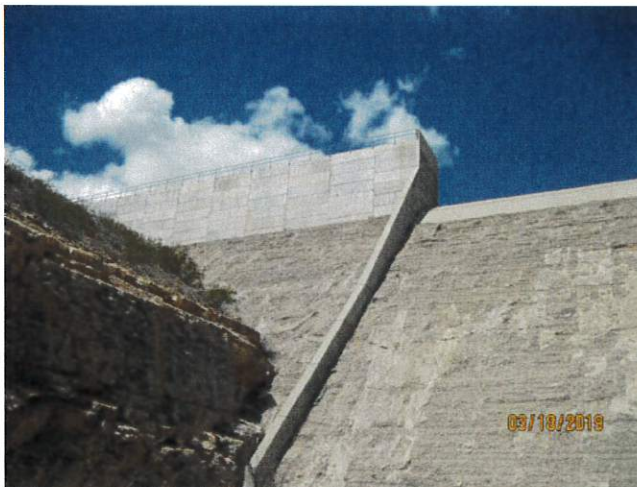
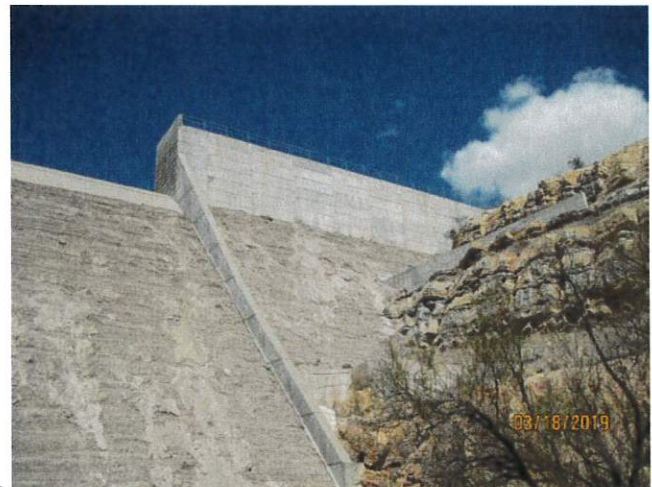
**Images 45 and 46:** views of the right and left service spillway training walls on the downstream face of the main dam as seen from the vicinity of the downstream toe.

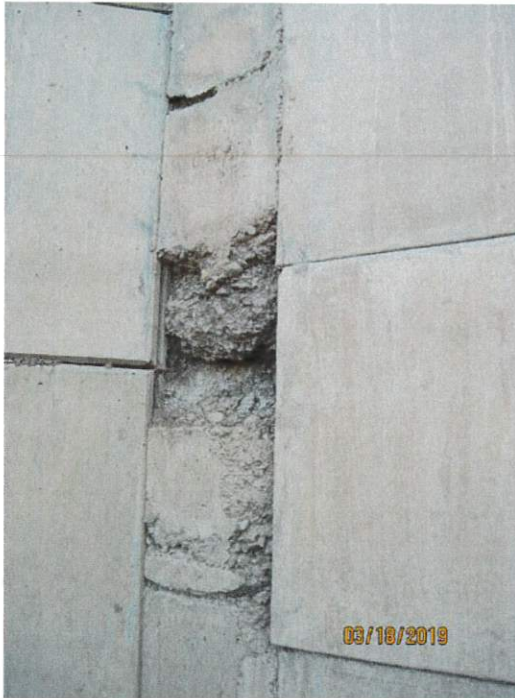
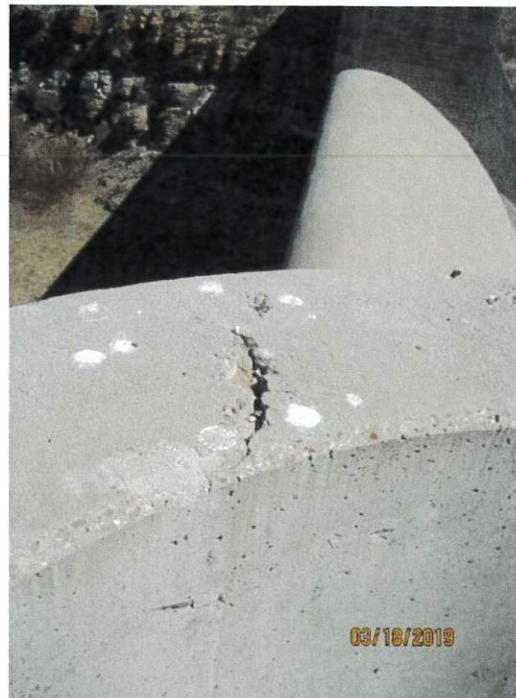
**Images 47 through 50:** Examples of concrete defects requiring patching at several locations on the main dam.

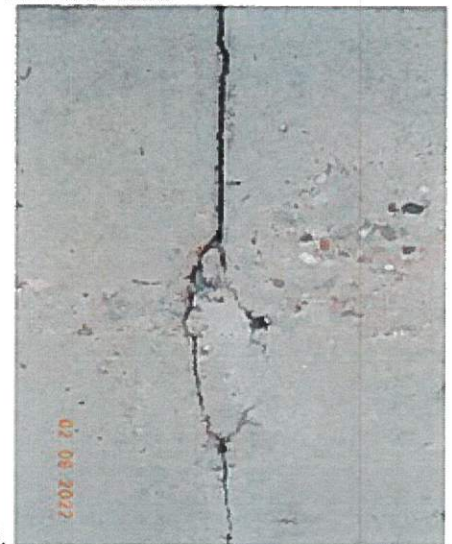
49.

**Images 47 through 49:** Examples of offset joints and cracks on the upstream face, crest of the main dam and upstream face of the emergency spillway ogee section that should be monitored over time.

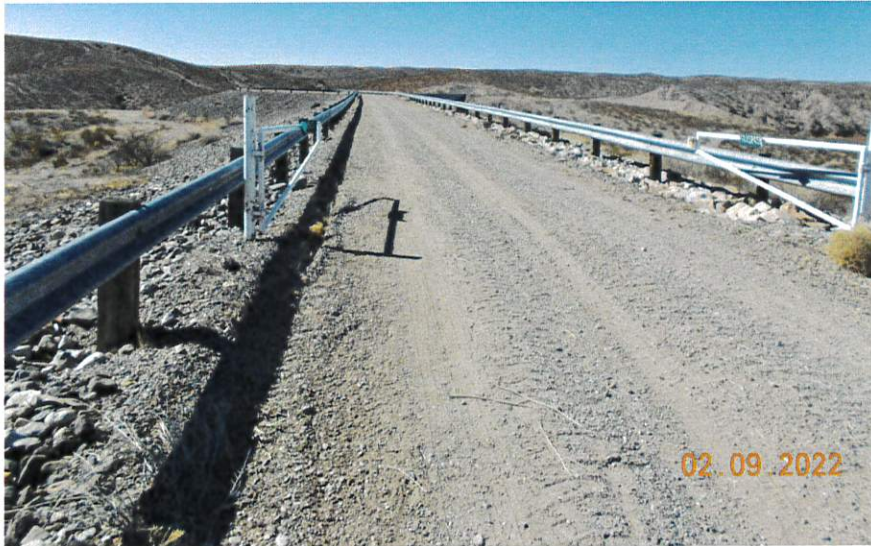
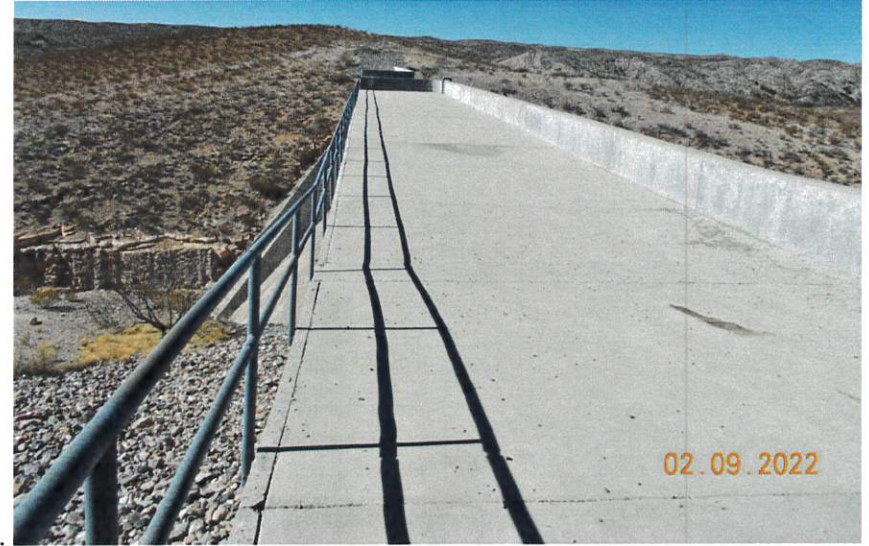
**Images 3 and 4:** Westerly views of the east end of the dam crest (Embankment Section -Image 3 and Concrete Section – Image 4).

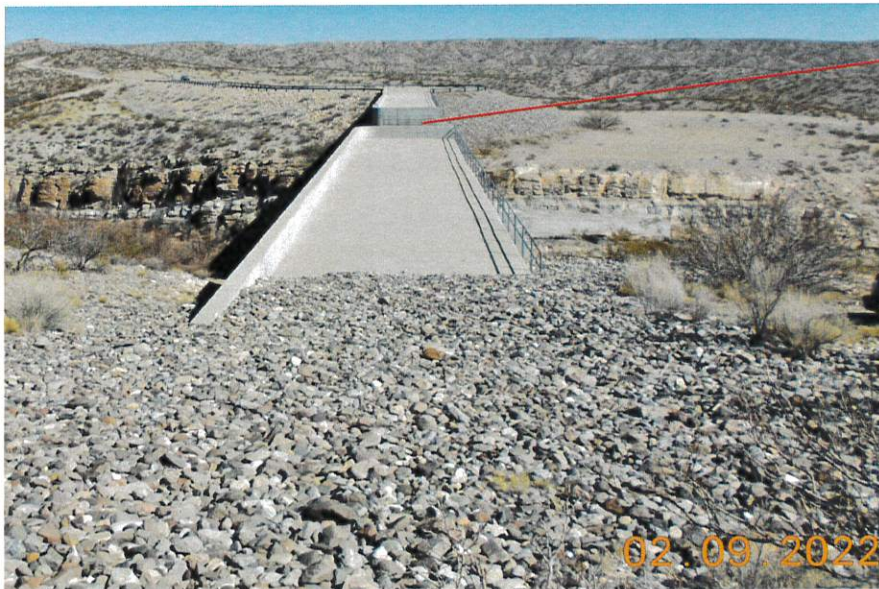
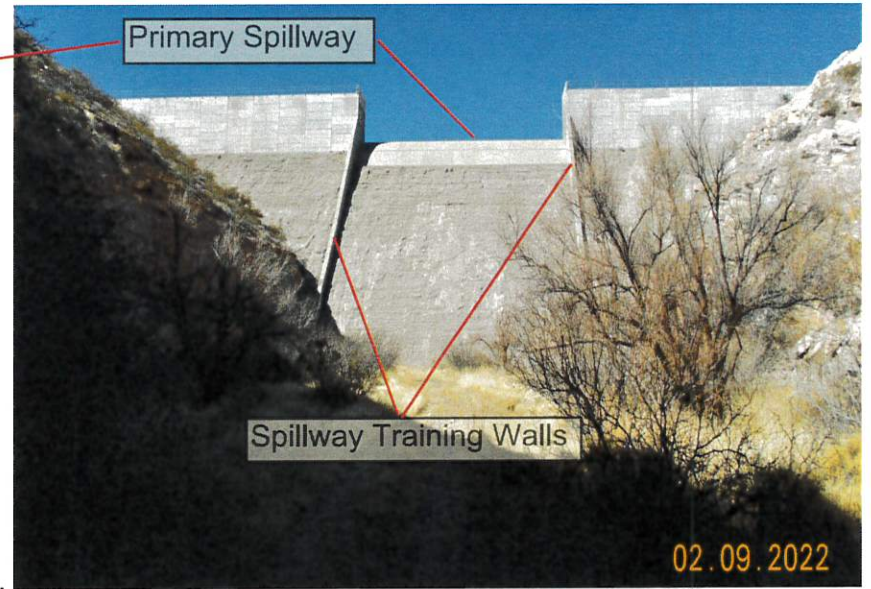
**Images 5 and 6:** Easterly view of the west end of the dam crest (Image 5) as seen from the vicinity of the right abutment and upstream (northerly) view (Image 6) of the downstream face of the main dam at the primary spillway overpour section.

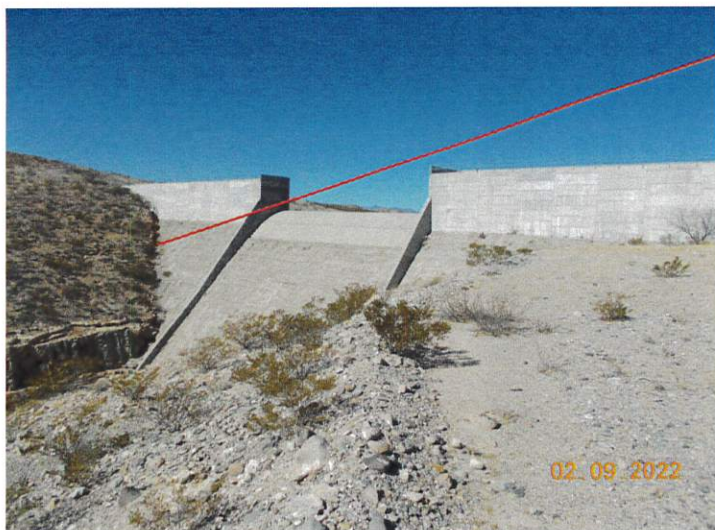
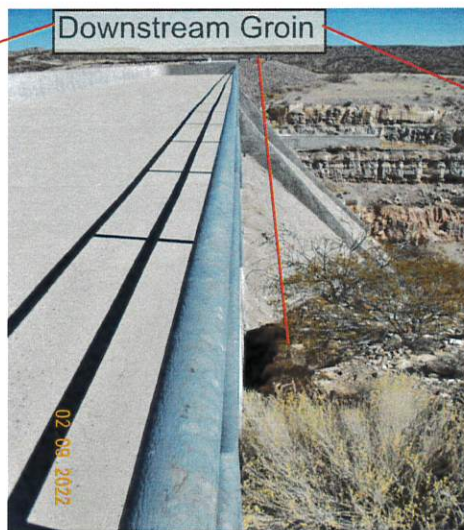
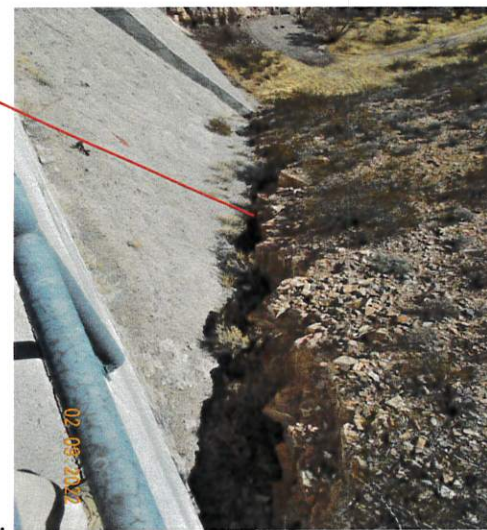
**Images 7 through 9:** Westerly view of the downstream slope of the main dam (Image 7) and easterly views along the downstream shoulder of the dam crest and the lower section of the right downstream groin (Images 8 and 9).

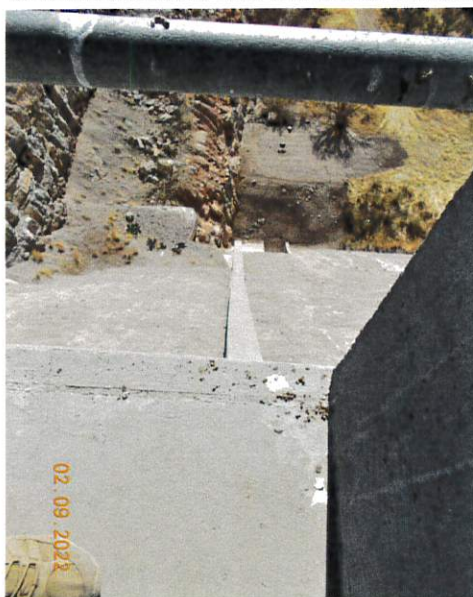
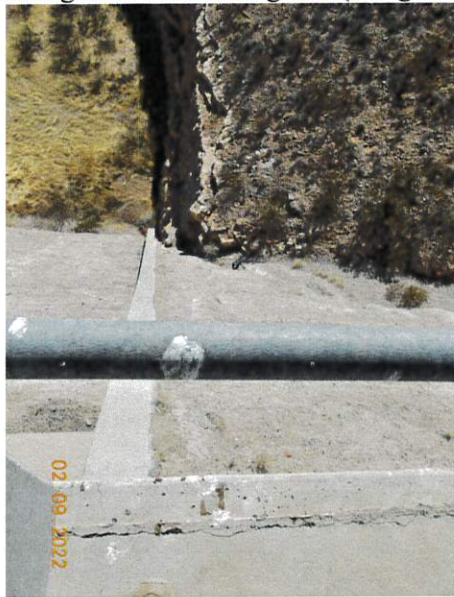
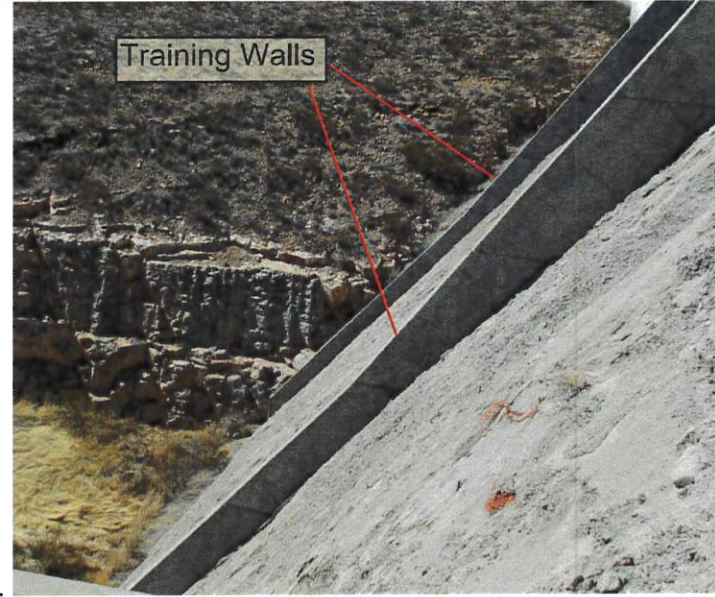
**Images 10 through 12:** Views along the left and right primary spillway training walls (Images 10 and 11) and transverse to the training walls (Image 12).
