## REGULAR MEETING

THE REGULAR MEETING OF THE CITY COMMISSION OF THE CITY OF TRUTH OR CONSEQUENCES, NEW MEXICO, TO BE HELD IN THE COMMISSION CHAMBERS, 405 W. 3RD ST., ON WEDNESDAY, MARCH 27, 2024; TO START AT 9:00 A.M.

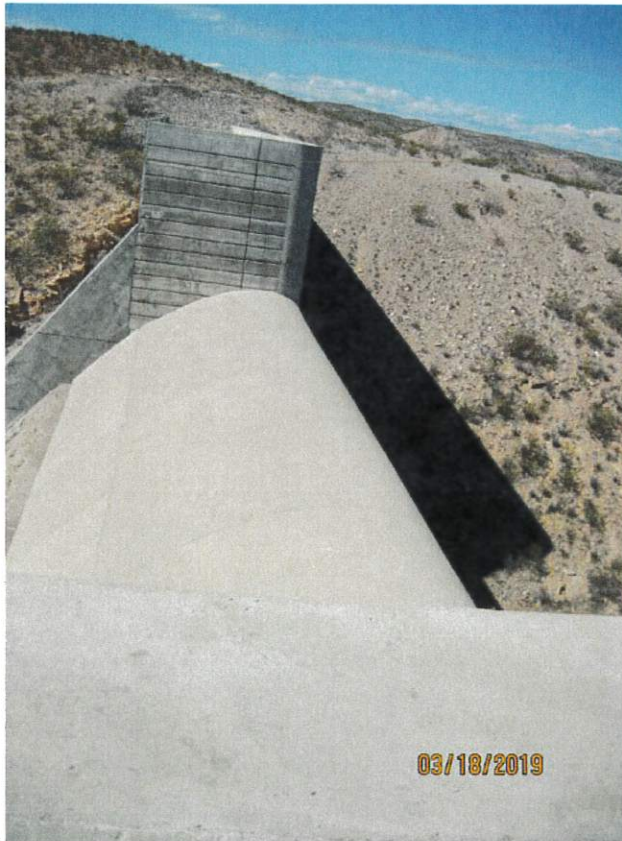
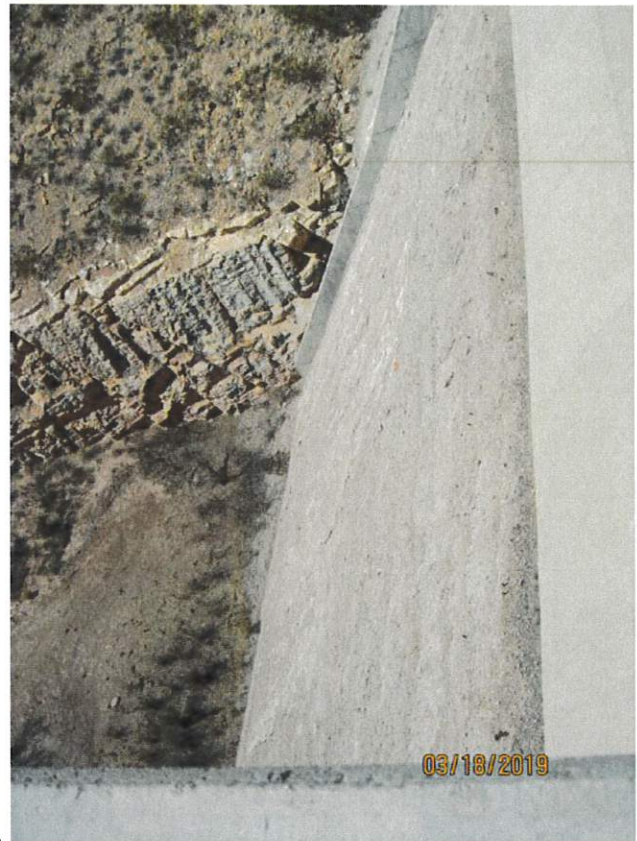
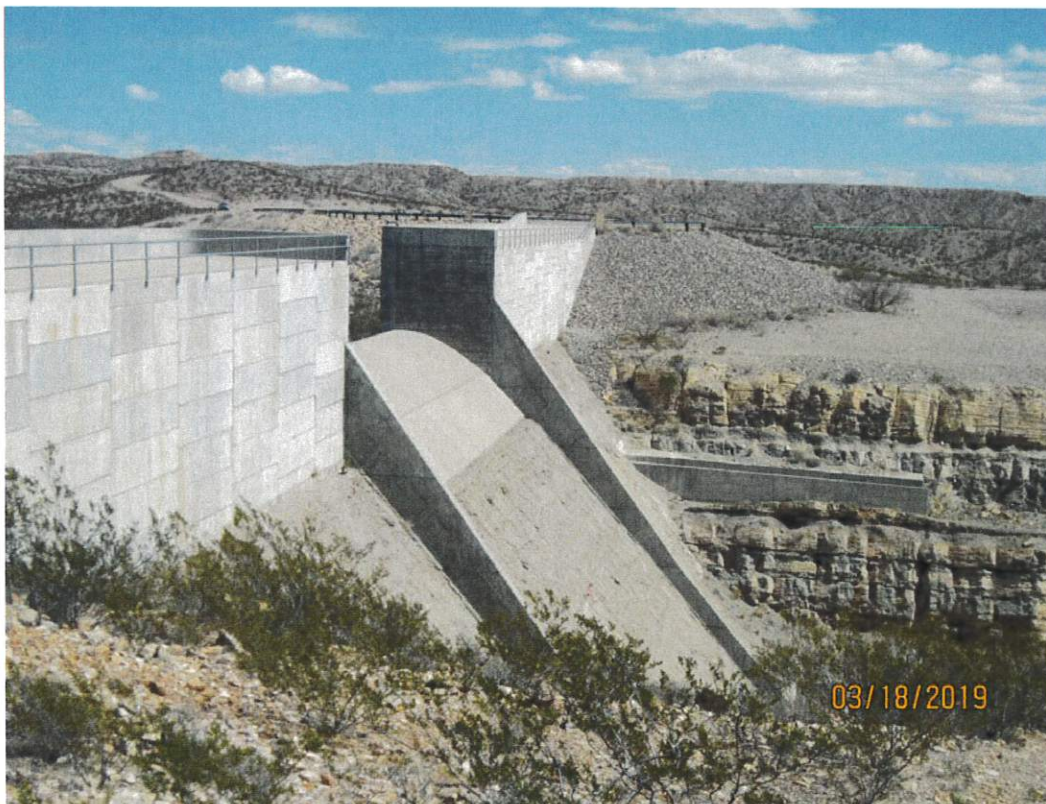
**Images 8 through 10:** Southwesterly view across the service spillway (Image 8), view of the service spillway discharge chute (Image 9), and northeasterly view of the main dam / service spillway (Image 10).

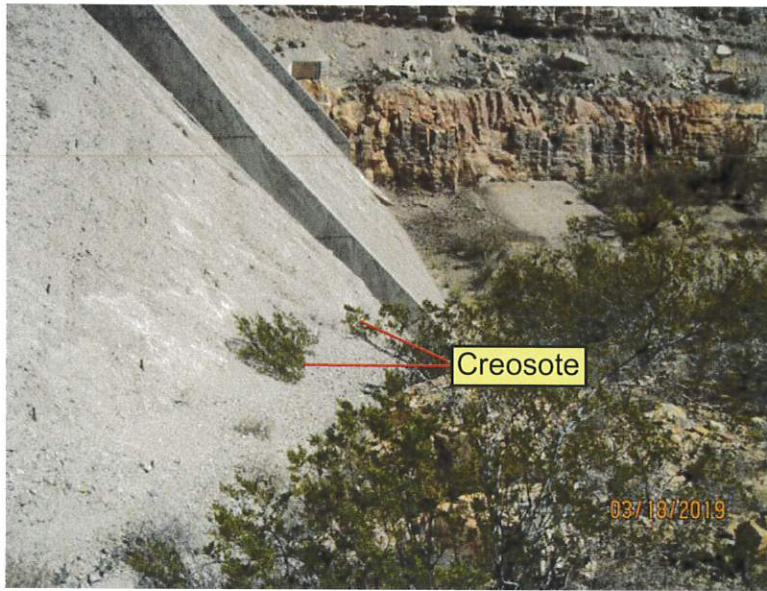
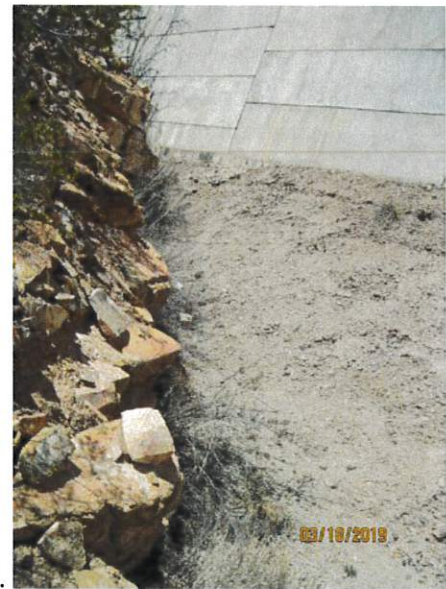
**Images 11 and 12:** Partial views of the right downstream groin of the main dam as seen from the vicinity of the right abutment contact.

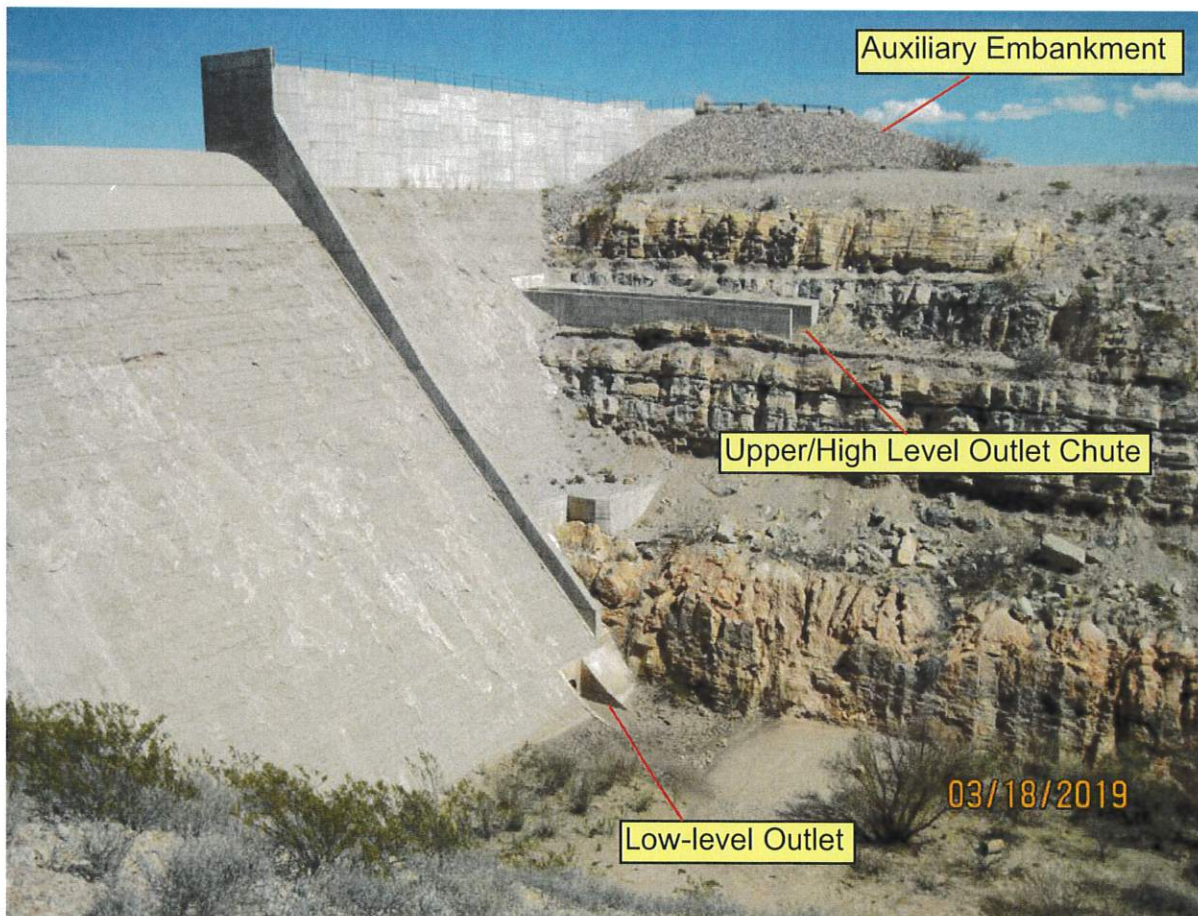
13.

**Image 13:** Easterly view of the left downstream groin with low-level and high-level outlet works features as indicated.

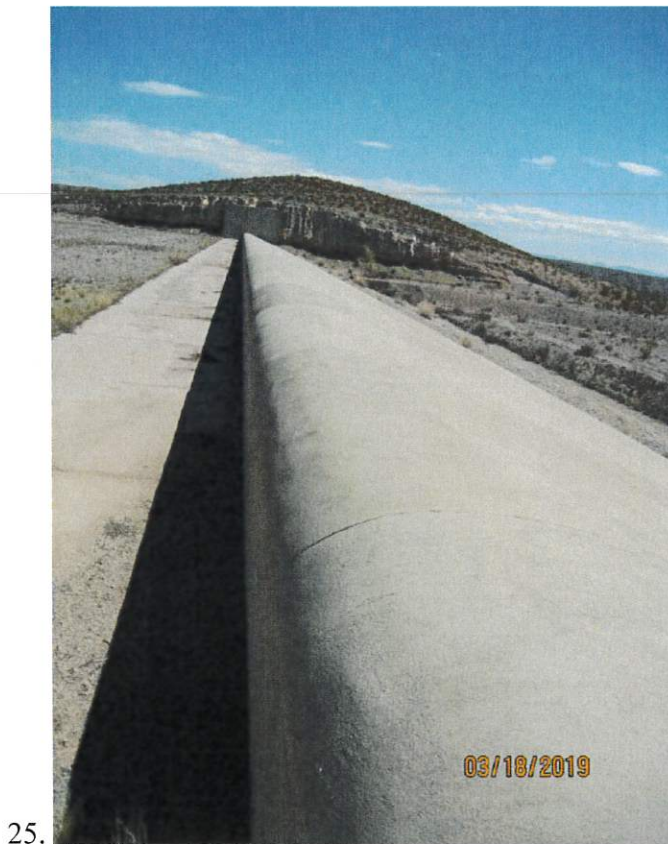
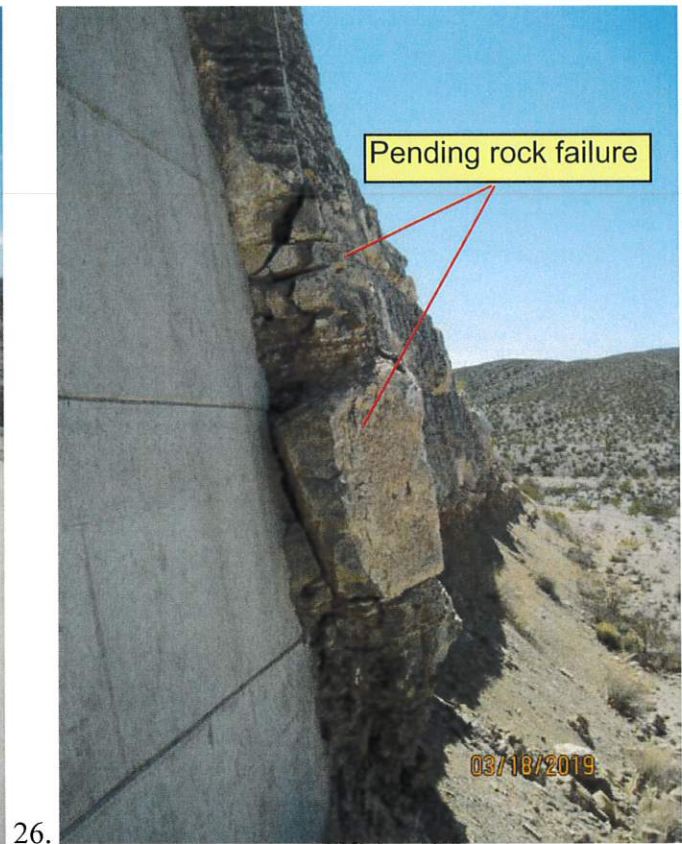
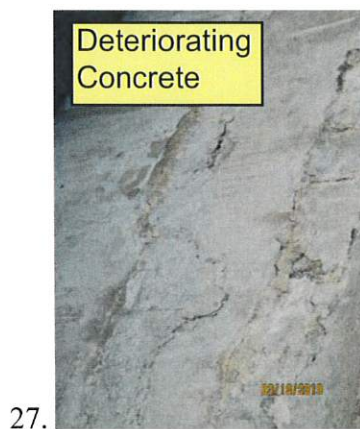
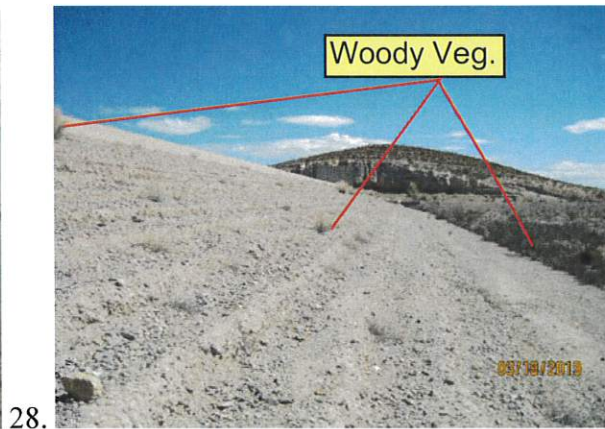
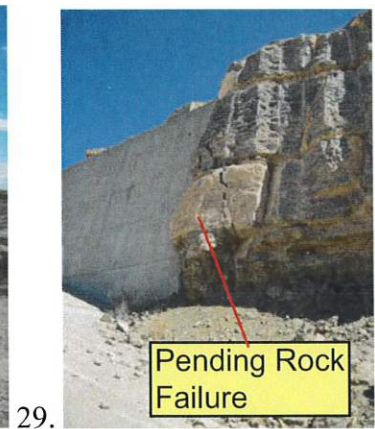
**Images 25 through 29:** Various views of the auxiliary spillway with defects as indicated.

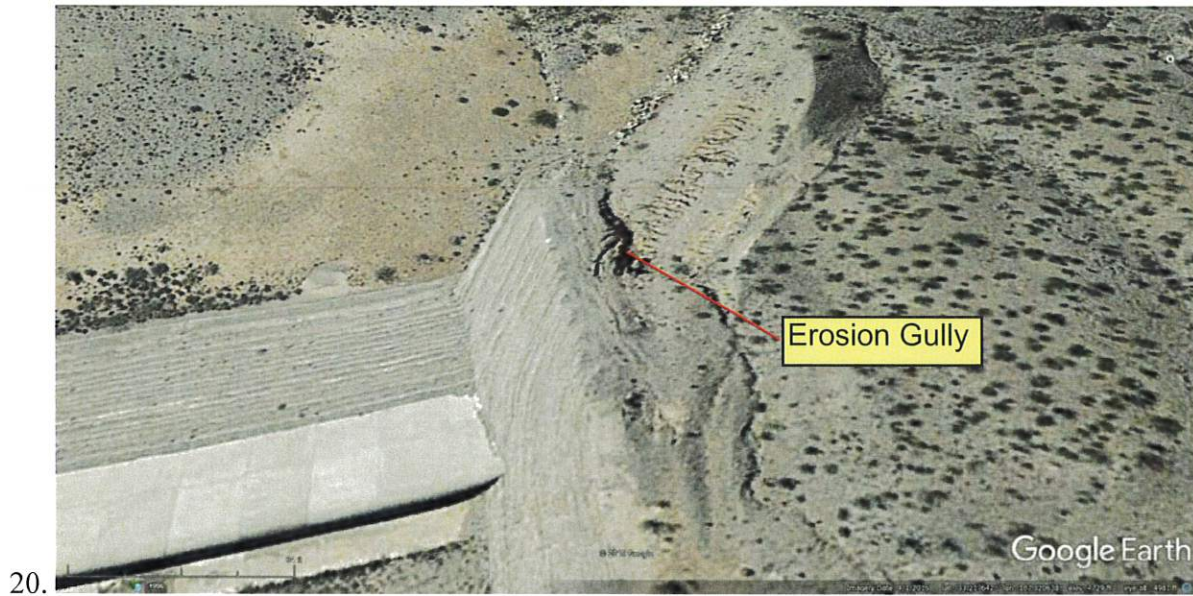
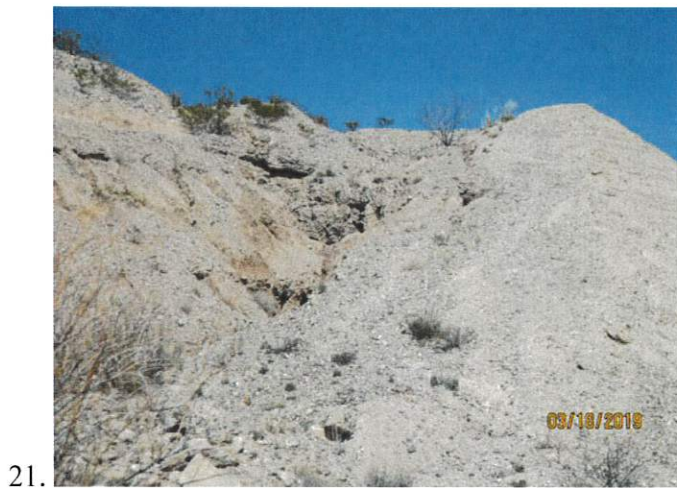
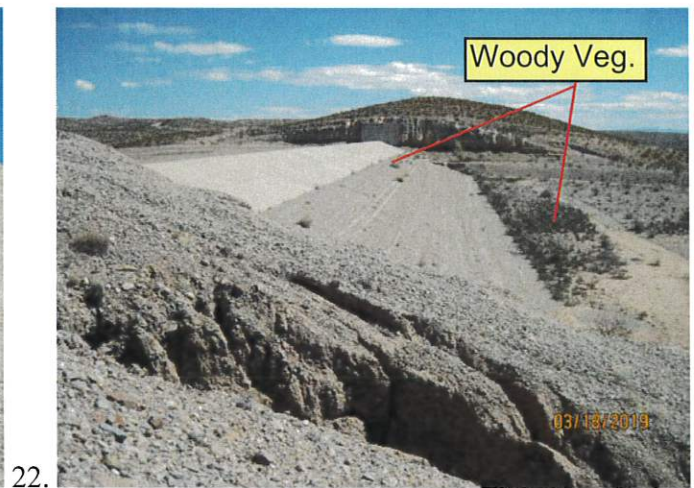
**Images 20 through 22:** Aerial view from GoogleEarth (Image 20) of large erosion gully located along the soil cement armored right abutment of the auxiliary spillway; additional views of the same erosion gully seen from ground level (Images 21 and 22).

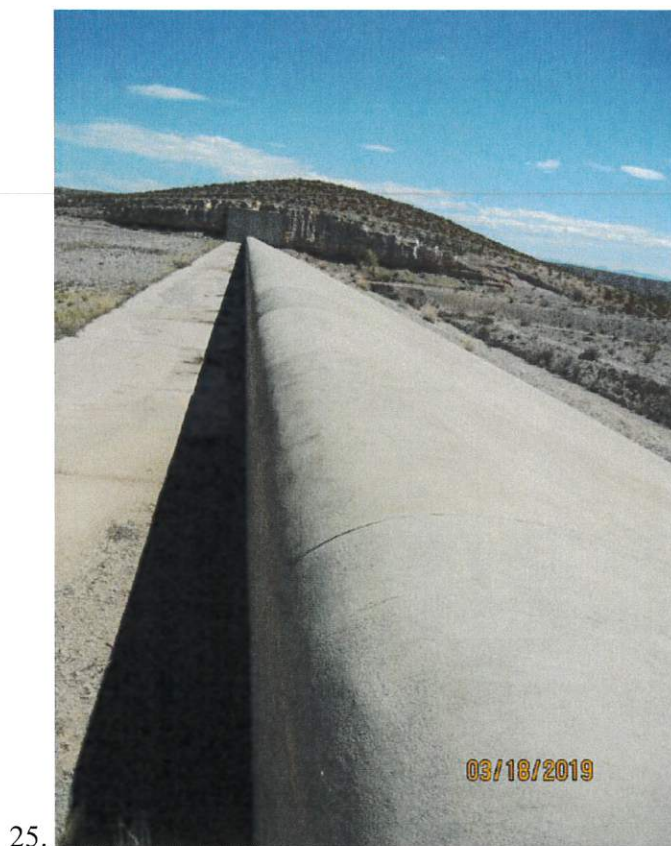
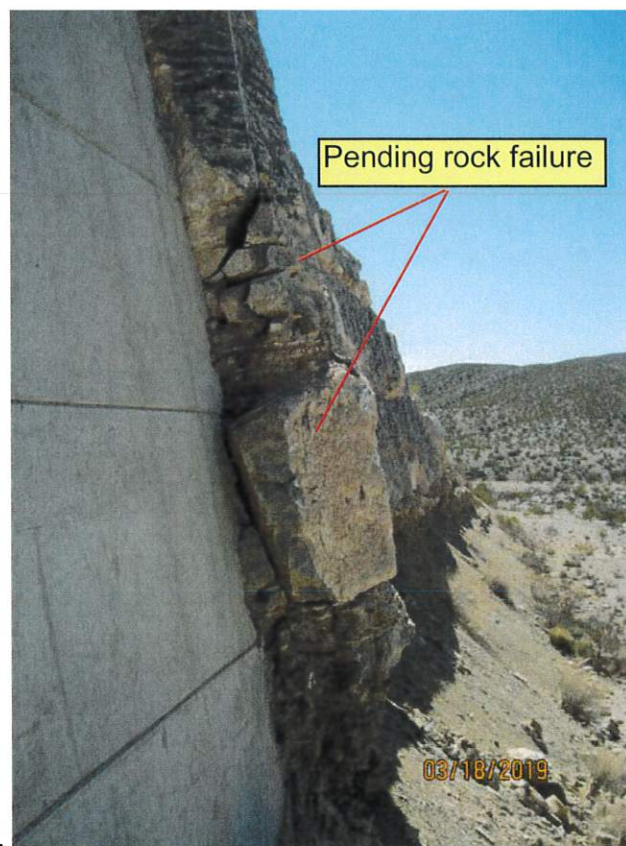
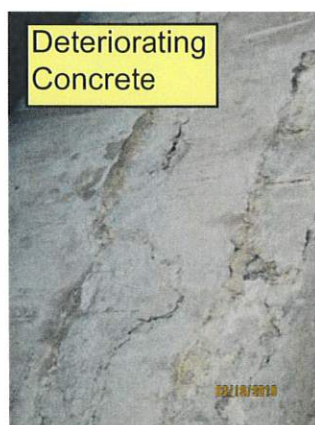
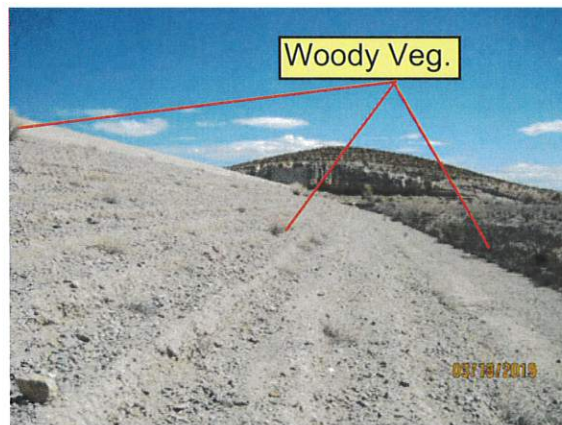
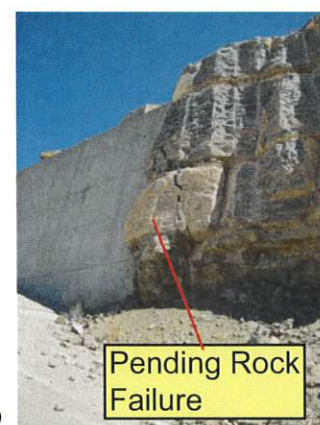
**Images 25 through 29:** Various views of the auxiliary spillway with defects as indicated.

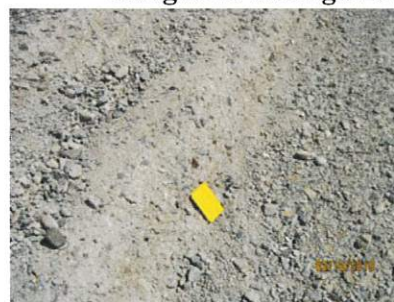
30.

**Images 30 through 32:** Typical views of details pertaining to the auxiliary spillway; RCC degradation on the downstream stepped section of the spillway (Image 30), deterioration of one of several patched portions of upstream face of the ogee section (Image 31), one of several daylighted drain outfalls on the downstream face auxiliary spillway (Image 32).

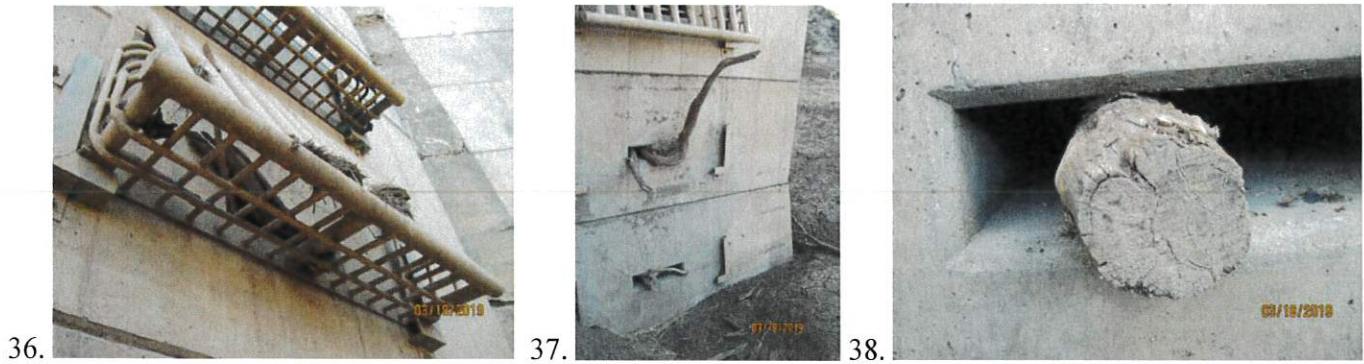
**Images 36 through 38:** Examples of several partially plugged ports on the outlet works lower-level intake.

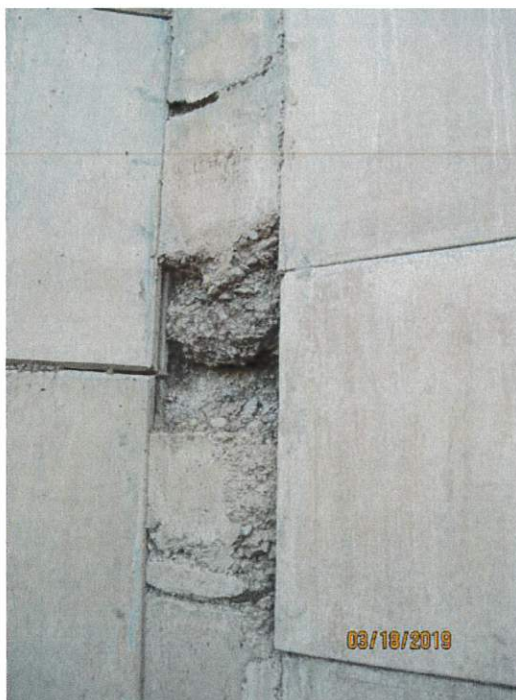
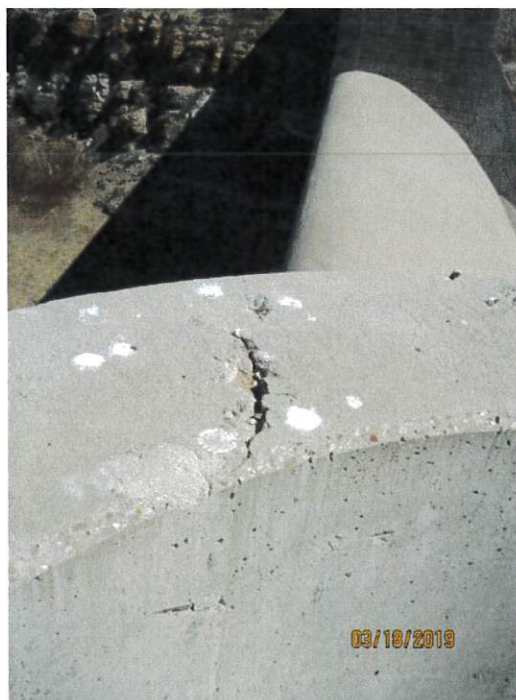
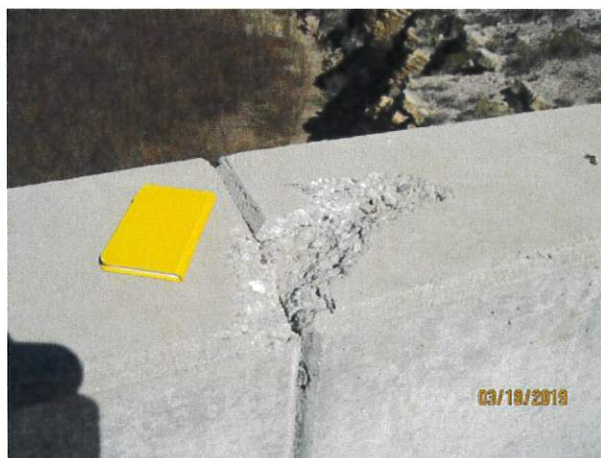
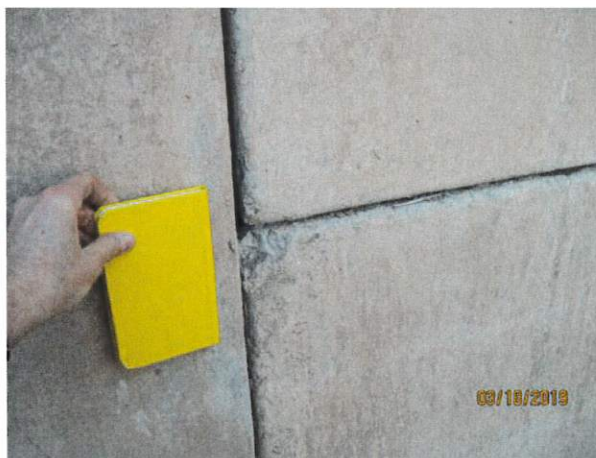
**Images 47 through 50:** Examples of concrete defects requiring patching at several locations on the main dam.

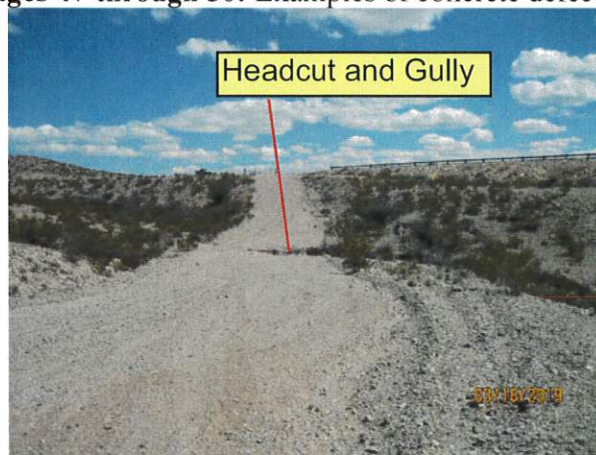
51.

**Image 51:** Headcut and erosion across access road to the detention basin. **Image 52:** Emerging woody vegetation emerging on the downstream face of the dam.

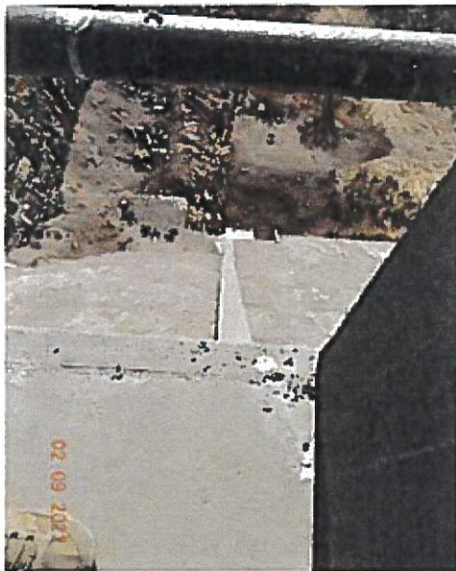
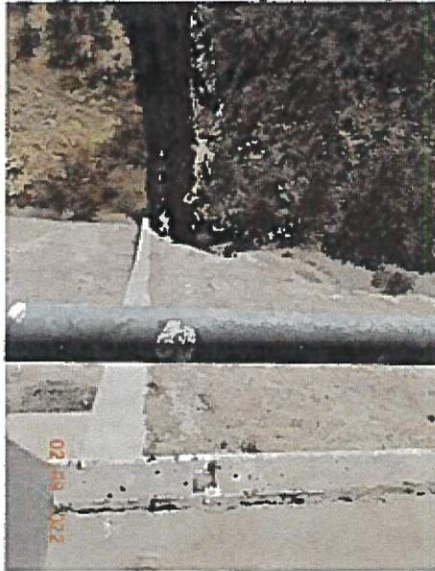
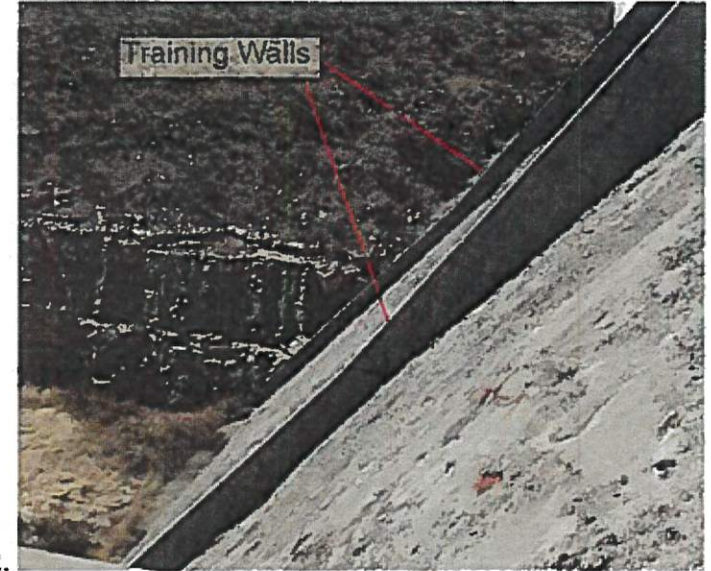
**Images 7 through 9:** Westerly view of the downstream slope of the main dam (Image 7) and easterly views along the downstream shoulder of the dam crest and the lower section of the right downstream groin (Images 8 and 9).

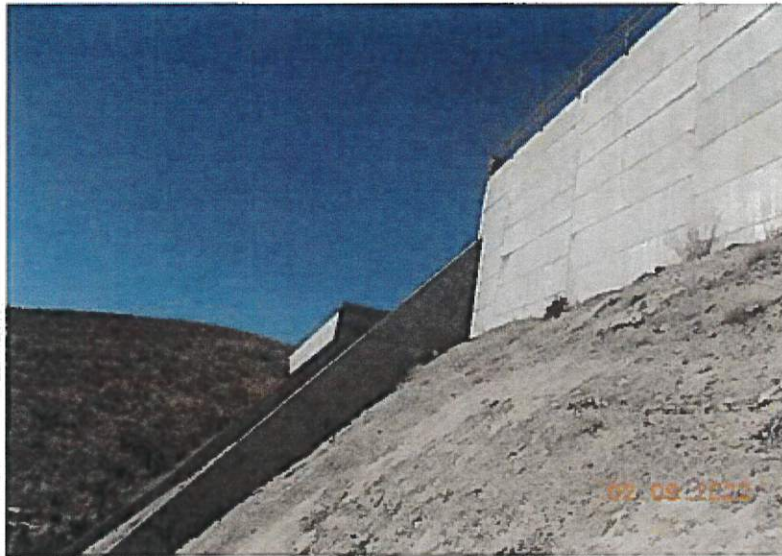
13.

**Images 13 and 14:** Westerly view of the top of the primary spillway training walls (Image 13) and westerly view of the downstream face of the main dam as seen from the west end of the embankment section at its transition zone with the concrete section of the dam.(Image 14).

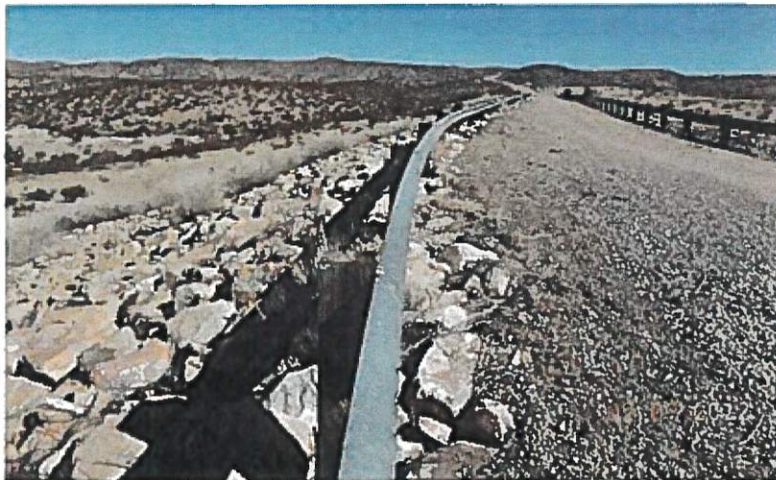
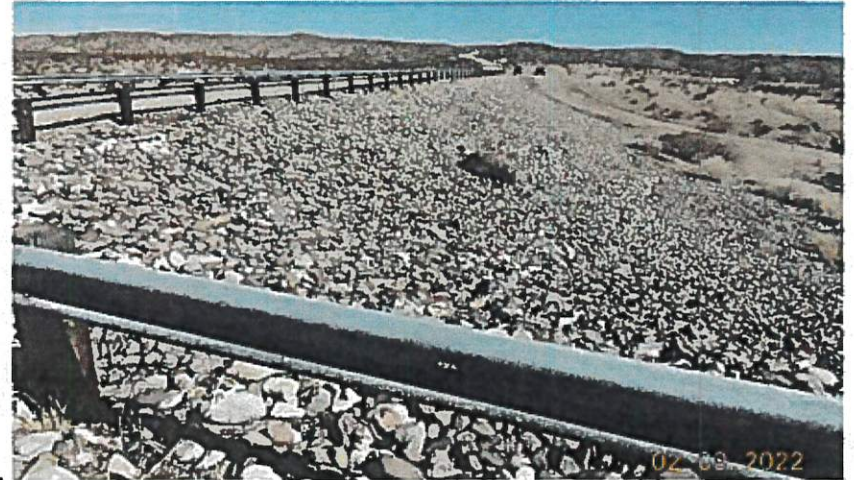
**Images 15 and 16:** Easterly views along the upstream and downstream slopes of the embankment section of the dam at the transition zone with the concrete section of the dam.

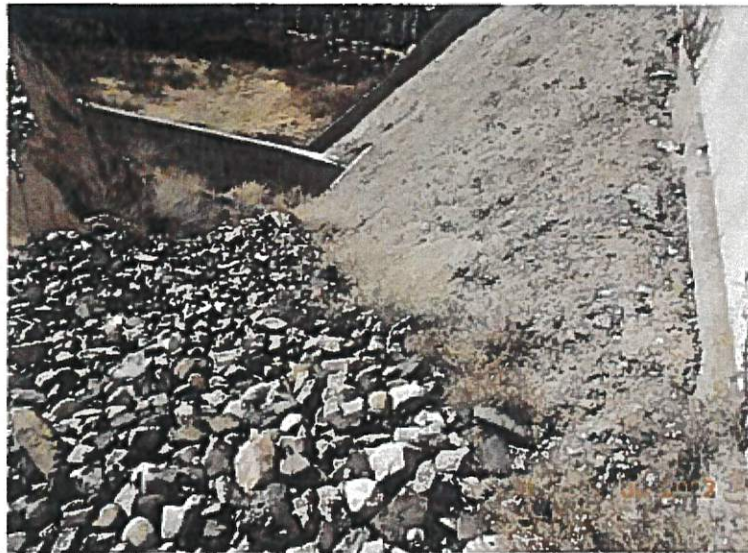
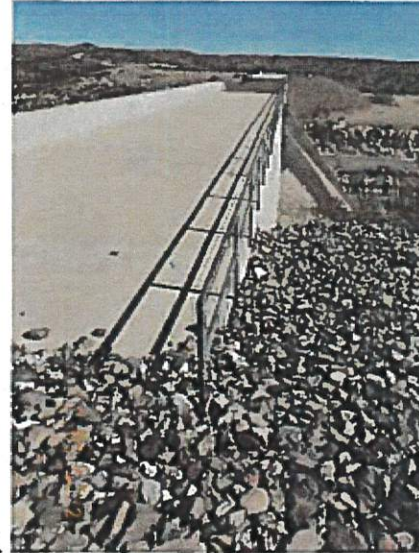
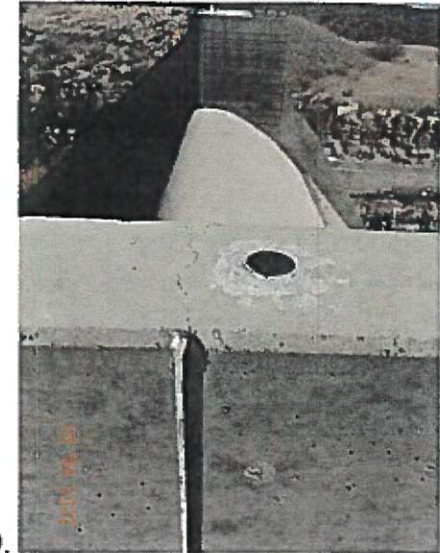
**Images 17 through 19:** Downstream (southwesterly) view of the upper left downstream groin of the main (concrete) dam (Image 17), downstream (northeasterly) view of the upper right downstream groin (Image 18), and easterly view of the right side primary spillway wall and spillway crest (Image 19).

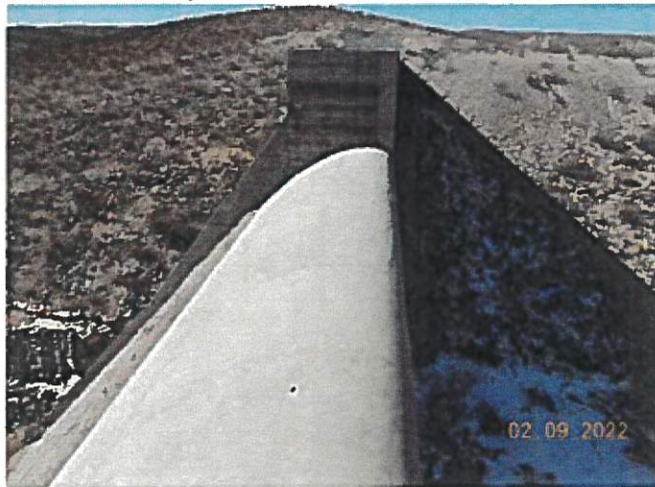
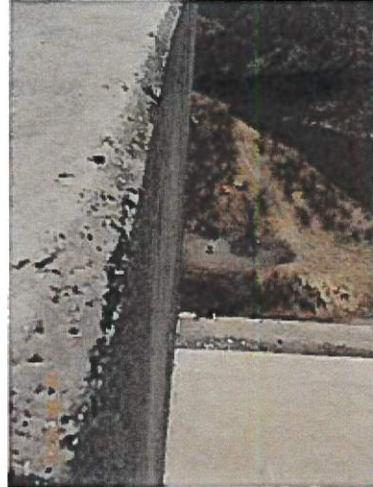
**Images 20 through 22:** Westerly view along the primary spillway crest (Image 20), southerly view along the left side primary spillway training wall (Image 21), and view of the lower portion of the left downstream groin of the main dam and spalled concrete at a contraction joint (Image 22).

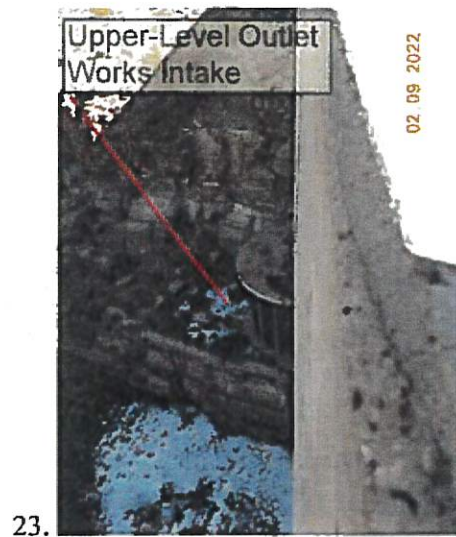
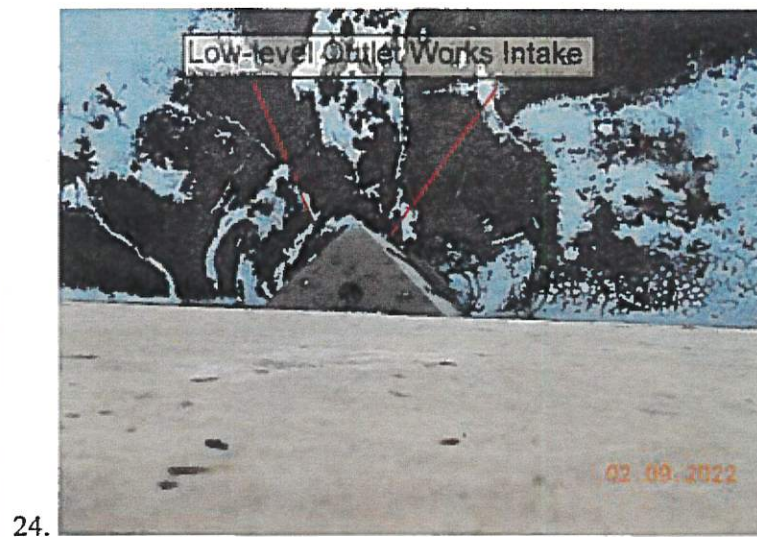
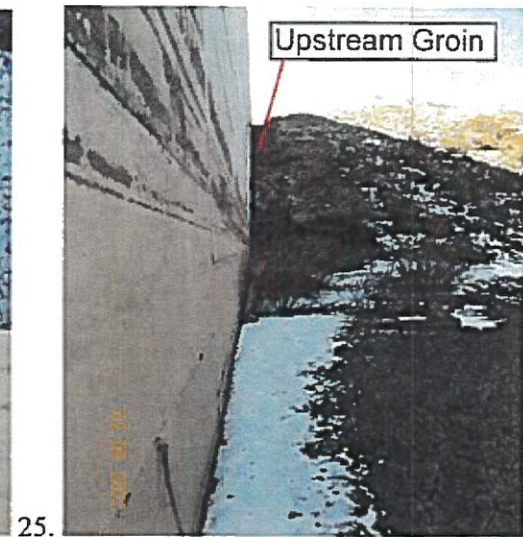
**Images 23 through 25:** Views of the upper and lower low-level outlet works intake structures located on the upstream face of the main dam (Images 23 and 24) and westerly view along the right upstream groin of the Main Dam (Image 25).

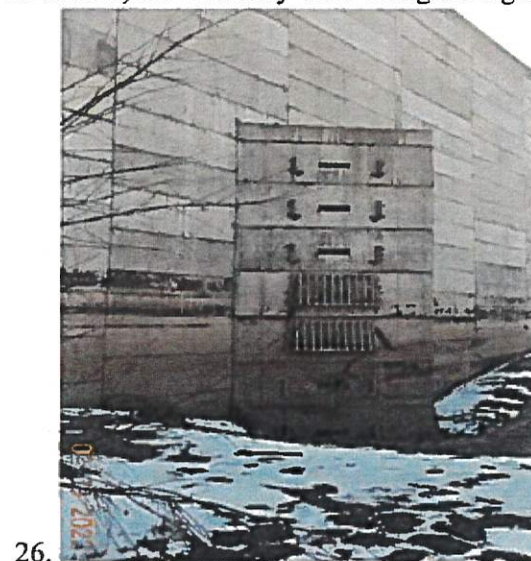
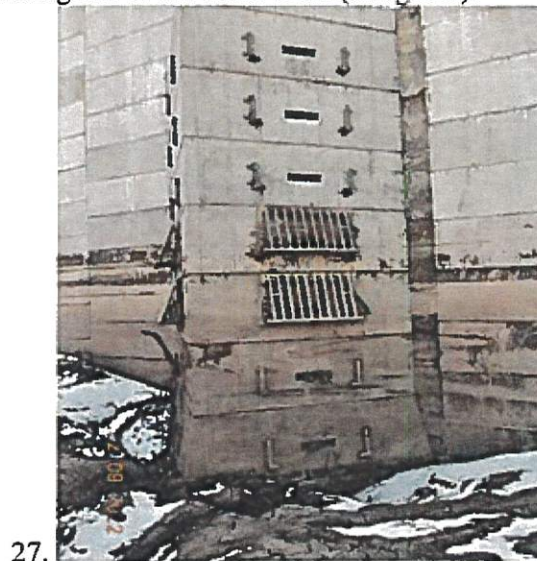
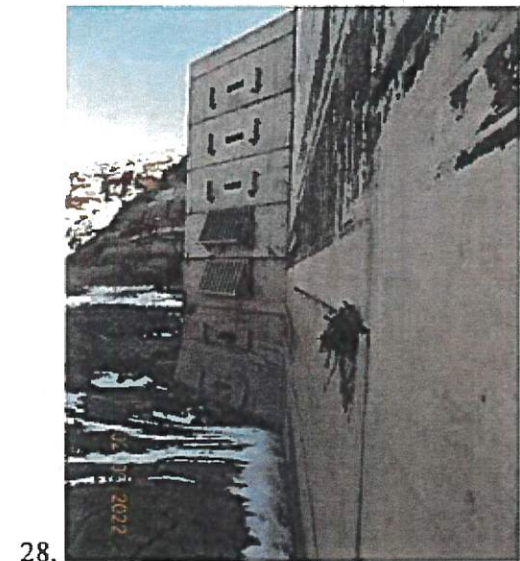
**Images 26 through 28:** Slightly distorted views of the low-level outlet works intake structure located at the base of the upstream face of the dam.

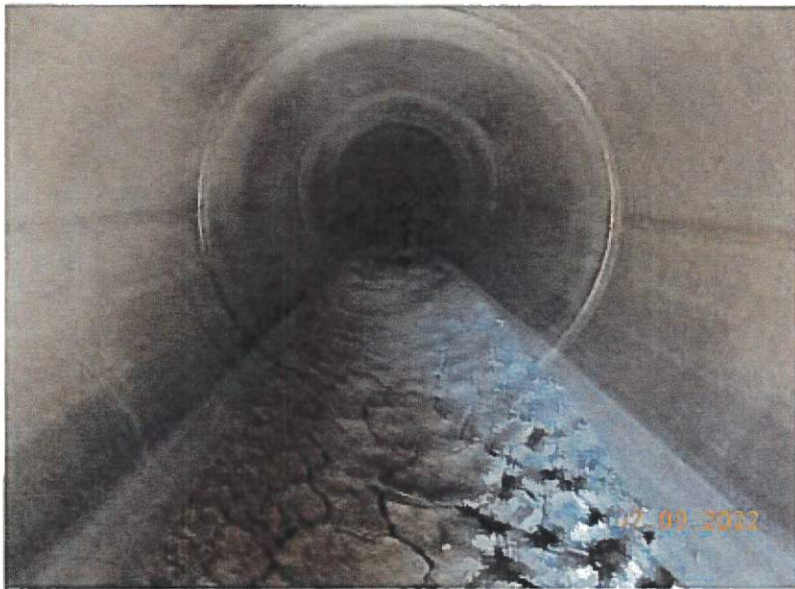
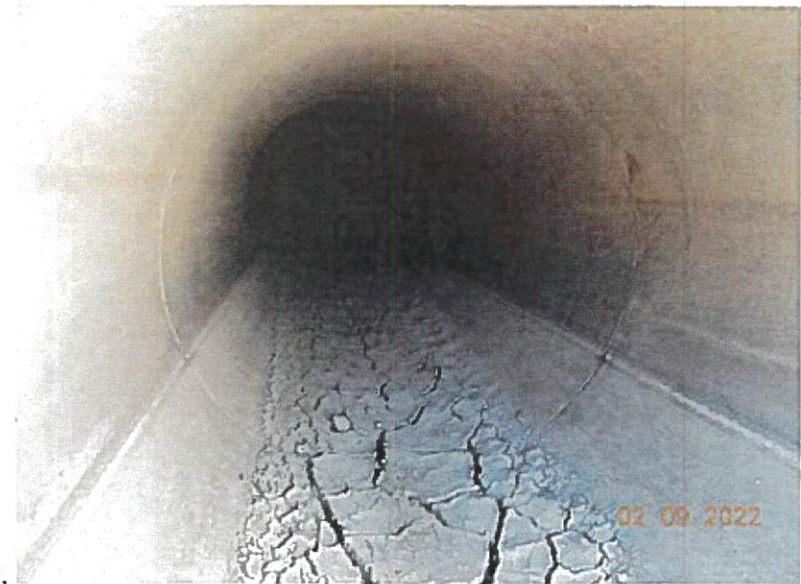
**Images 29 and 30:** Upstream interior views of the low-level outlet conduit as seen from the discharge end of the conduit. The upstream end of the conduit is located at the upstream face of the dam and within the outlet works structure shown in Images 26 through 28.

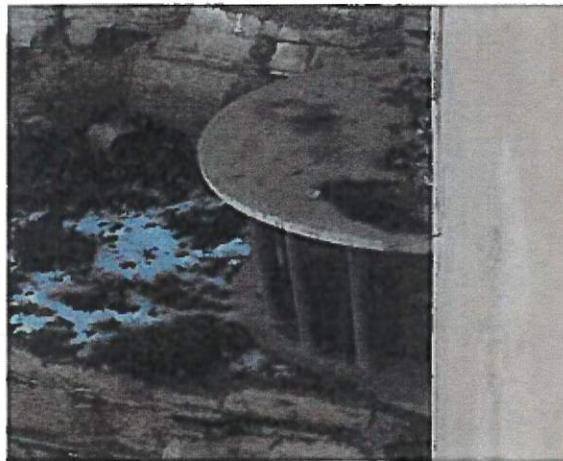
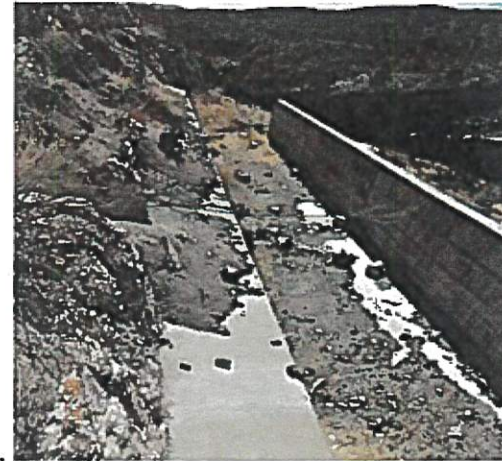
**Images 31 and 32:** Horizontally distorted views of the upper-level outlet works intake structure (Image 31) and concrete chute discharge channel (Image 32).

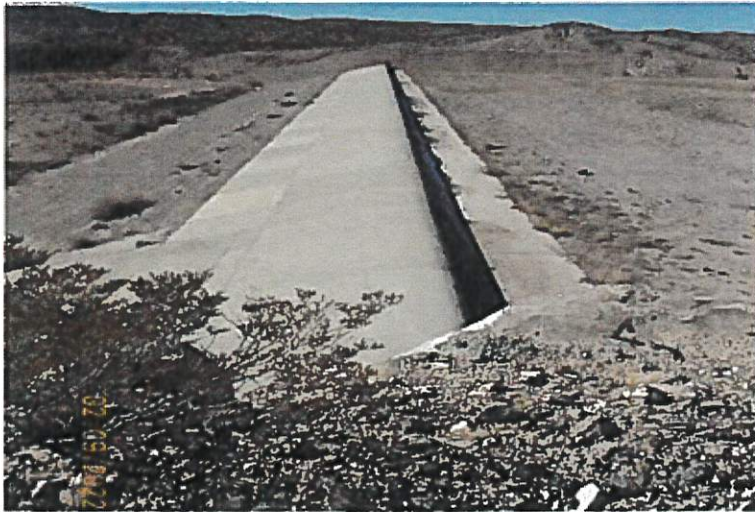
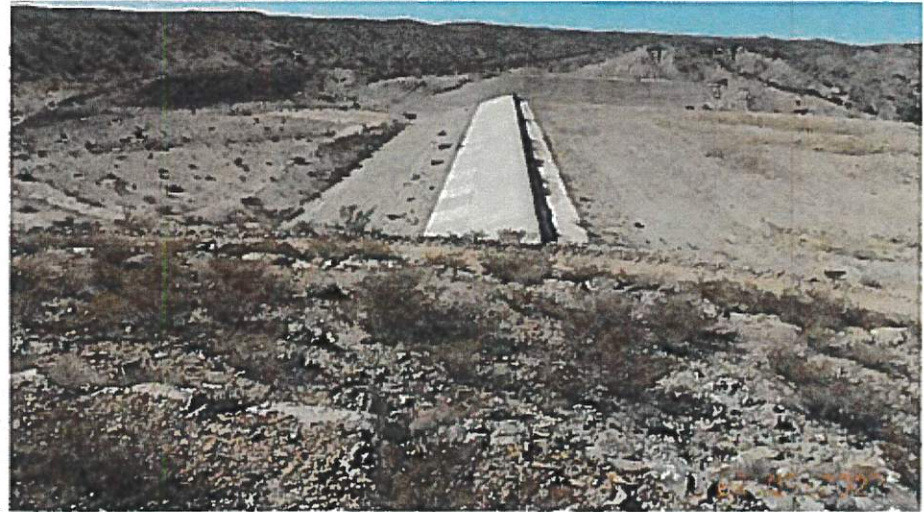
**Images 33 and 34:** Westerly views of the emergency spillway ogee weir located approximately 300 feet west of the right abutment of the Main Dam.

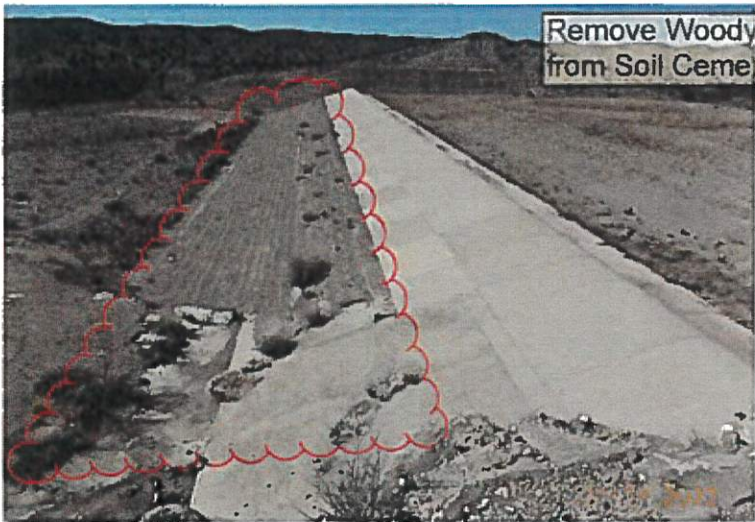
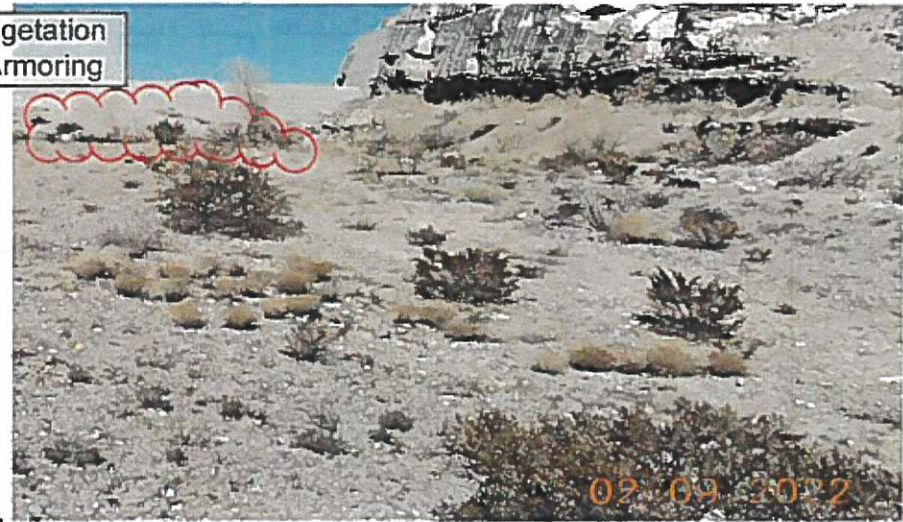
**Images 35 and 36:** Additional westerly view of the emergency spillway (Image 35) and a northerly view of the right downstream groin of the emergency spillway.

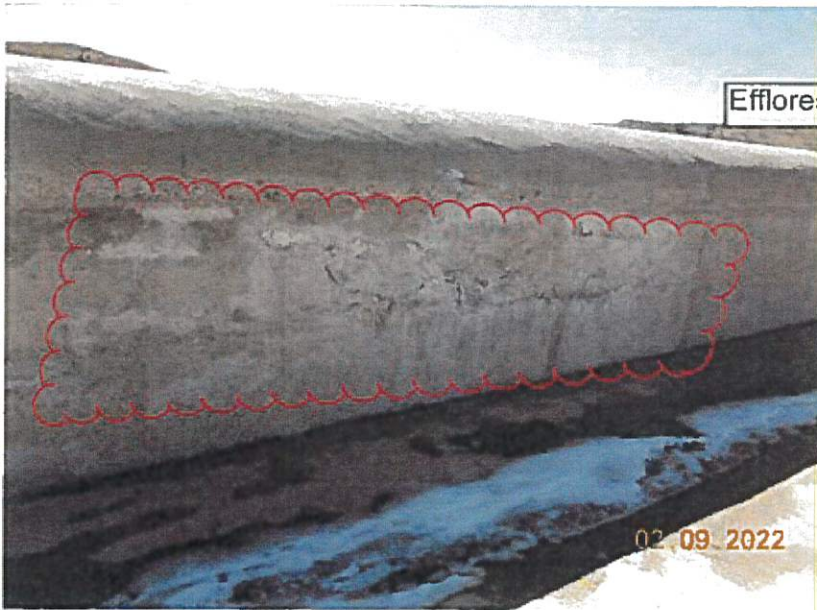
37.

**Images 37 and 38:** Examples of concrete efflorescence and spalling on the upstream face of the emergency spillway ogee weir.

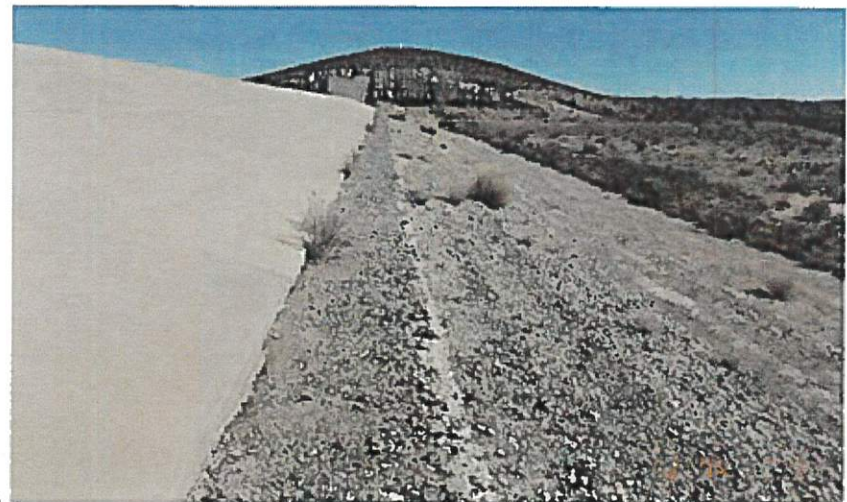
40.

**Images 39 and 40:** Views of soil cement armoring on right side slope of emergency spillway approach channel (Image 39) and armoring on the downstream slope of the emergency spillway ogee section.

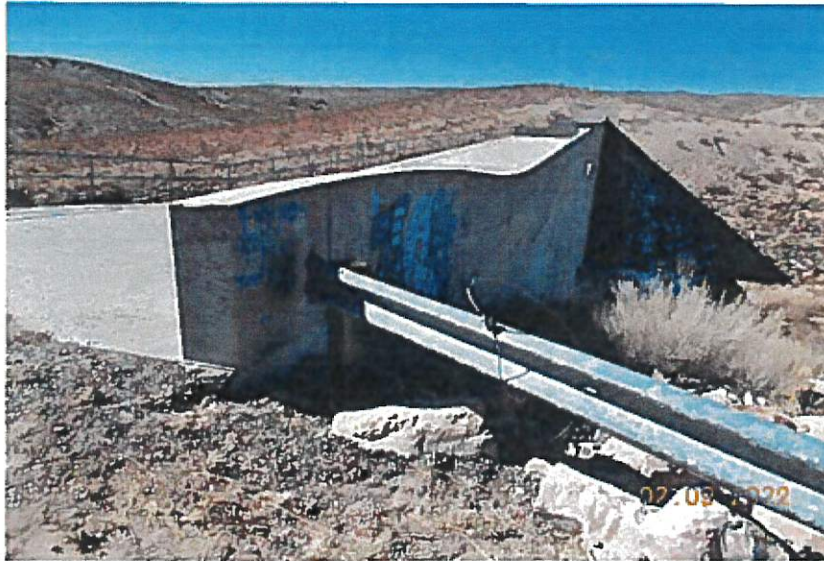
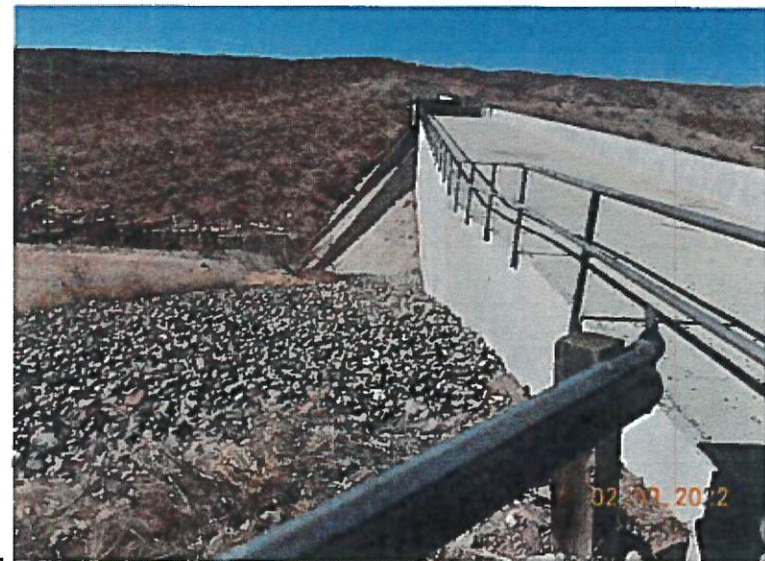
**Images 45 and 46: Westerly views along the upstream and downstream faces of the main dam.**

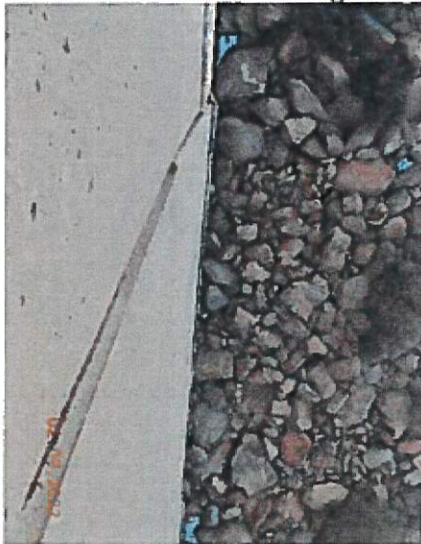
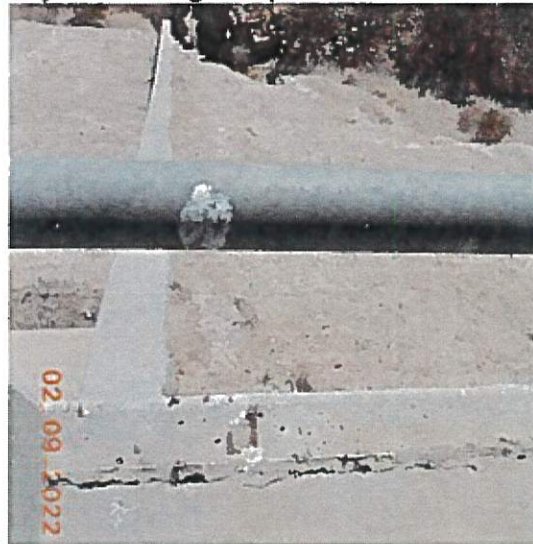
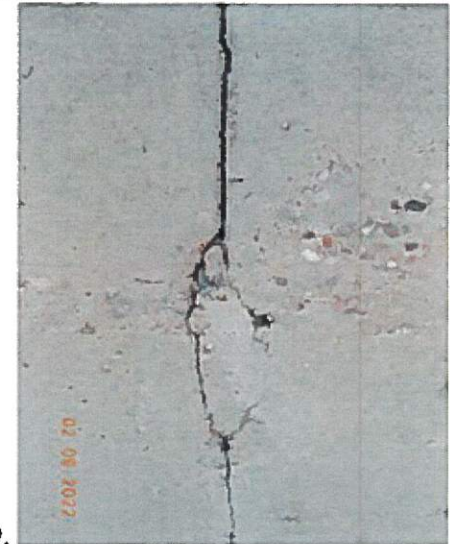
**Images 47 through 49: Examples of offset joints and cracks on the upstream face, crest of the main dam and upstream face of the emergency spillway ogee section that should be monitored over time.**
