## REGULAR MEETING

THE REGULAR MEETING OF THE CITY COMMISSION OF THE CITY OF TRUTH OR CONSEQUENCES, NEW MEXICO, TO BE HELD IN THE COMMISSION CHAMBERS, 405 W. 3RD ST., ON WEDNESDAY, MARCH 27, 2024; TO START AT 9:00 A.M.

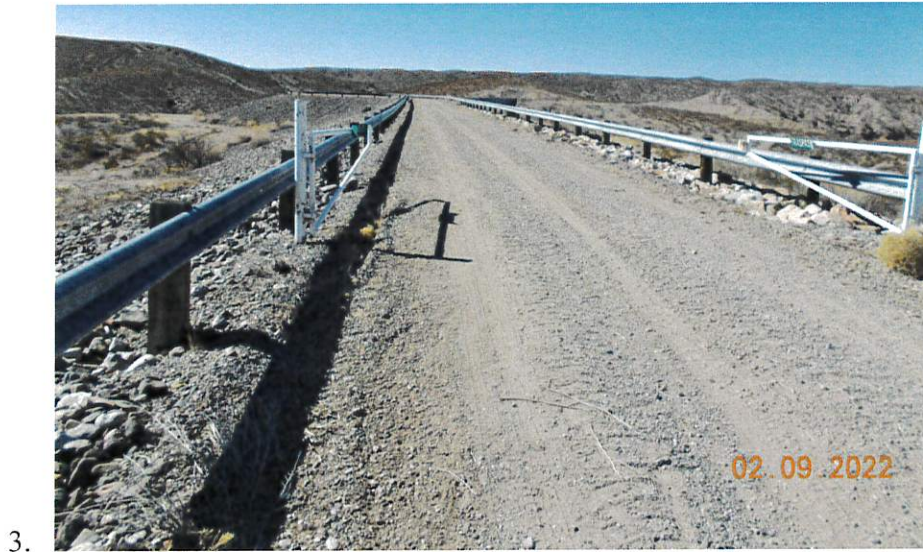
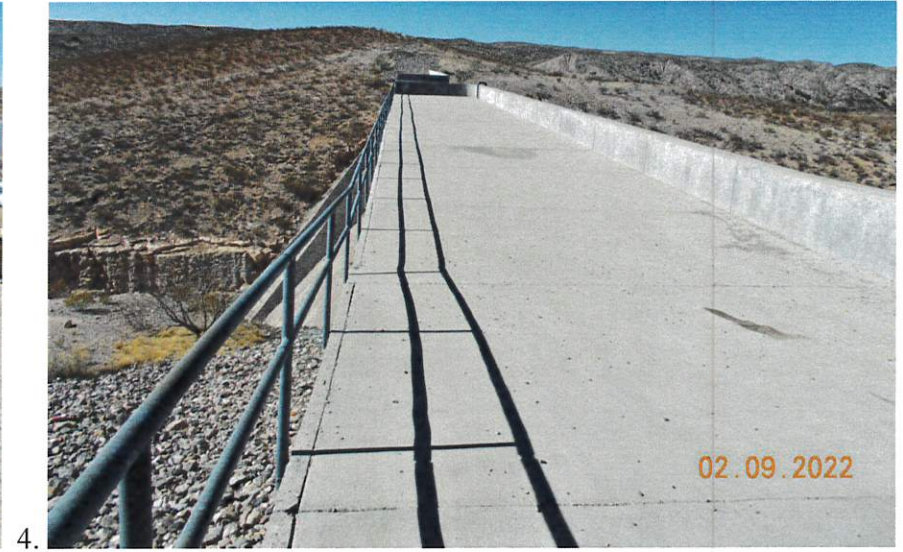
**Images 3 and 4:** Westerly views of the east end of the dam crest (Embankment Section -Image 3 and Concrete Section – Image 4).

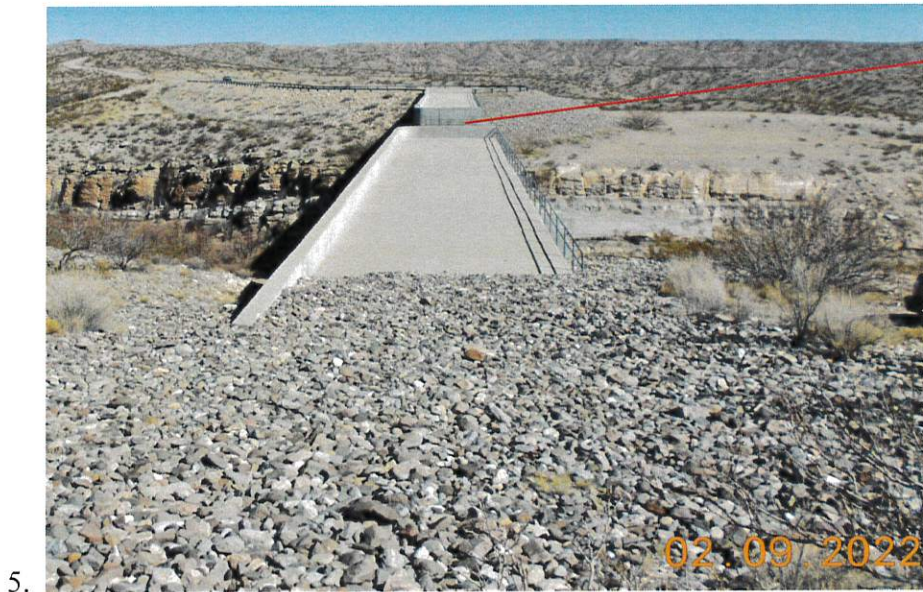
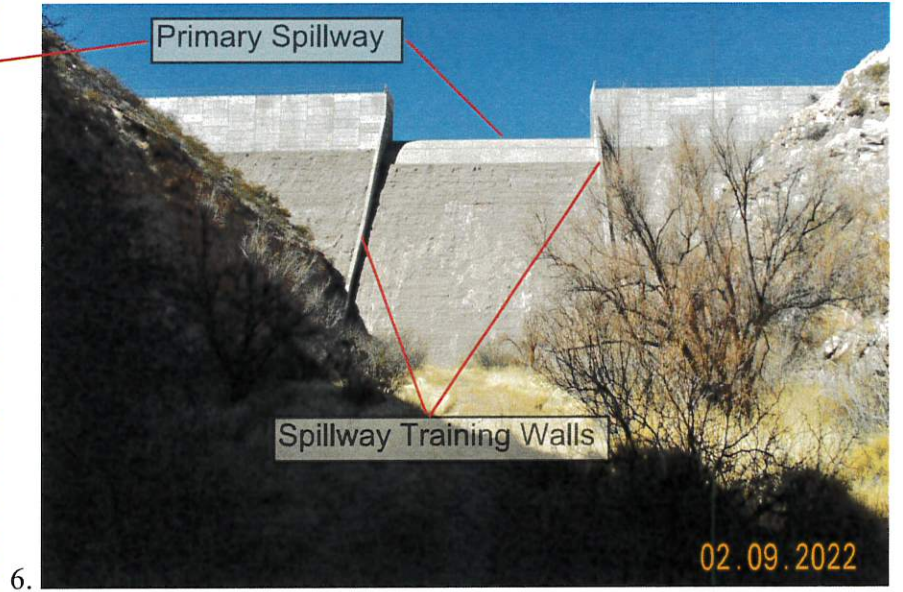
**Images 5 and 6:** Easterly view of the west end of the dam crest (Image 5) as seen from the vicinity of the right abutment and upstream (northerly) view (Image 6) of the downstream face of the main dam at the primary spillway overpour section.

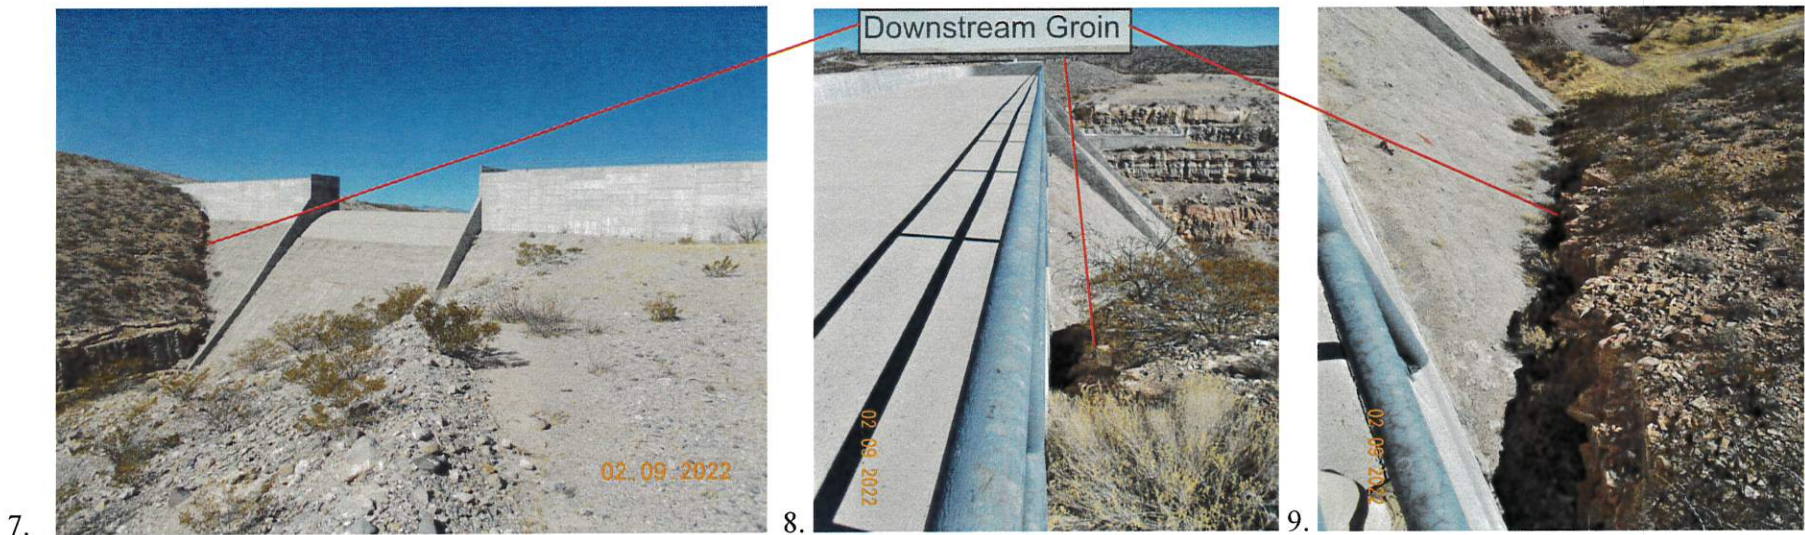
**Images 7 through 9:** Westerly view of the downstream slope of the main dam (Image 7) and easterly views along the downstream shoulder of the dam crest and the lower section of the right downstream groin (Images 8 and 9).

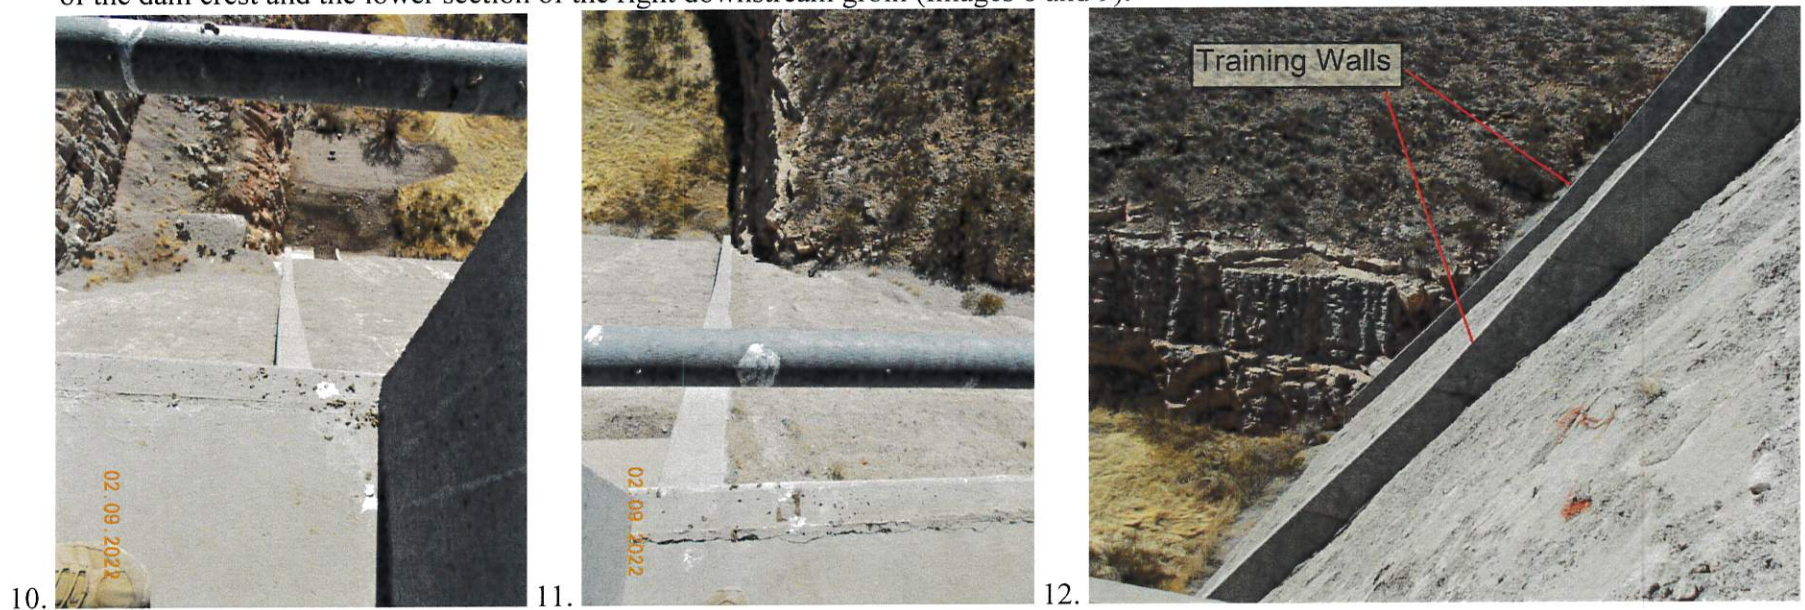
**Images 10 through 12:** Views along the left and right primary spillway training walls (Images 10 and 11) and transverse to the training walls (Image 12).

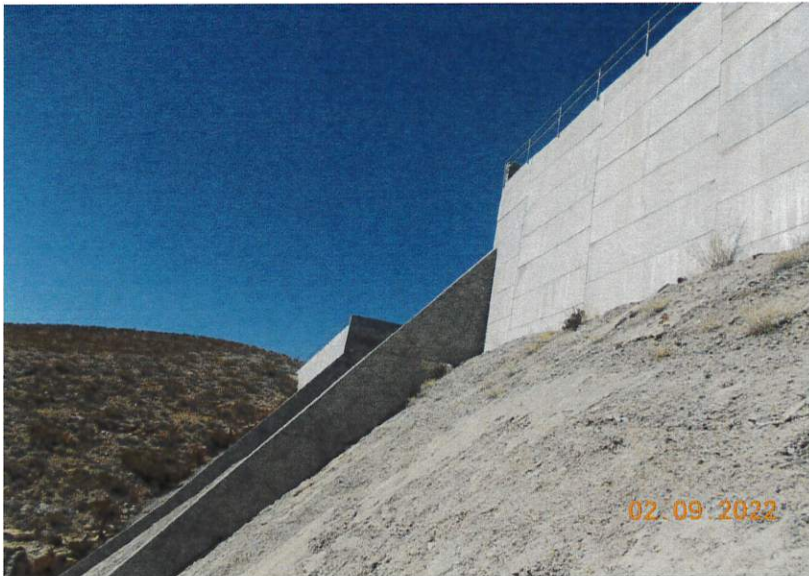
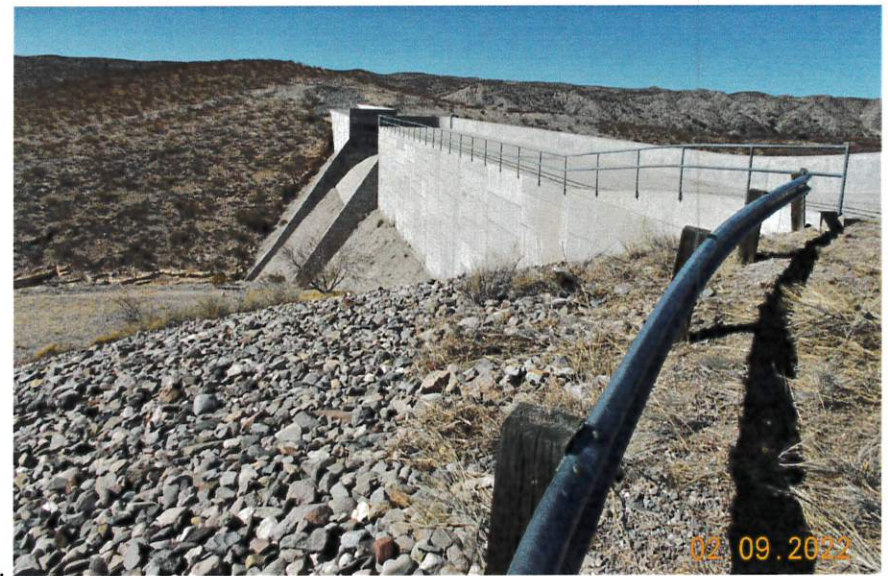
**Images 13 and 14:** Westerly view of the top of the primary spillway training walls (Image 13) and westerly view of the downstream face of the main dam as seen from the west end of the embankment section at its transition zone with the concrete section of the dam.(Image 14).

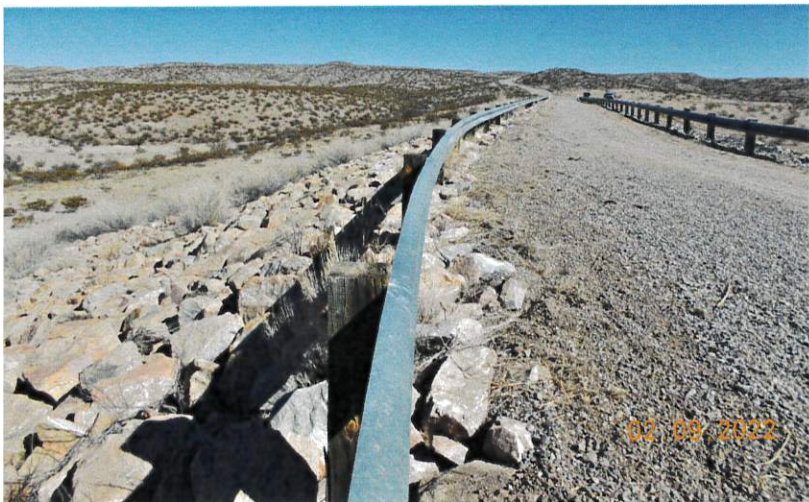
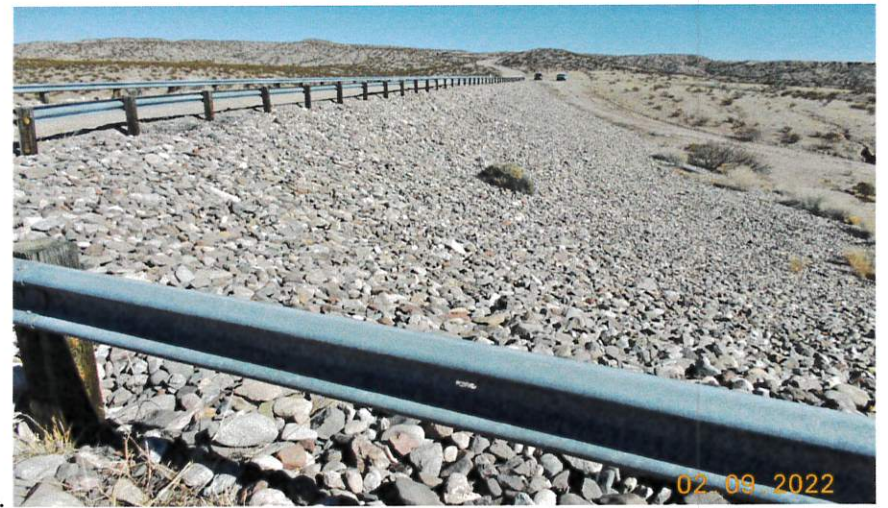
**Images 15 and 16:** Easterly views along the upstream and downstream slopes of the embankment section of the dam at the transition zone with the concrete section of the dam.

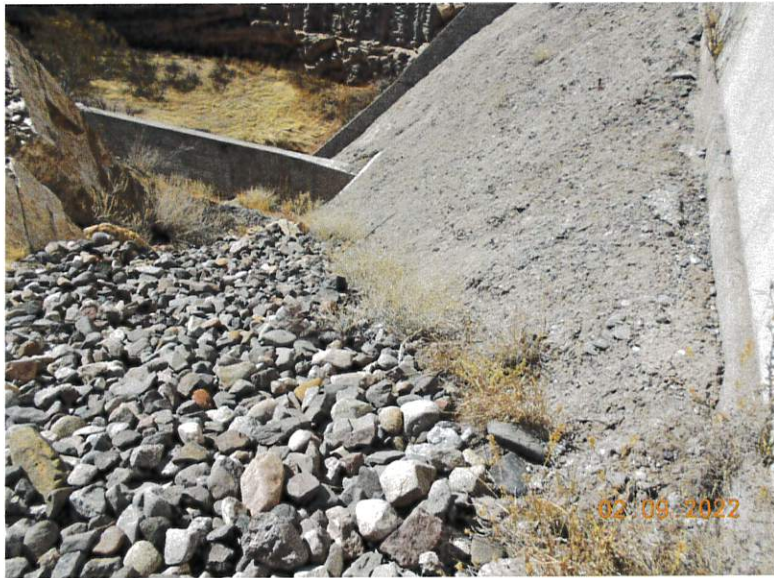
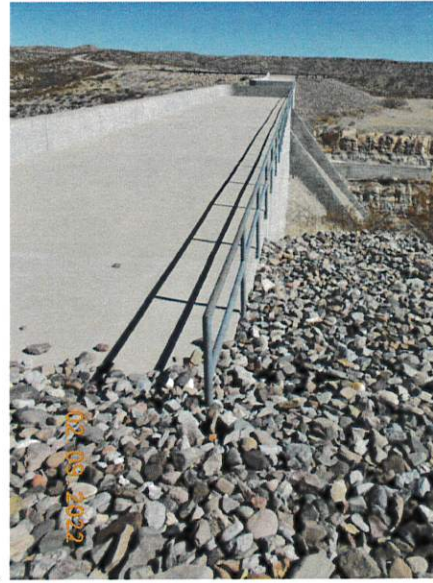
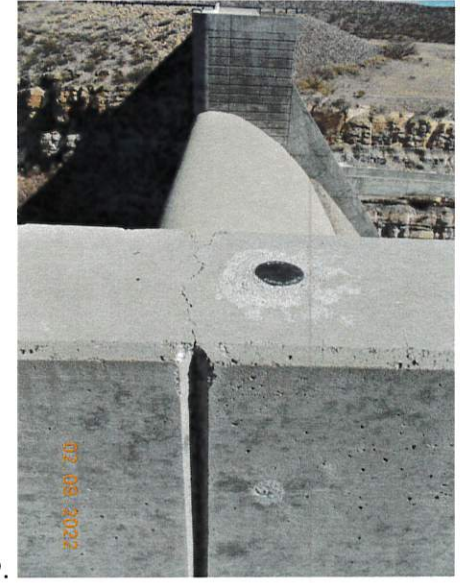
**Images 17 through 19:** Downstream (southwesterly) view of the upper left downstream groin of the main (concrete) dam (Image 17), downstream (northeasterly) view of the upper right downstream groin (Image 18), and easterly view of the right side primary spillway wall and spillway crest (Image 19).

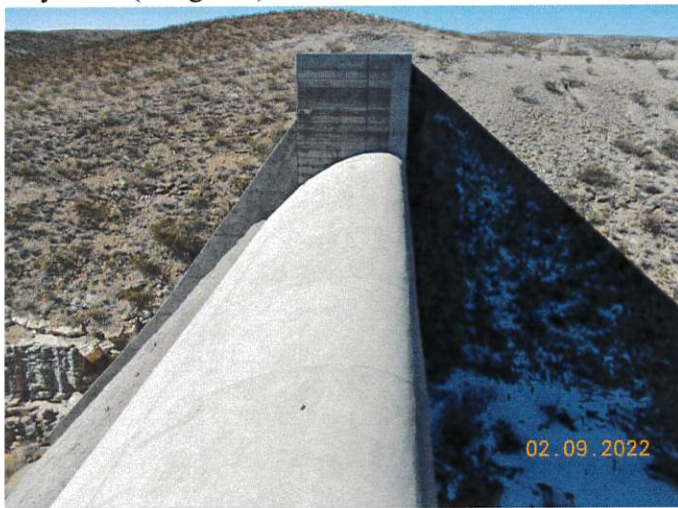
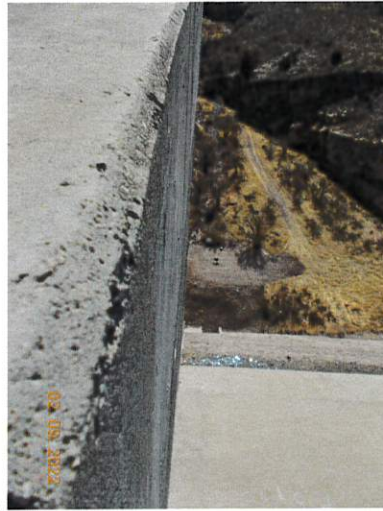
**Images 20 through 22:** Westerly view along the primary spillway crest (Image 20), southerly view along the left side primary spillway training wall (Image 21), and view of the lower portion of the left downstream groin of the main dam and spalled concrete at a contraction joint (Image 22).

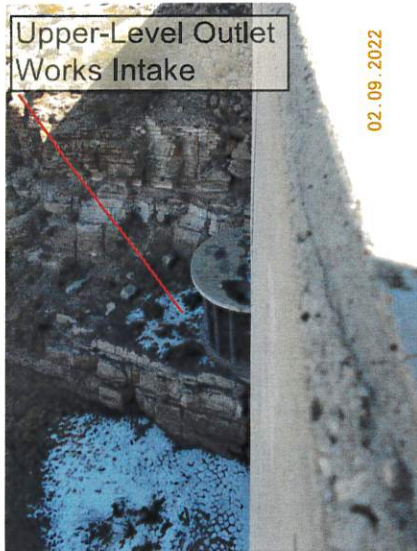
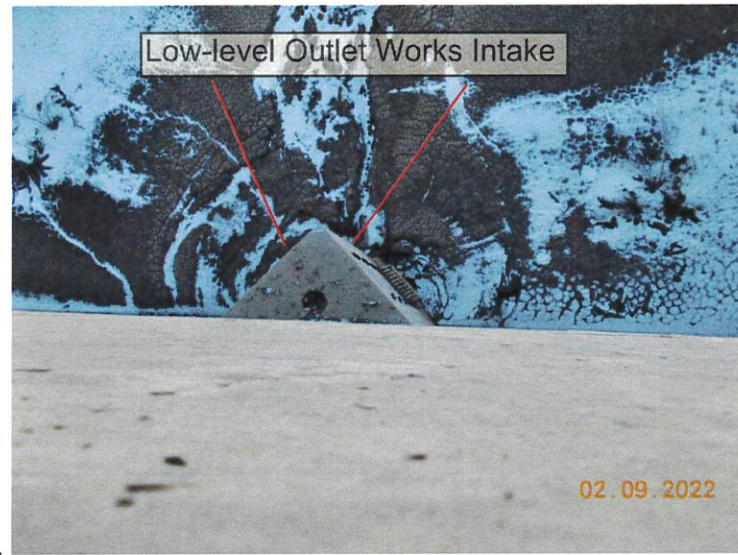
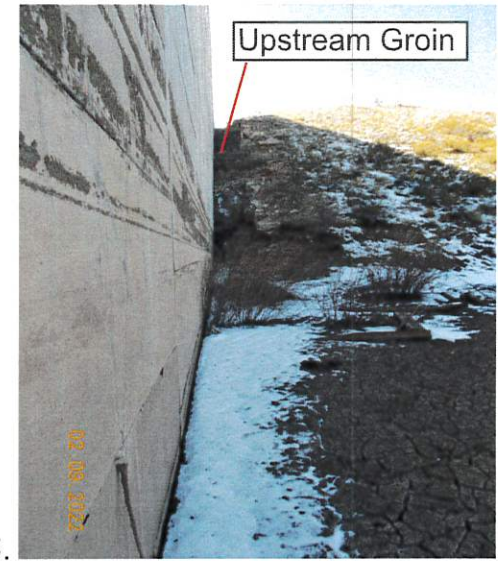
**Images 23 through 25:** Views of the upper and lower low-level outlet works intake structures located on the upstream face of the main dam (Images 23 and 24) and westerly view along the right upstream groin of the Main Dam (Image 25).

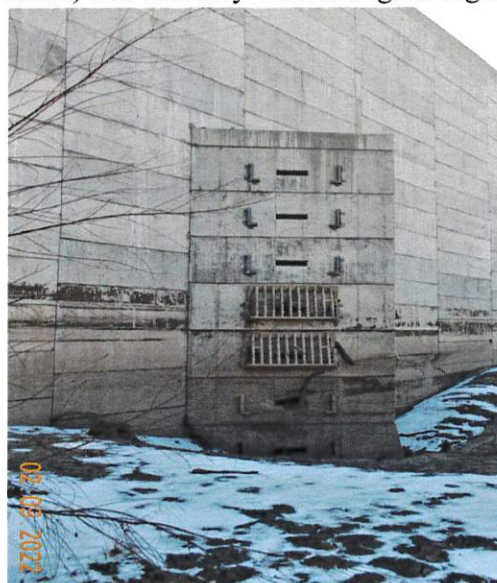
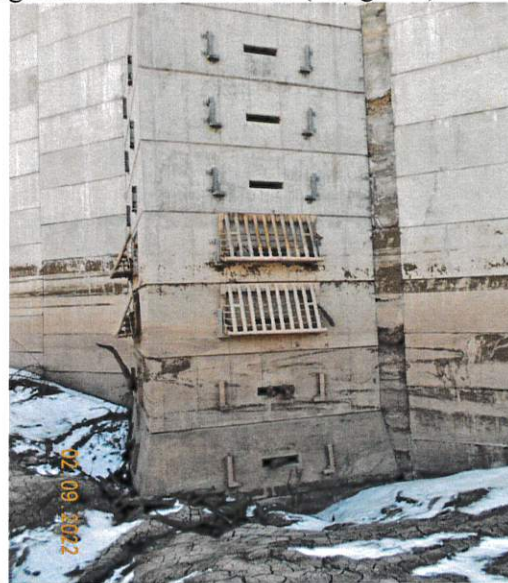
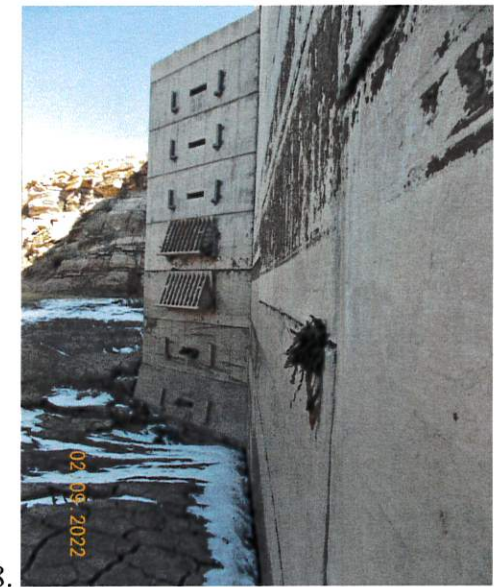
**Images 26 through 28:** Slightly distorted views of the low-level outlet works intake structure located at the base of the upstream face of the dam.

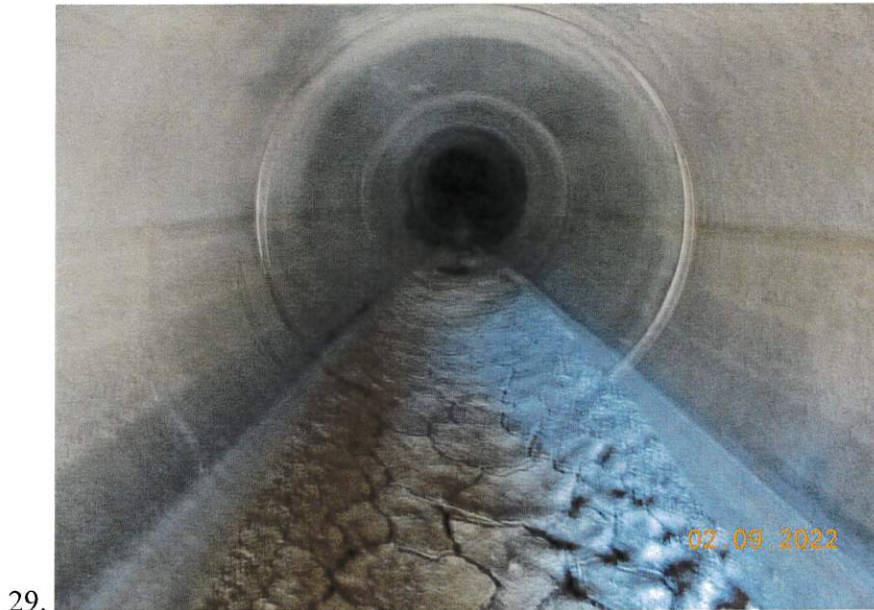
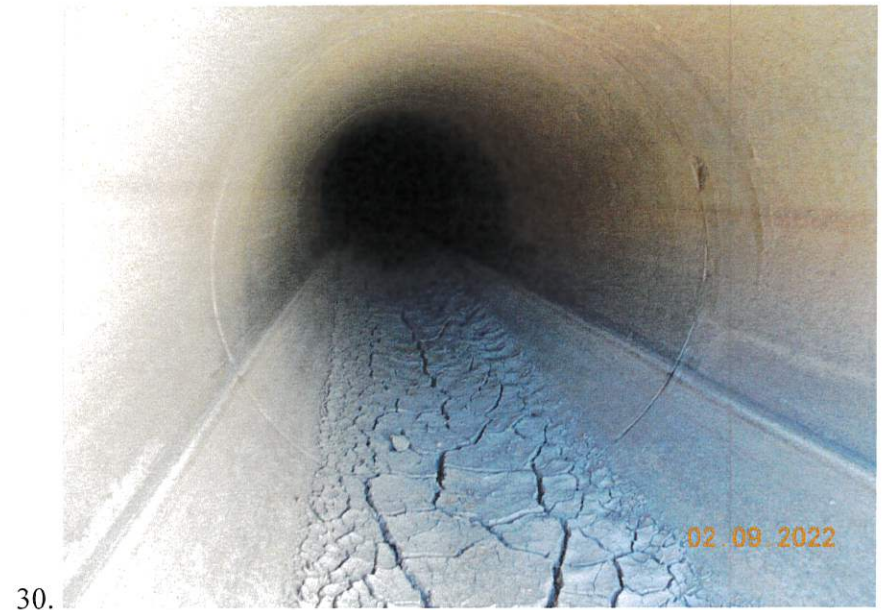
**Images 29 and 30:** Upstream interior views of the low-level outlet conduit as seen from the discharge end of the conduit. The upstream end of the conduit is located at the upstream face of the dam and within the outlet works structure shown in Images 26 through 28.

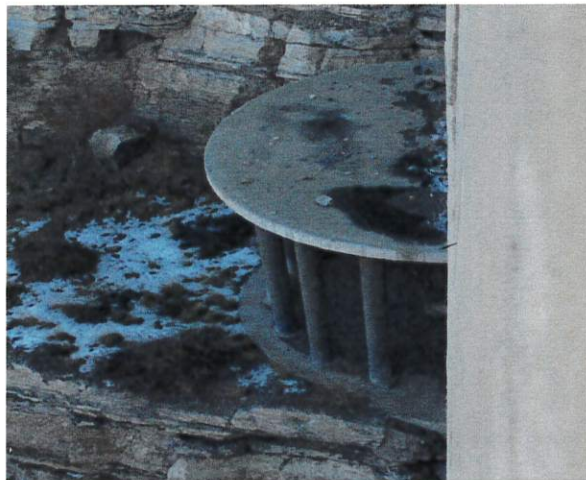
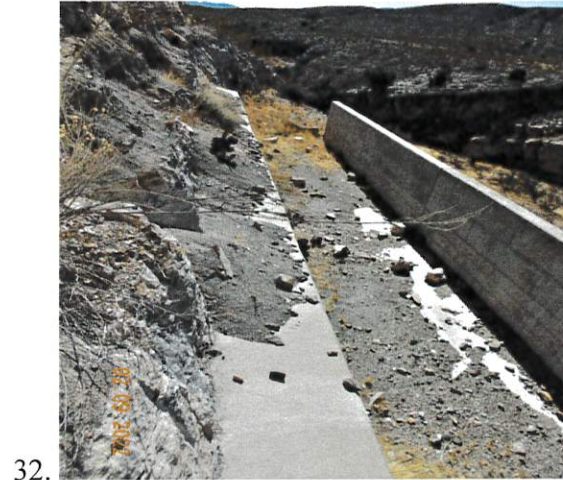
**Images 31 and 32:** Horizontally distorted views of the upper-level outlet works intake structure (Image 31) and concrete chute discharge channel (Image 32).

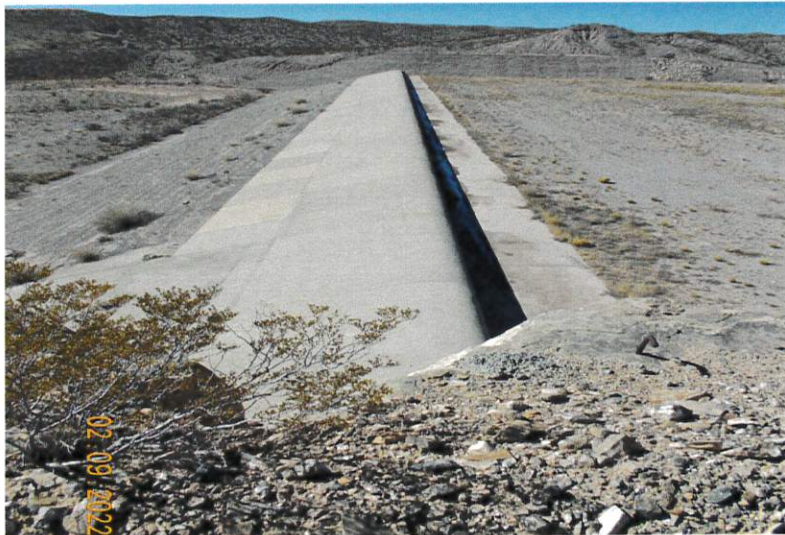
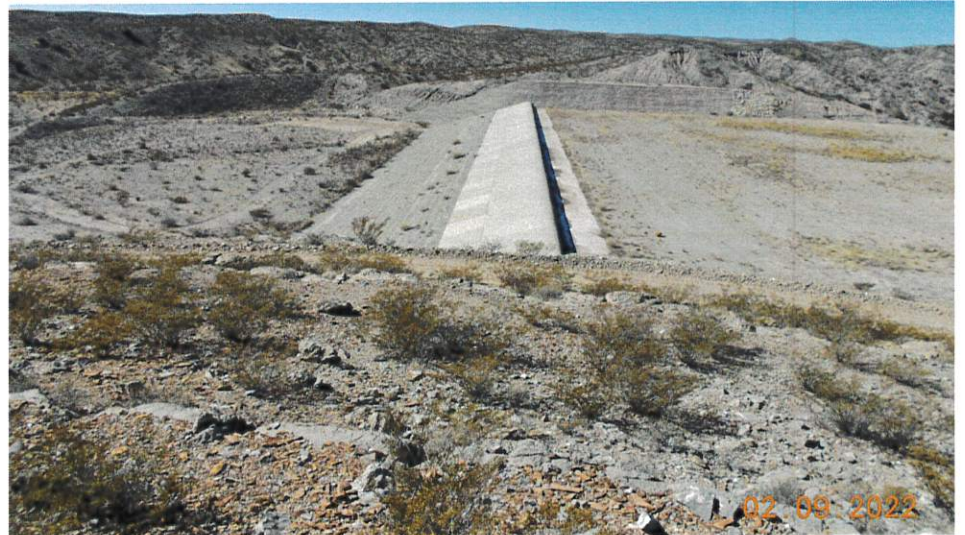
**Images 33 and 34:** Westerly views of the emergency spillway ogee weir located approximately 300 feet west of the right abutment of the Main Dam.

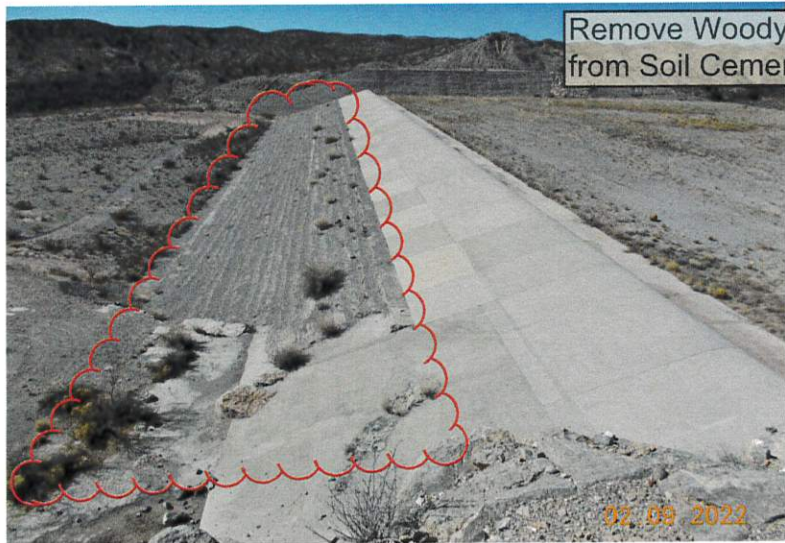
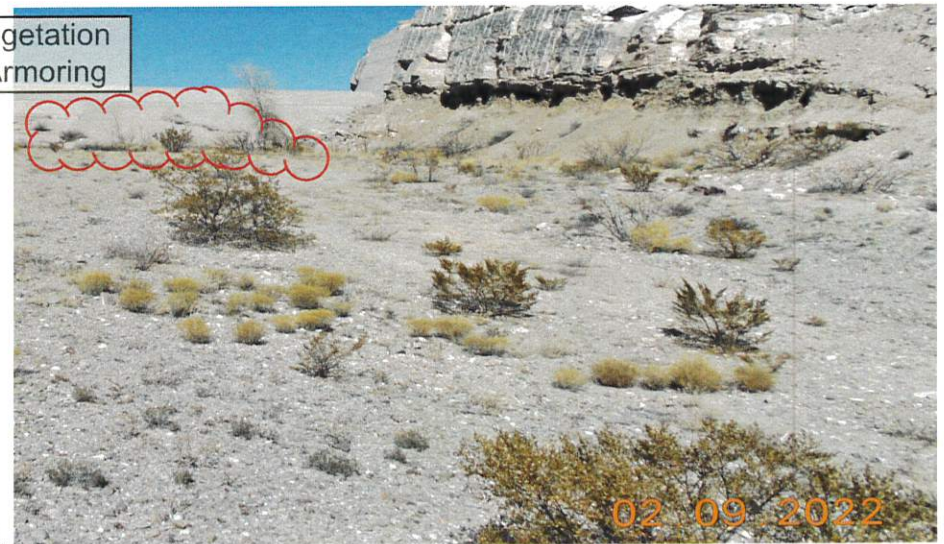
**Images 35 and 36:** Additional westerly view of the emergency spillway (Image 35) and a northerly view of the right downstream groin of the emergency spillway.

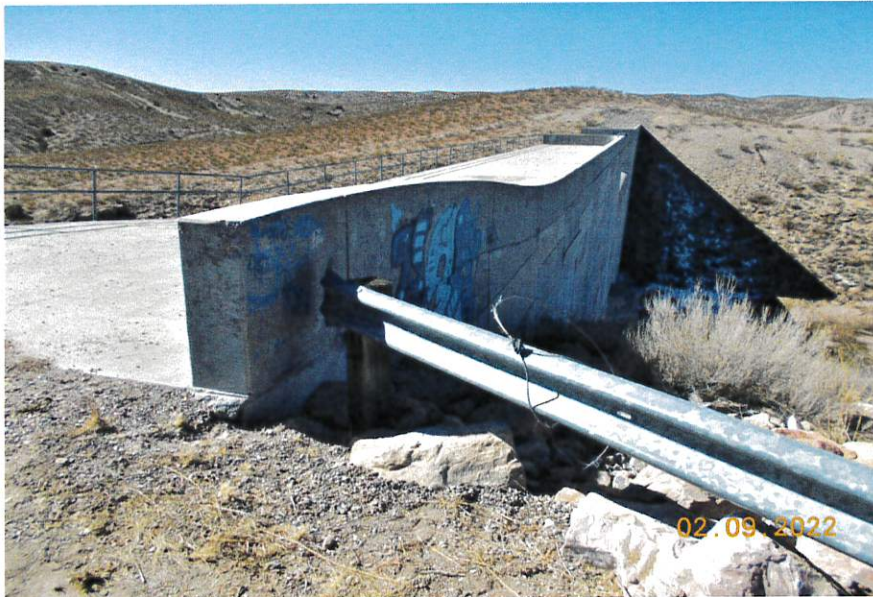
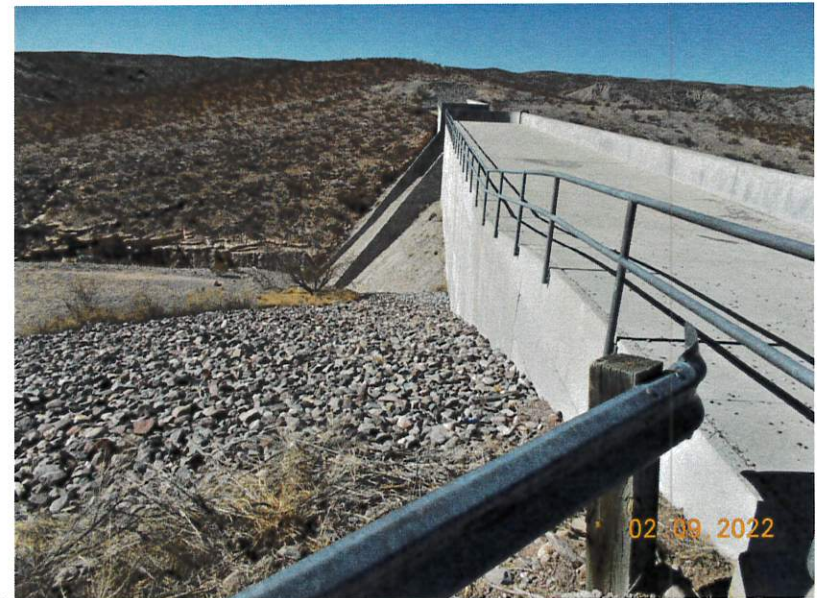
45. 46. **Images 45 and 46:** Westerly views along the upstream and downstream faces of the main dam.

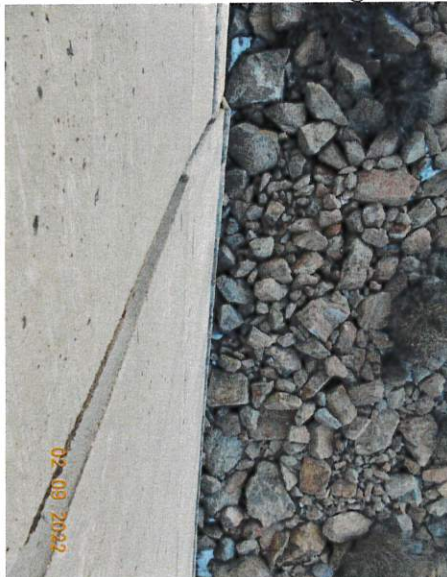
47. 48. 49. **Images 47 through 49:** Examples of offset joints and cracks on the upstream face, crest of the main dam and upstream face of the emergency spillway ogee section that should be monitored over time.

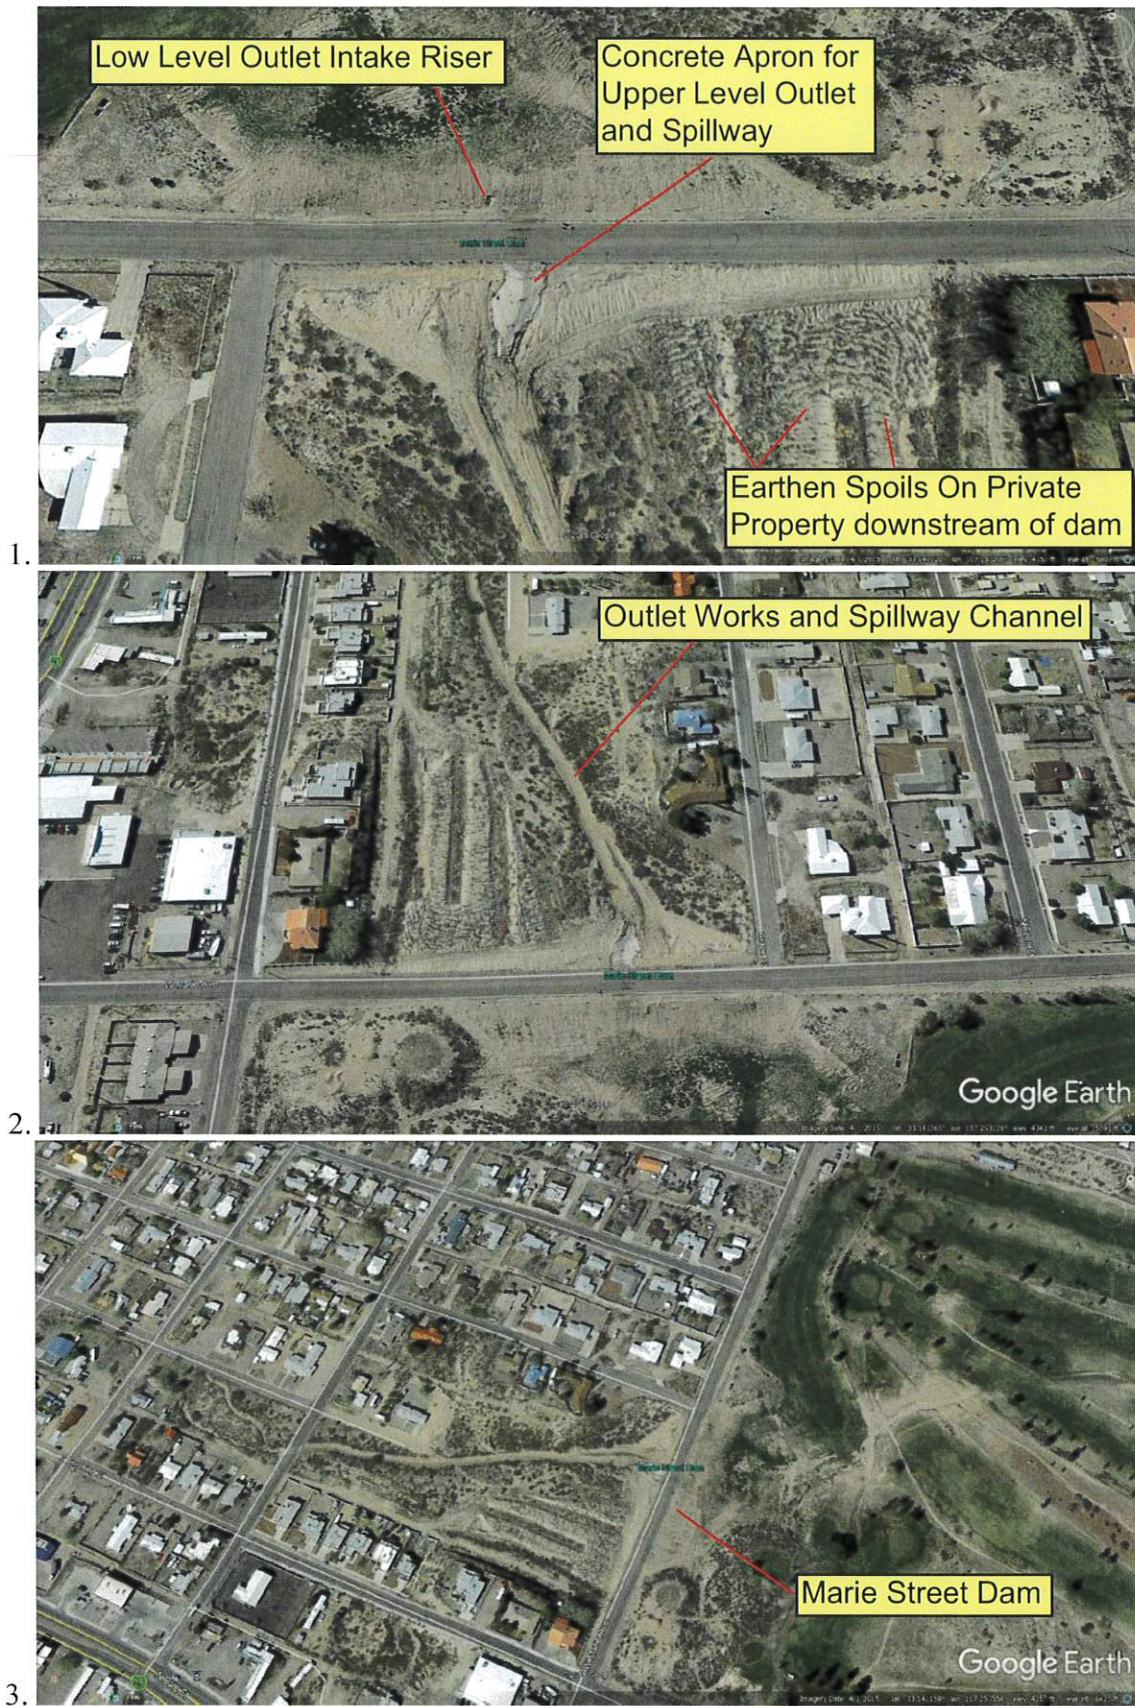
**Images 1 through 3:** Aerial views of the dam courtesy of GoogleEarth (circa 2015).

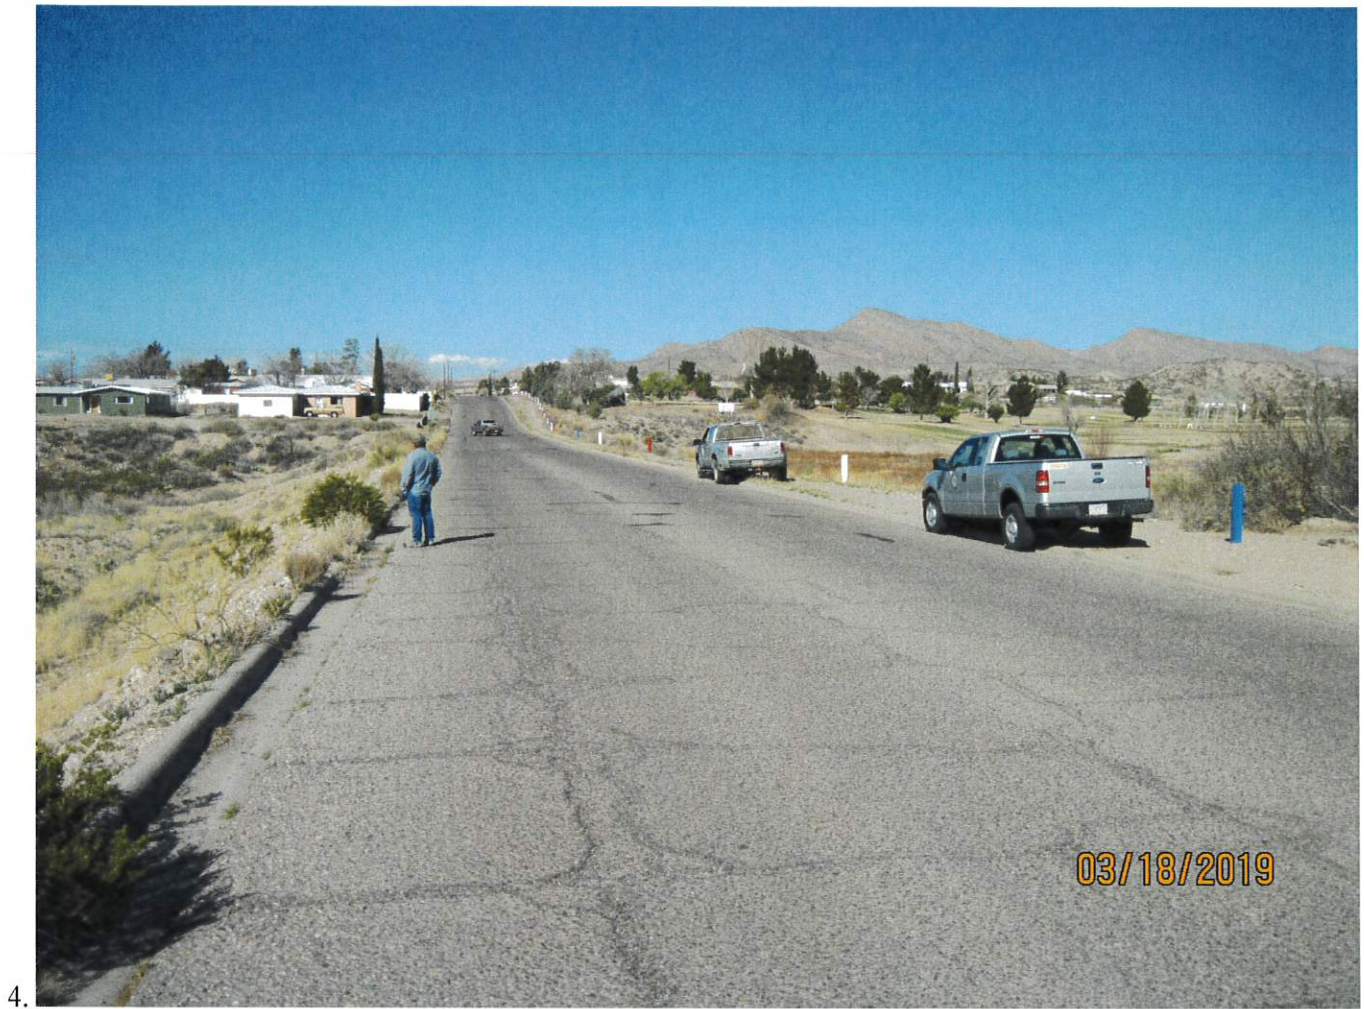
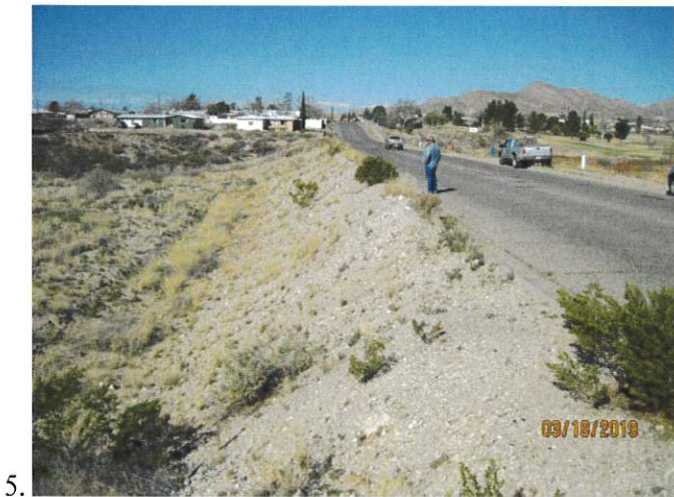
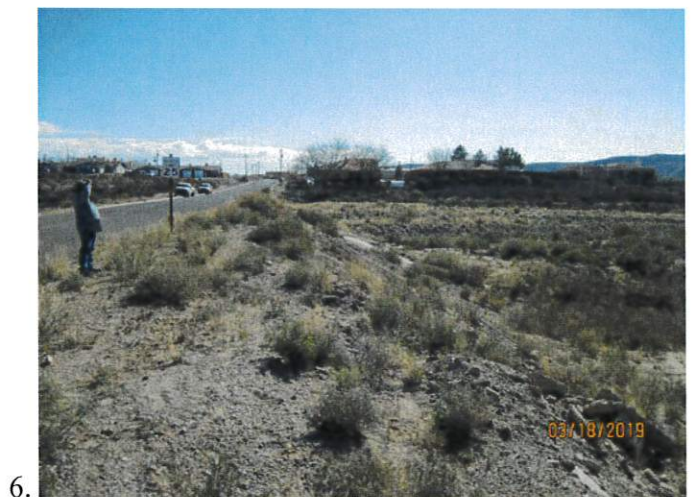
**Images 4 through 6:** Westerly view along the dam crest / Marie Street and the downstream slope (Images 4 and 5), and easterly view of the downstream slope (Image 6).

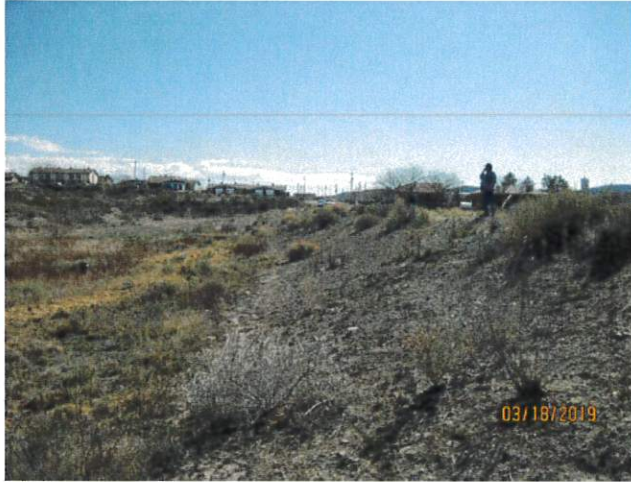
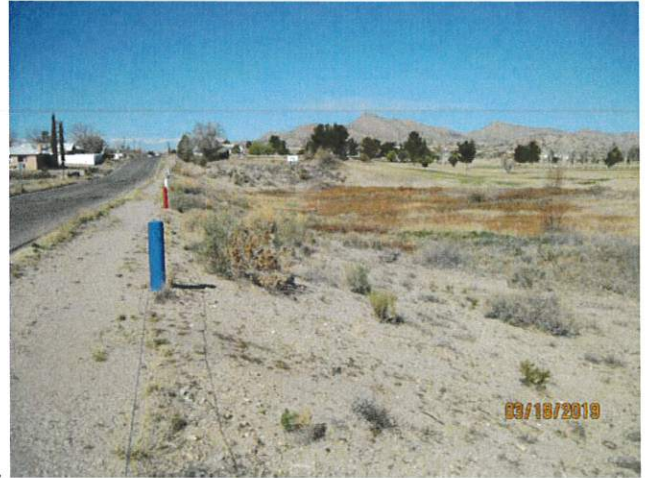
**Images 7 and 8:** Easterly and westerly views, respectively, of the upstream slope.

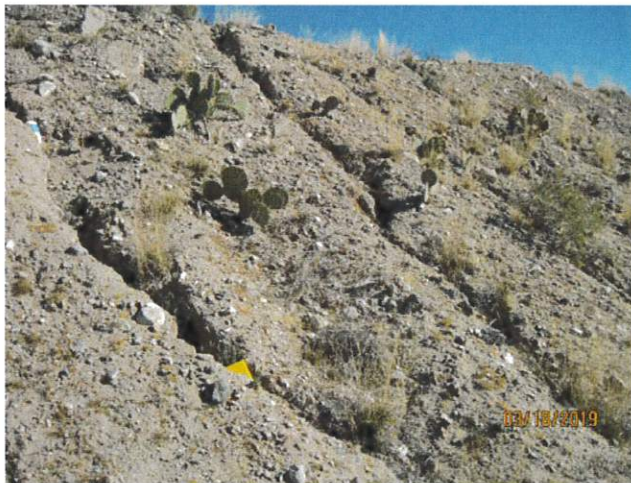
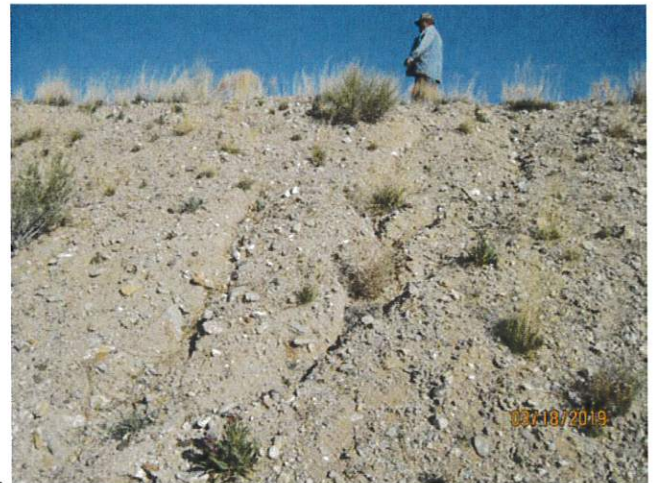
**Images 9 and 10:** Northerly (upstream) views of erosion on the downstream slope.

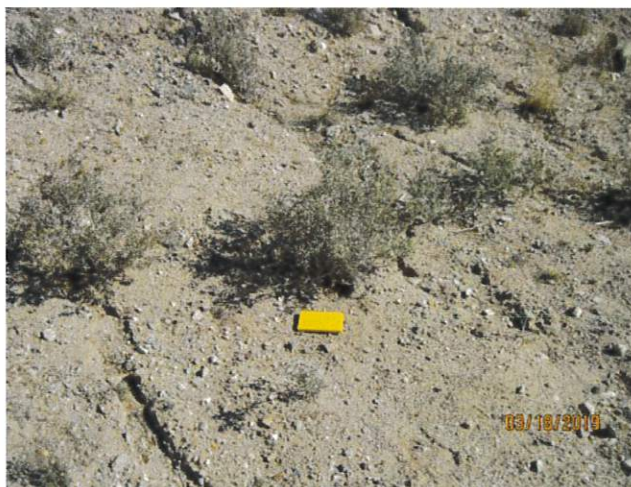
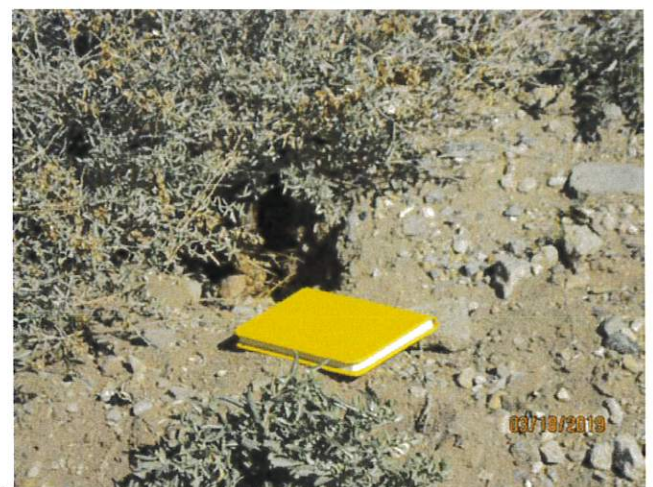
**Images 11 and 12:** Typical views of rodent burrows on the downstream slope.

3. Rodent burrows were observed on the upstream and downstream slopes of the dam. All rodent burrows need to be collapsed and backfilled with appropriate embankment material. Continuous or regularly scheduled rodent abatement measures need to be implemented.

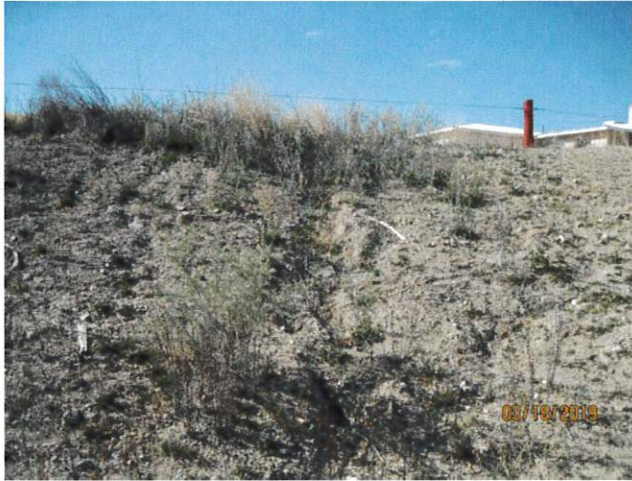
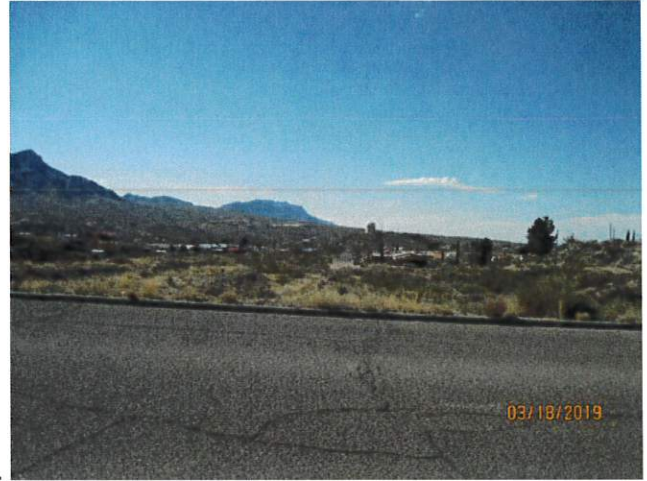
**Images 13 and 14:** Southerly views of erosion typical to the upstream slope and the area downstream of the dam, respectively.

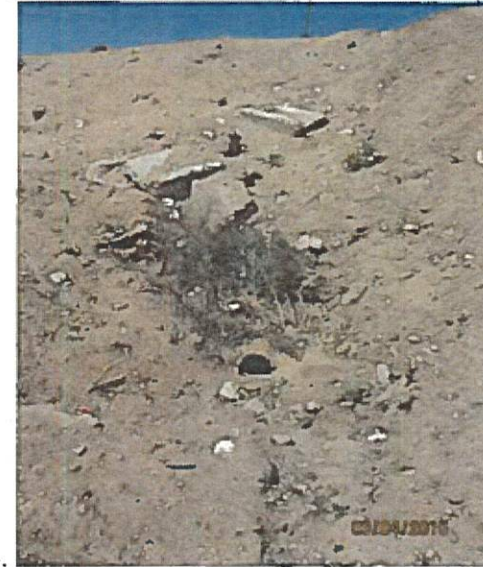
14.

**Images 13 and 14:** Upstream views of the lower level outlet outfall in 2022 and 2015, respectively. The outfall is currently obscured and needs to be maintained in an exposed condition.

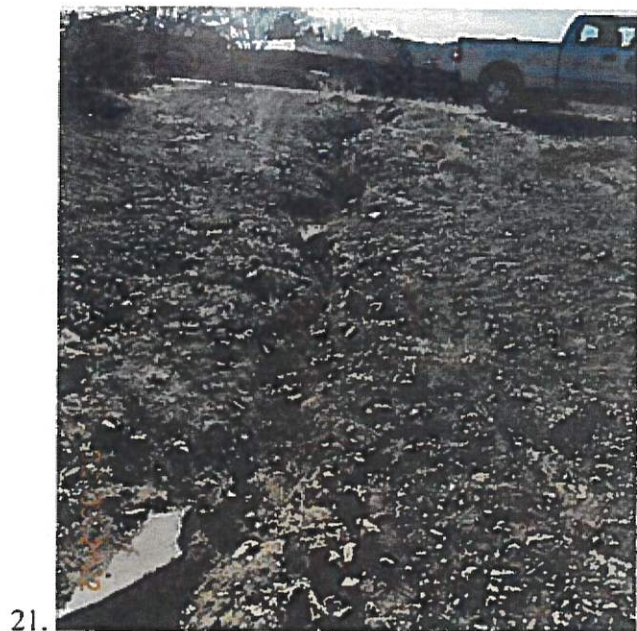
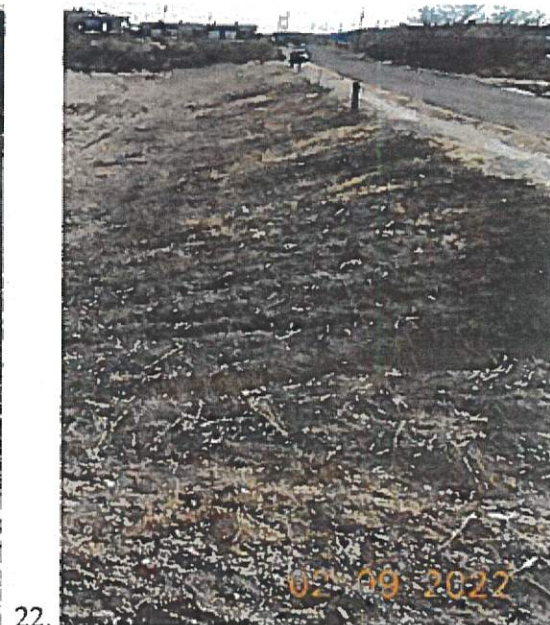
**Images 21 through 23:** Erosion gullies in need of repair on the upstream slope (Images 21 and 22) and more of the same on the downstream slope (Image 23).
