## REGULAR MEETING

THE REGULAR MEETING OF THE CITY COMMISSION OF THE CITY OF TRUTH OR CONSEQUENCES, NEW MEXICO, TO BE HELD IN THE COMMISSION CHAMBERS, 405 W. 3RD ST., ON WEDNESDAY, MARCH 27, 2024; TO START AT 9:00 A.M.

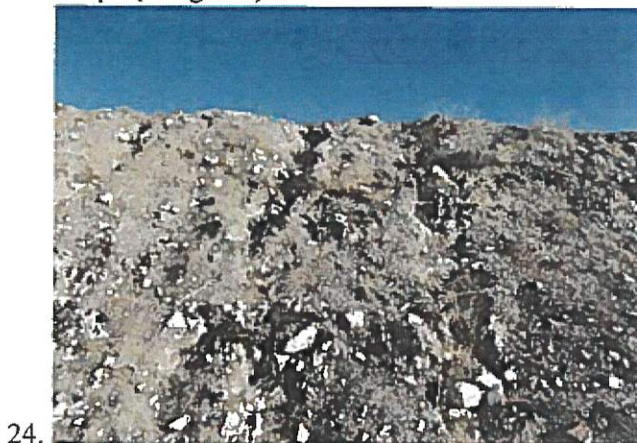
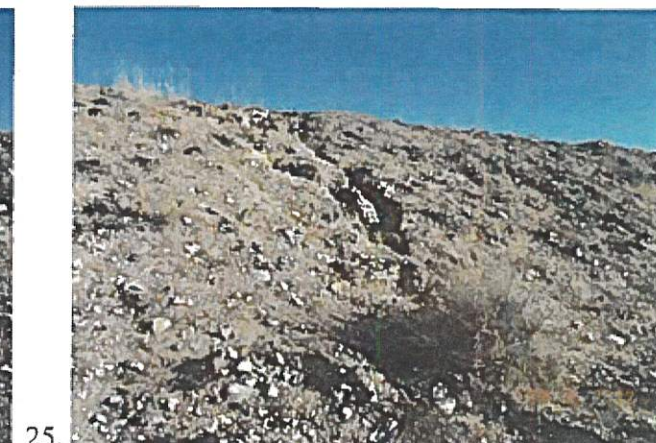
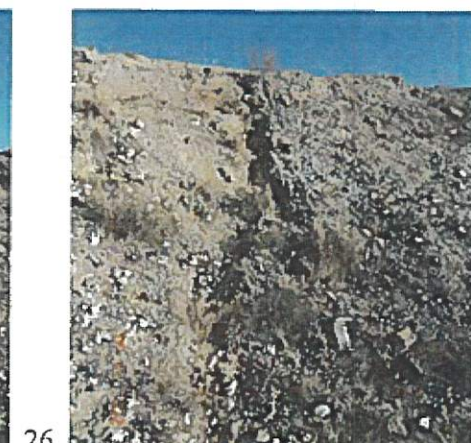
**Images 24 through 26:** Additional views of erosion on the downstream slope. A gravel/cobble mulch placed on the embankment slopes and abutment contacts at the upstream and downstream groins of the dam would serve well towards diminishing erosion.

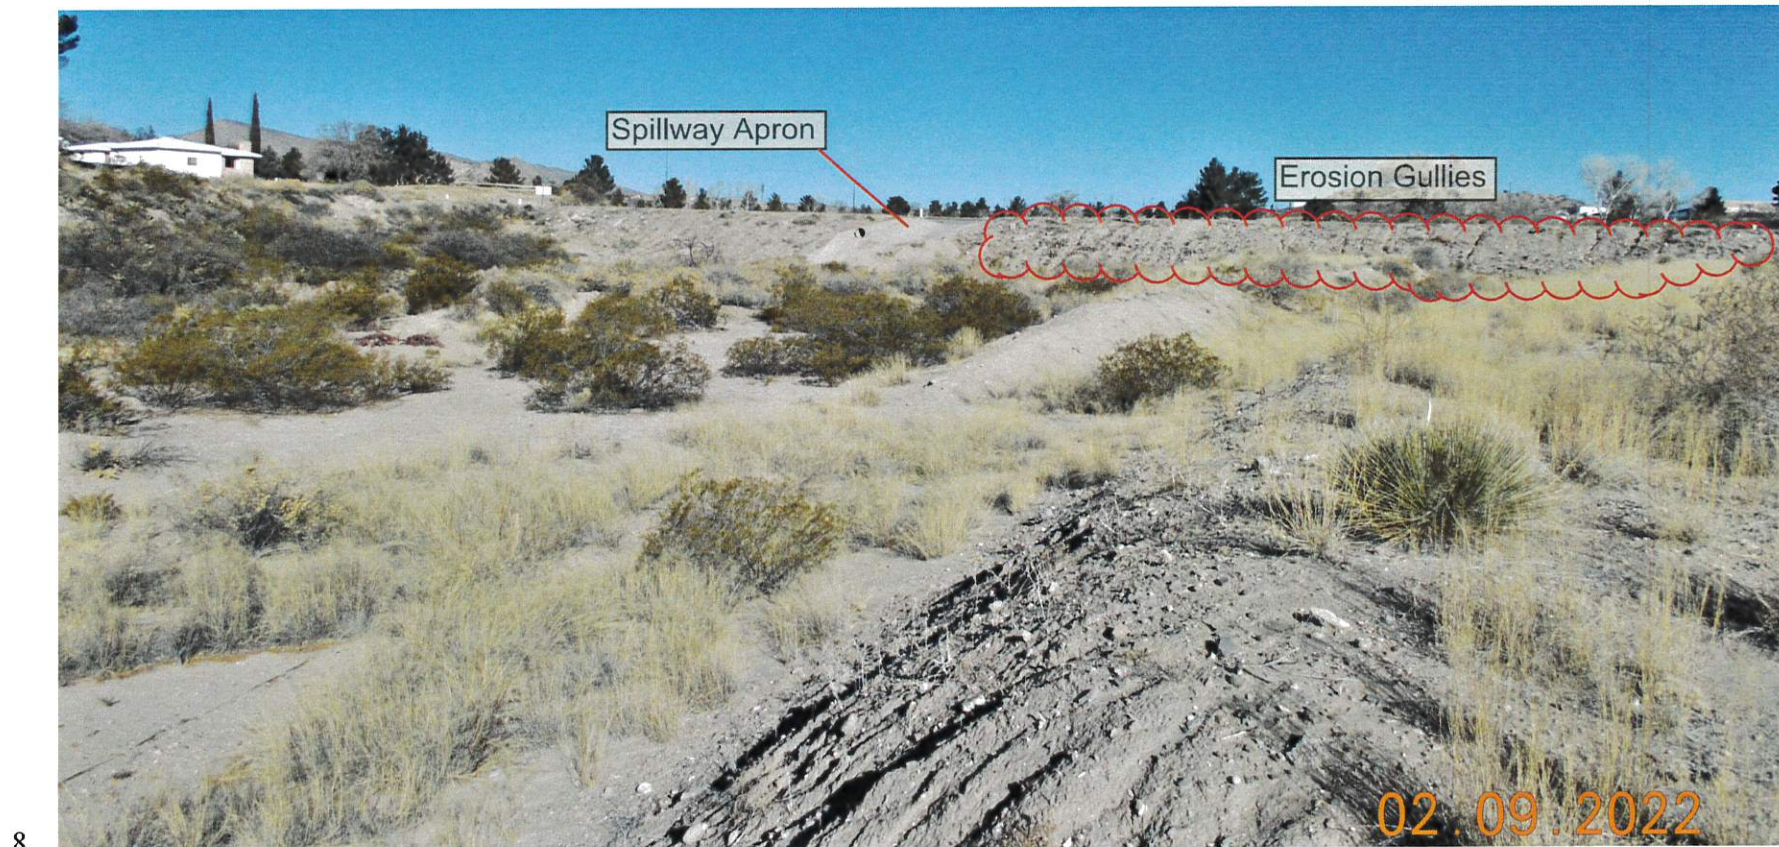
**Image 8:** Northerly view of the downstream slope with areas of erosion and spillway apron as indicated.

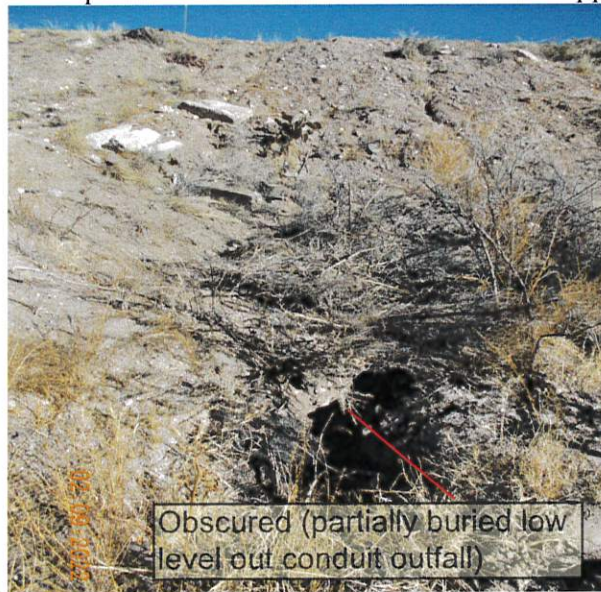
13.

**Images 13 and 14:** Upstream views of the lower level outlet outfall in 2022 and 2015, respectively. The outfall is currently obscured and needs to be maintained in an exposed condition.

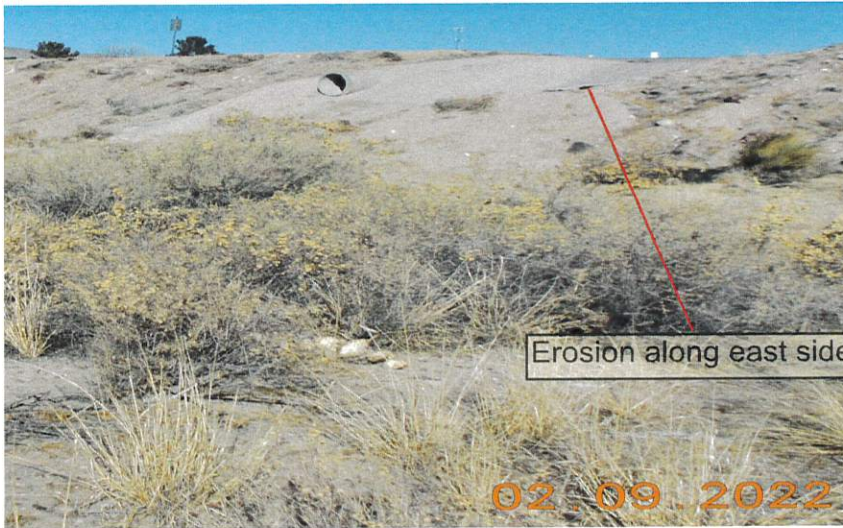
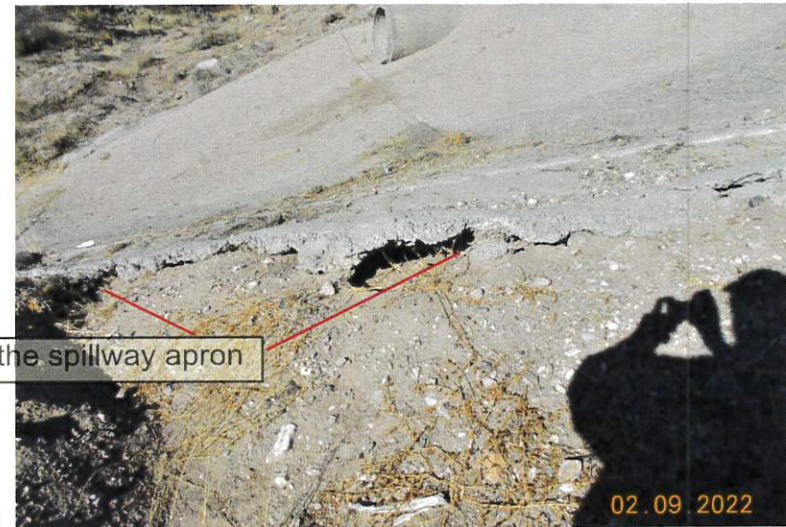
**Images 18 and 19:** Northwesterly view of the spillway apron on the downstream slope of the dam (Image 18) and erosion along the east side of the apron (Image 19). The flood discharge that occurred as a result of heavy rains in July 2020 overtopped the dam at the spillway and eroded the east side of the spillway apron. This area was apparently backfilled to some degree, but additional erosion or not enough backfill was placed to fill the eroded area that occurred in July 2020.

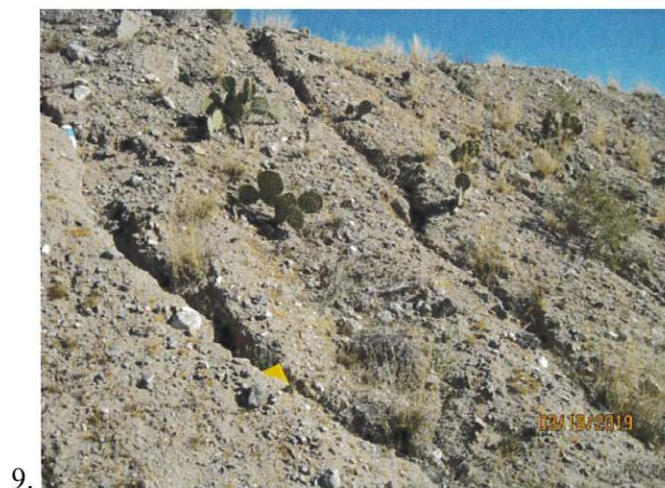
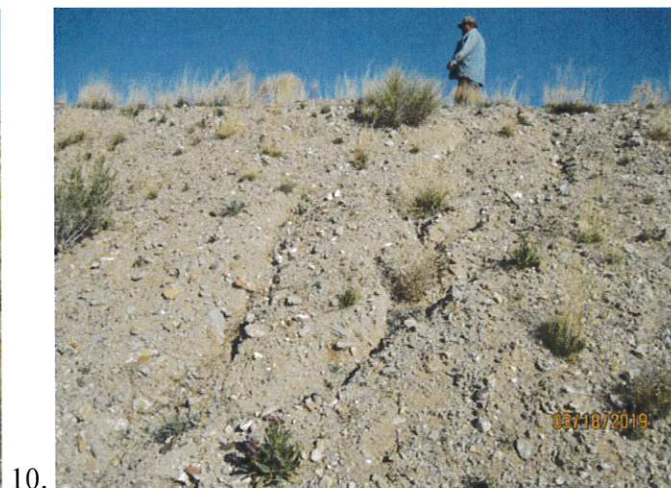
**Images 9 and 10:** Northerly (upstream) views of erosion on the downstream slope.

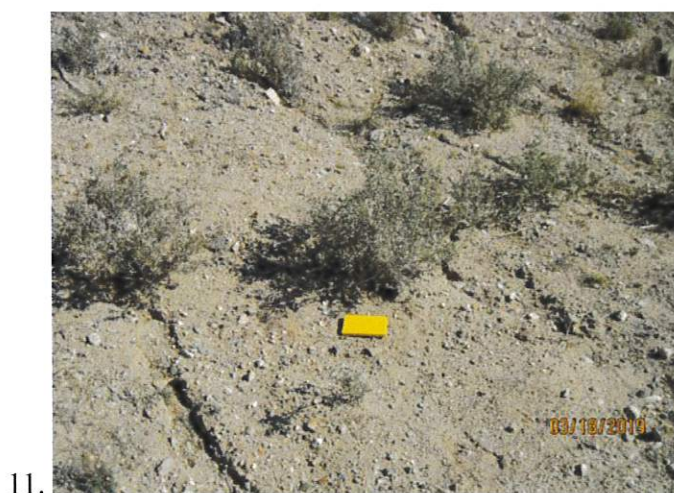
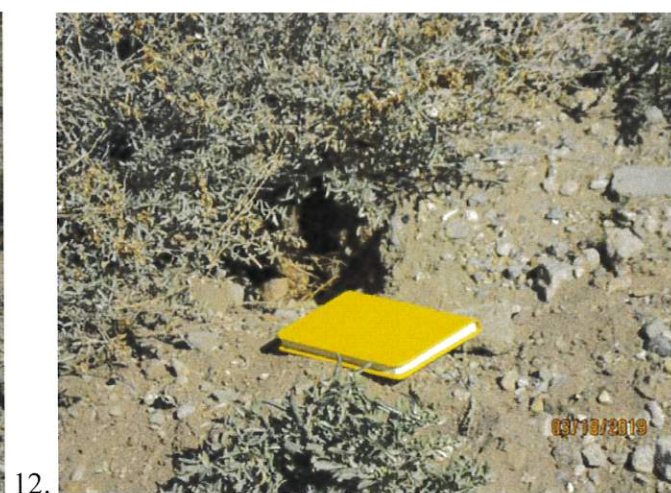
**Images 11 and 12:** Typical views of rodent burrows on the downstream slope.

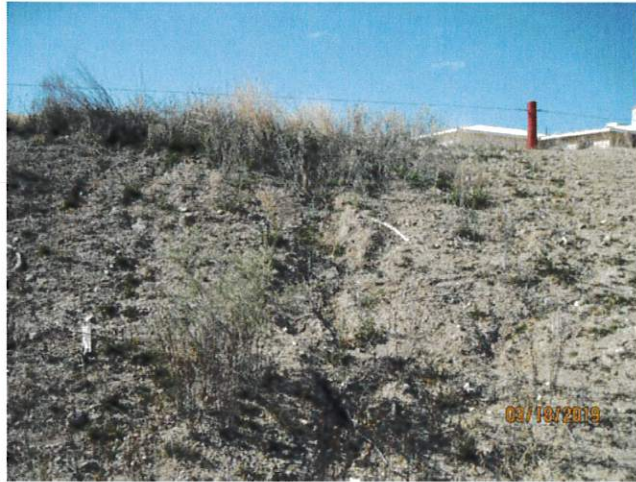
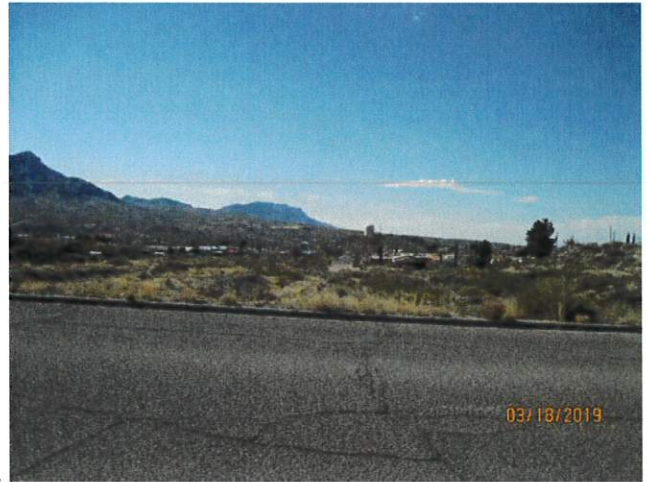
**Images 13 and 14:** Southerly views of erosion typical to the upstream slope and the area downstream of the dam, respectively.

| 2. Upstream Slope | Satisfactory | Needs Attention | N/A | Remarks: |
|---|---|---|---|---|
| a. Erosion control | <input type="checkbox"/> | <input checked="" type="checkbox"/> | <input type="checkbox"/> | Repair existing erosion and monitor and repair future erosion for erosion rill/gully depths greater than 3 inches. Backfill with suitable embankment material (preferably gravelly clay). |

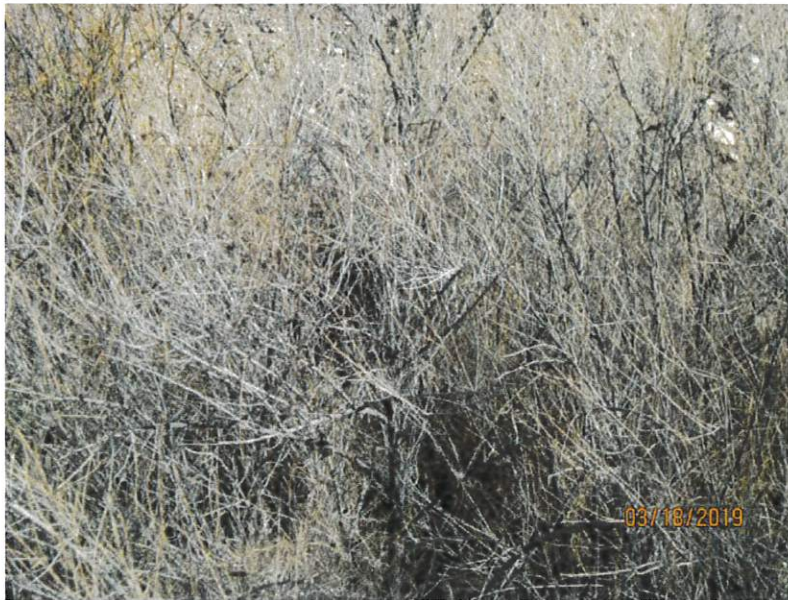
18.

**Images 18 and 19:** Vegetation immediately downstream of the lower level outlet conduit (Image 18) and easterly view of the outlet works metal riser located in the vicinity of the upstream toe of the dam.

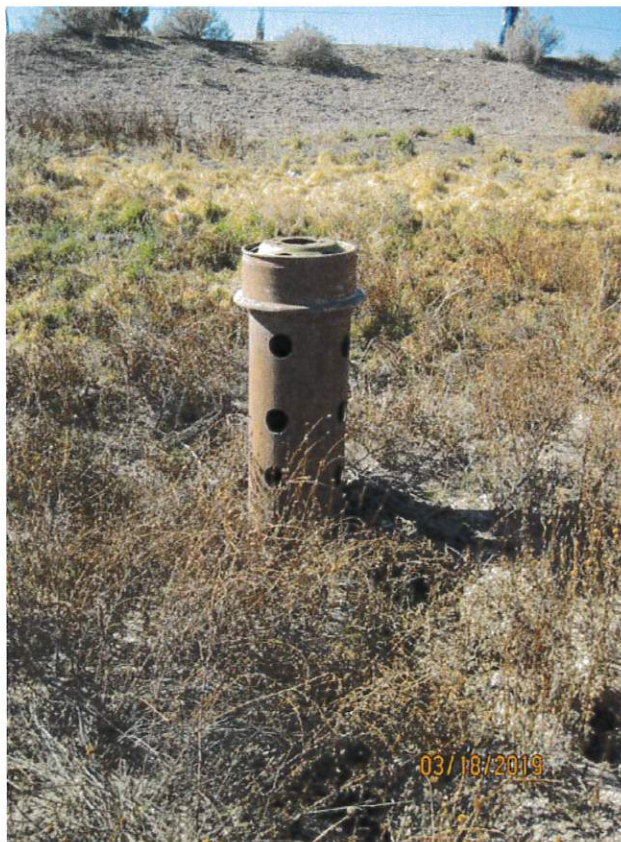
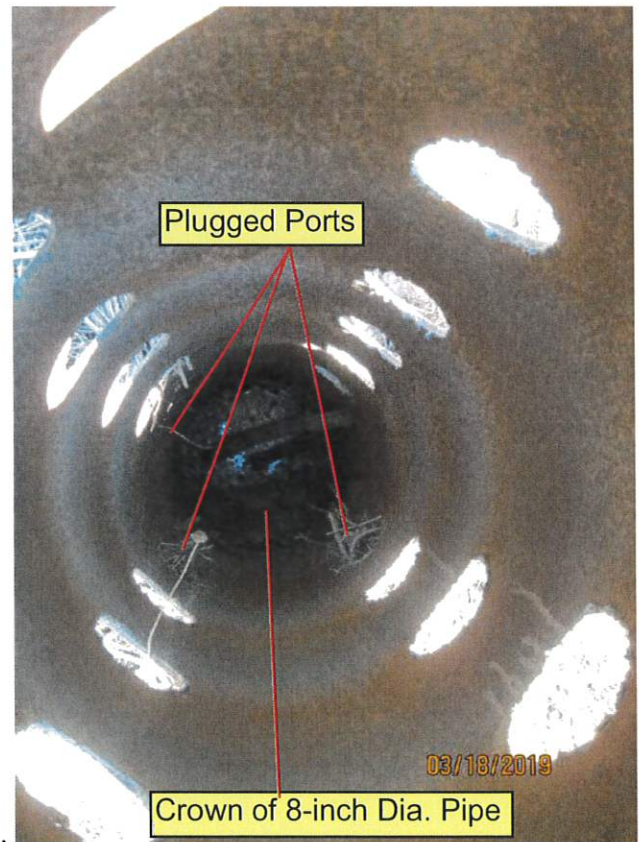
**Images 20 and 21:** Additional view of the low level outlet works riser (Image 20) and interior view of the riser (Image 21) with plugged ports as an approximate indication of the sediment level.

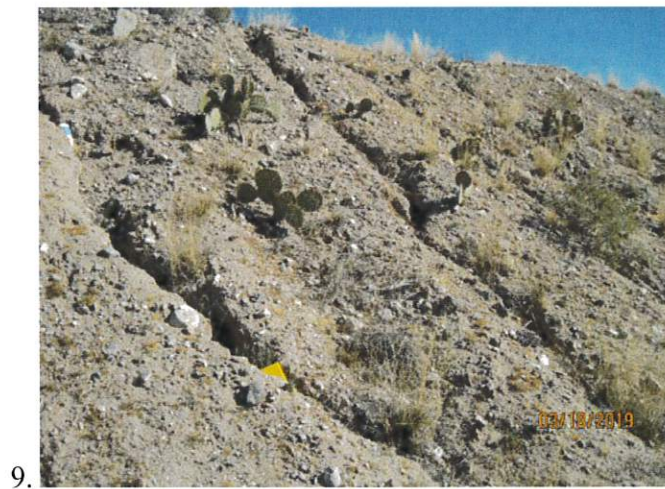
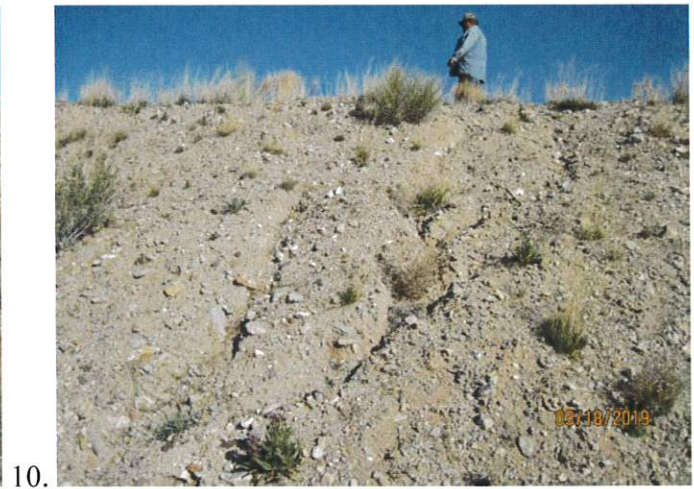
**Images 9 and 10:** Northerly (upstream) views of erosion on the downstream slope.

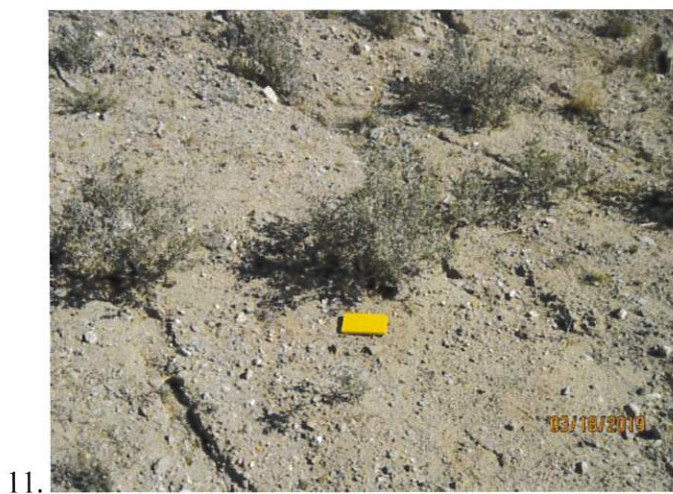
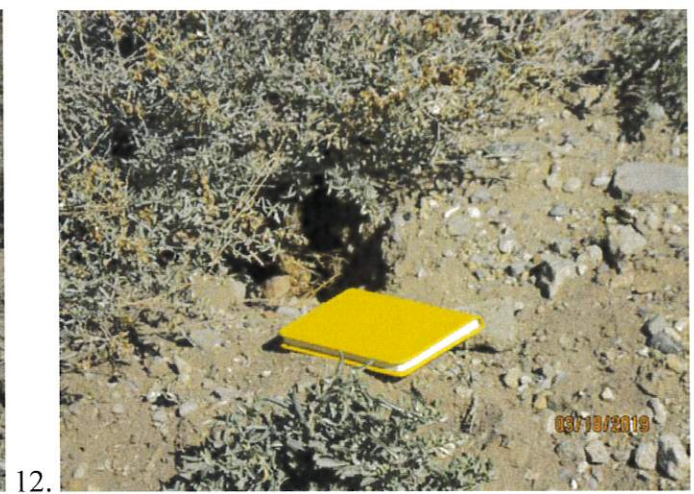
**Images 11 and 12:** Typical views of rodent burrows on the downstream slope.

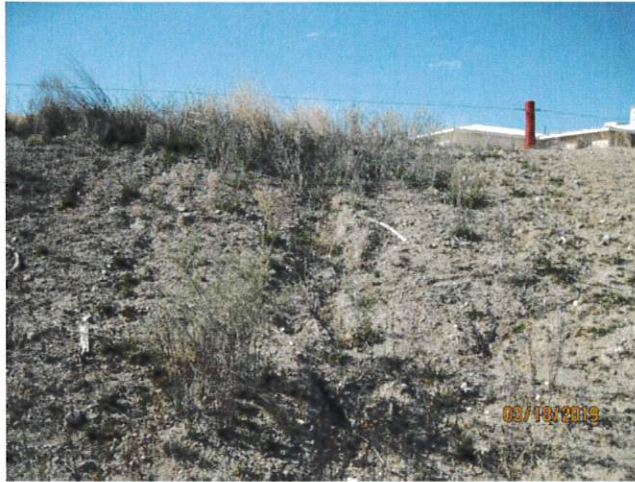
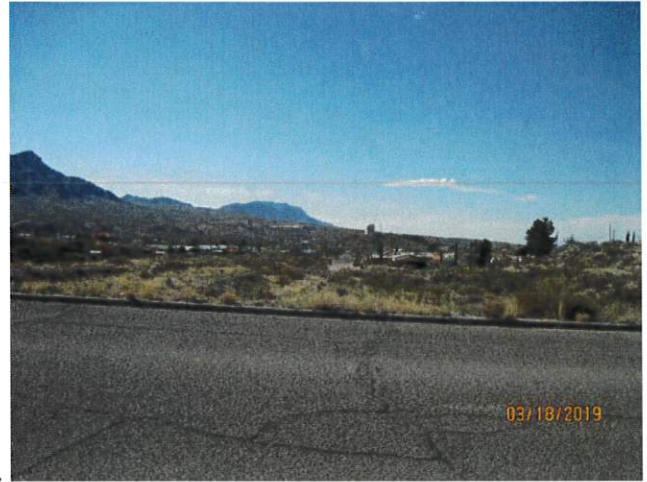
**Images 13 and 14:** Southerly views of erosion typical to the upstream slope and the area downstream of the dam, respectively.

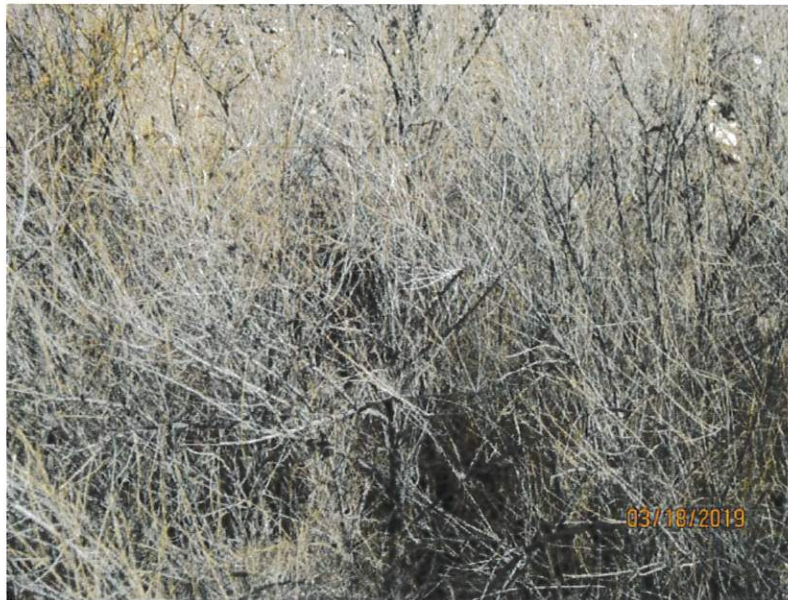
18.

**Images 18 and 19:** Vegetation immediately downstream of the lower level outlet conduit (Image 18) and easterly view of the outlet works metal riser located in the vicinity of the upstream toe of the dam.

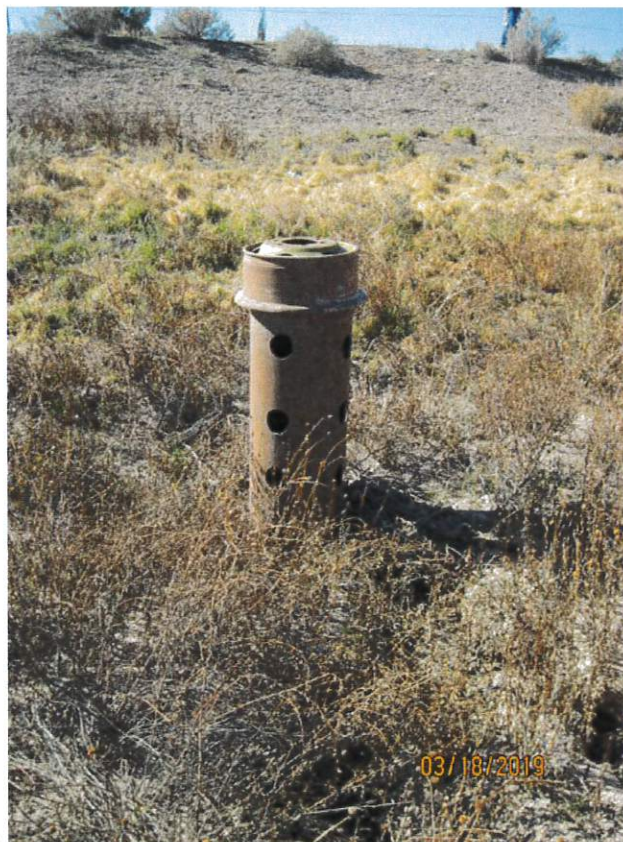
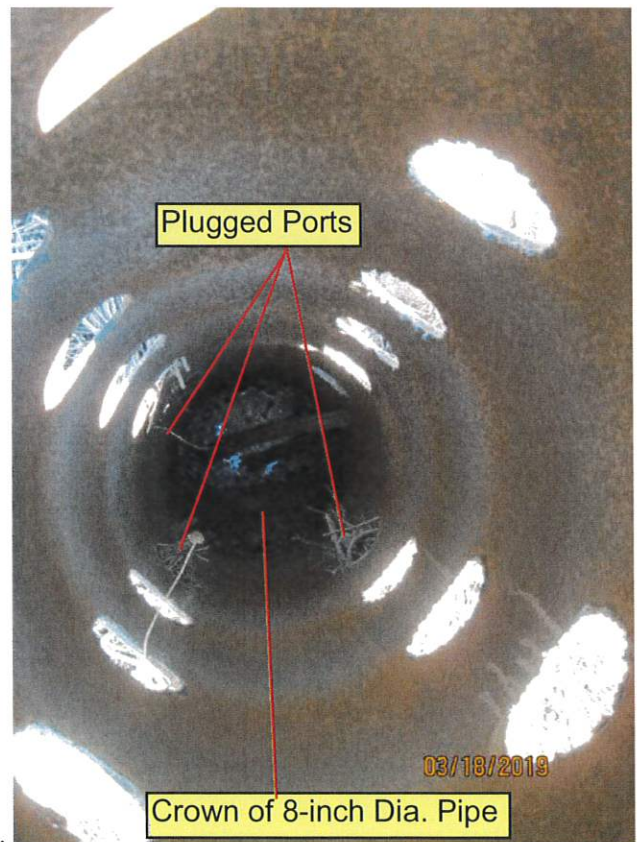
**Images 20 and 21:** Additional view of the low level outlet works riser (Image 20) and interior view of the riser (Image 21) with plugged ports as an approximate indication of the sediment level.

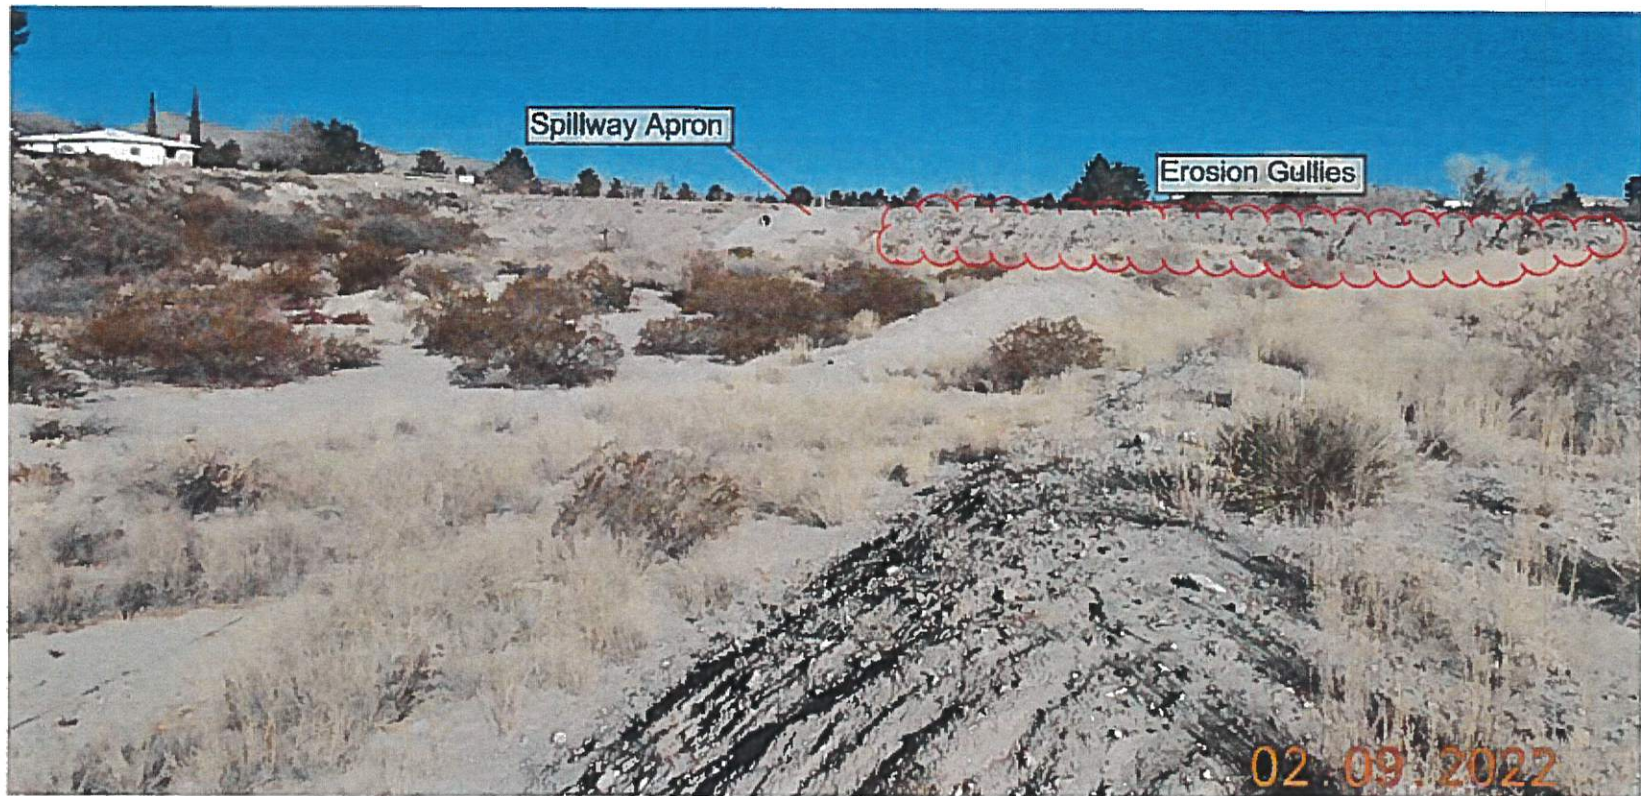
8.

**Image 8:** Northerly view of the downstream slope with areas of erosion and spillway apron as indicated.

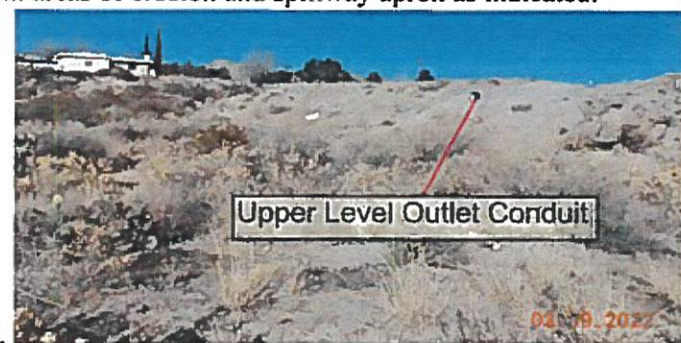
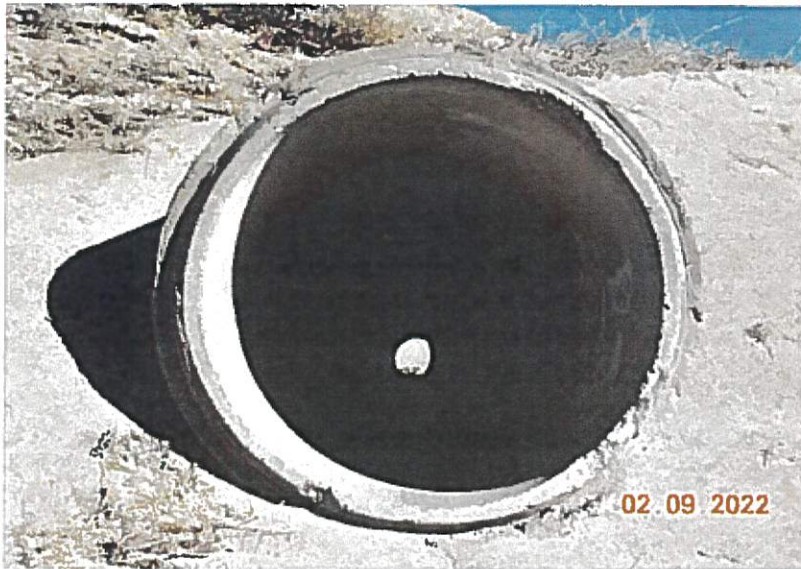
**Images 9 and 10:** Northerly views of the downstream slope at the right abutment with the location of the upper level outlet conduit as indicated.

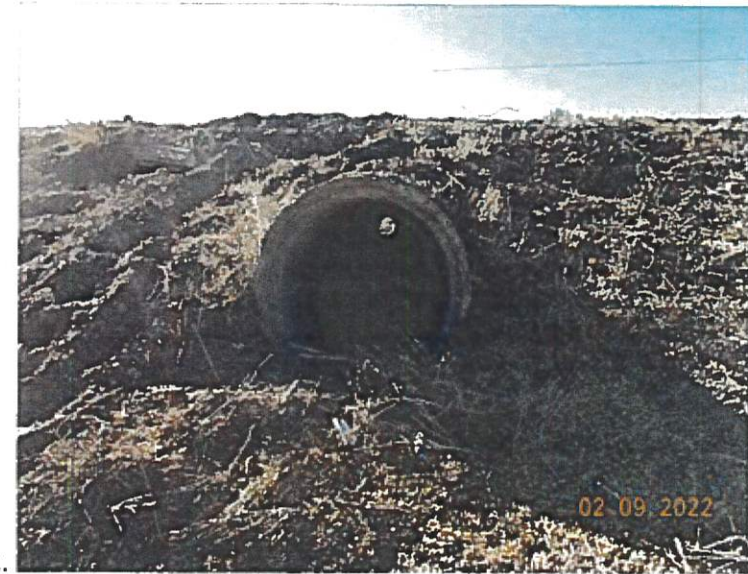
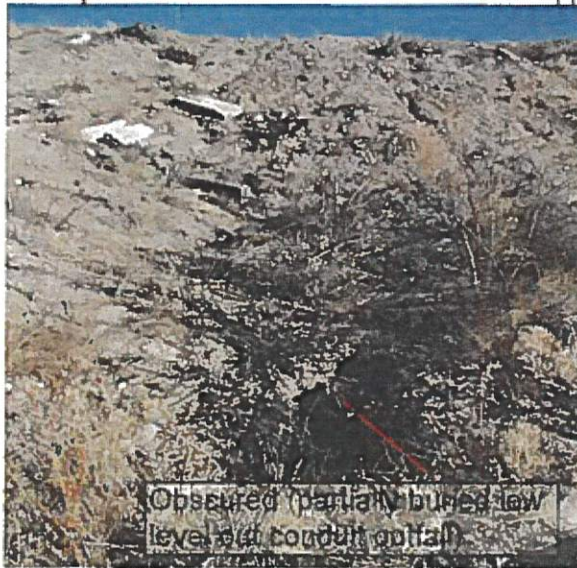
**Images 11 and 12:** Upstream and downstream views of the upper level outlet conduit beneath Marie Street (aka the dam crest).

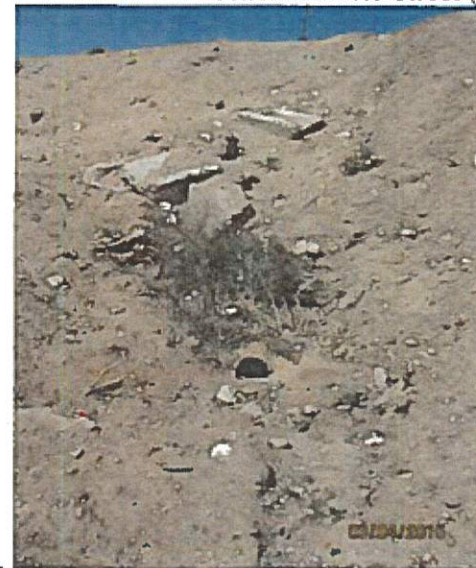
**Images 13 and 14:** Upstream views of the lower level outlet outfall in 2022 and 2015, respectively. The outfall is currently obscured and needs to be maintained in an exposed condition.

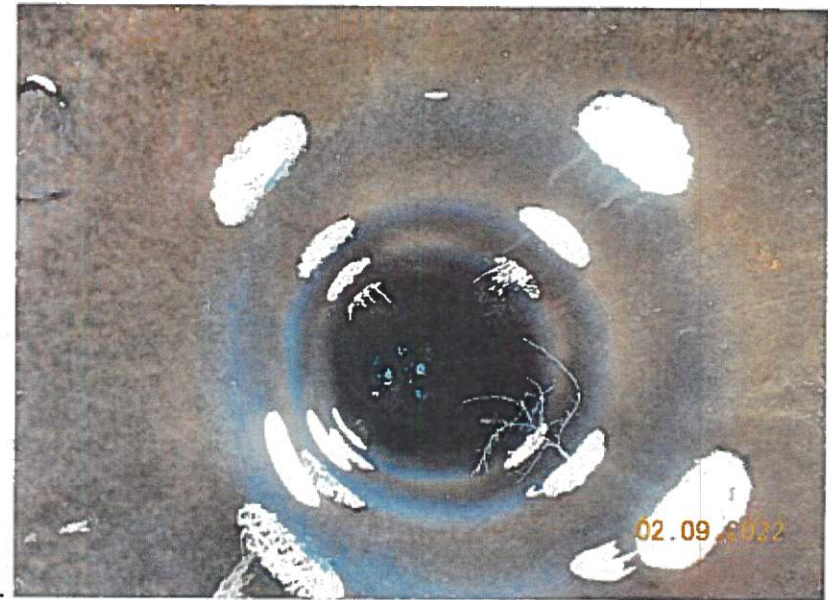
**Images 15 and 16:** Distant northerly view of the outlet works intake riser (Image 15) and interior view of the riser (Image 16).

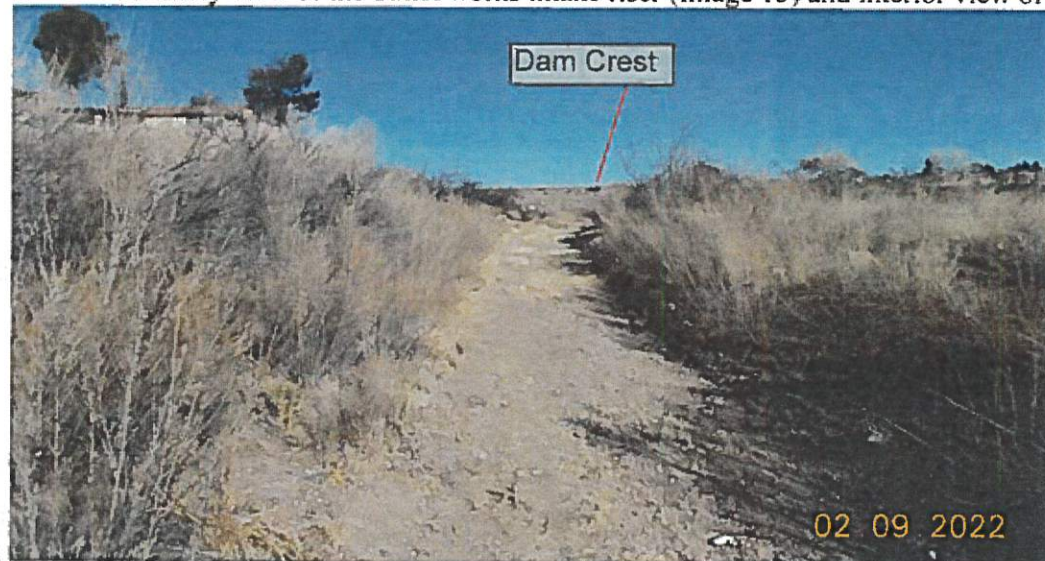
**Image 17:** Northerly (upstream) view of the combination outlet works / spillway exit channel with the dam crest as indicated.

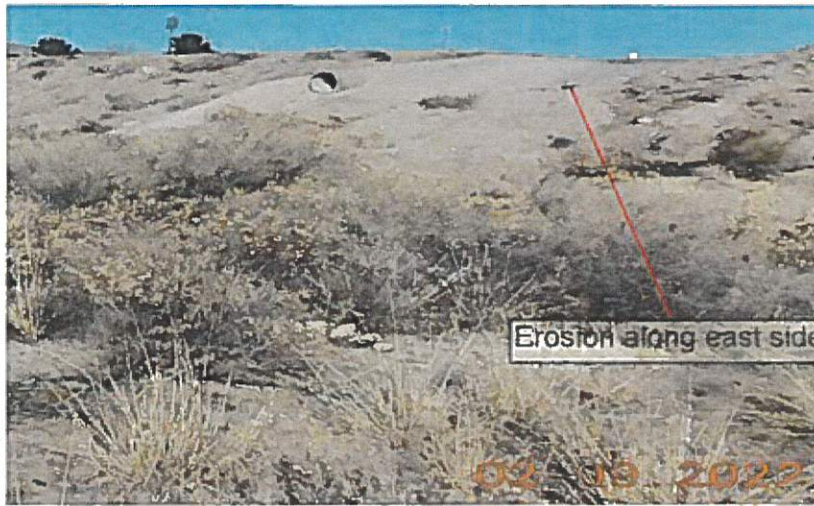
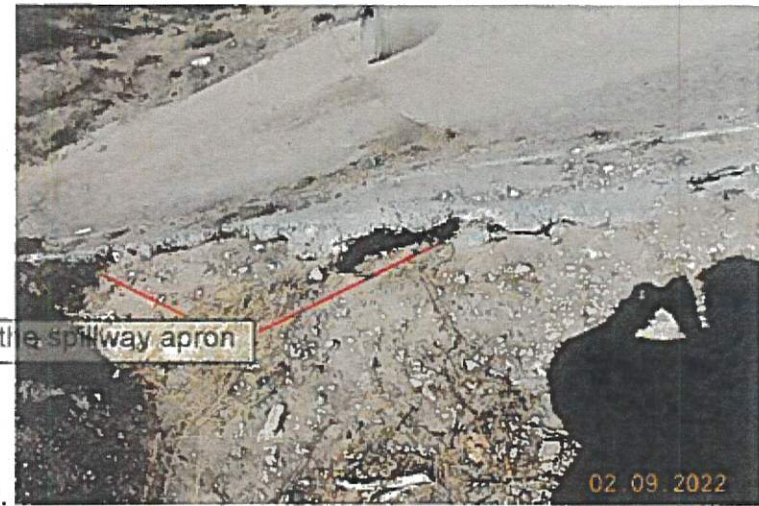
**Images 18 and 19:** Northwesterly view of the spillway apron on the downstream slope of the dam (Image 18) and erosion along the east side of the apron (Image 19). The flood discharge that occurred as a result of heavy rains in July 2020 overtopped the dam at the spillway and eroded the east side of the spillway apron. This area was apparently backfilled to some degree, but additional erosion or not enough backfill was placed to fill the eroded area that occurred in July 2020.

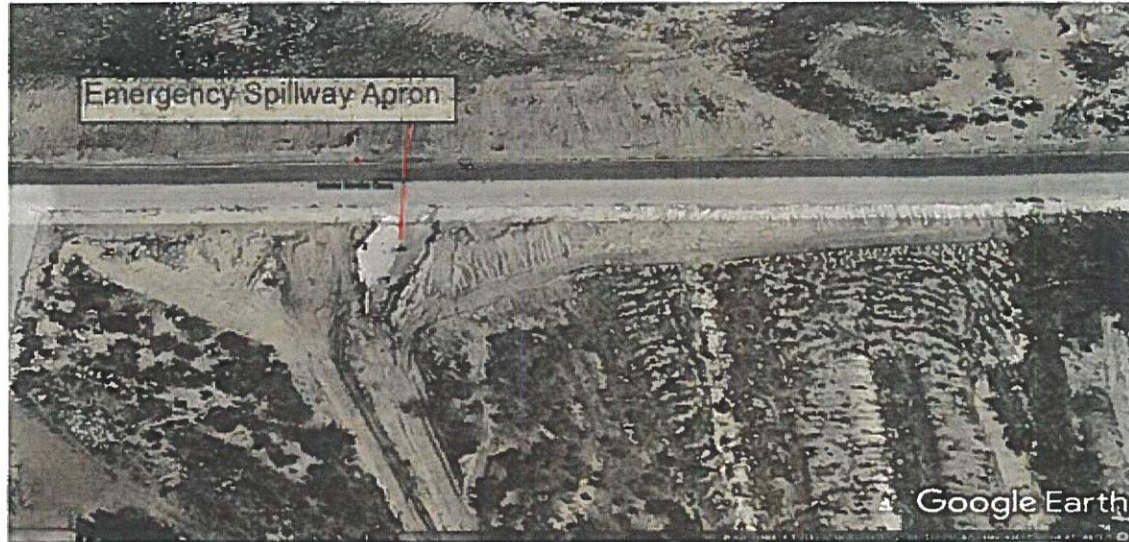
**Image 20:** Overview of the overflow spillway (across Marie Street) with spillway apron as indicated.

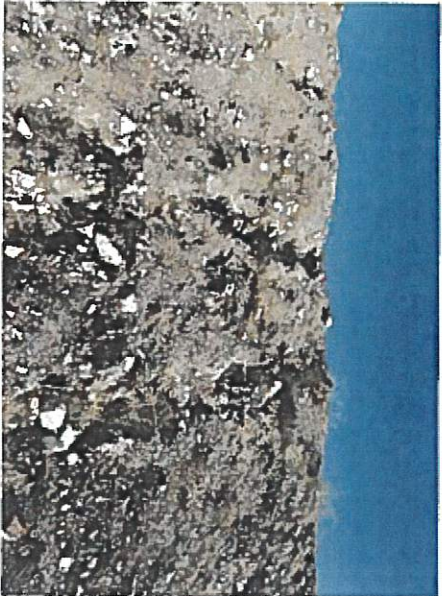
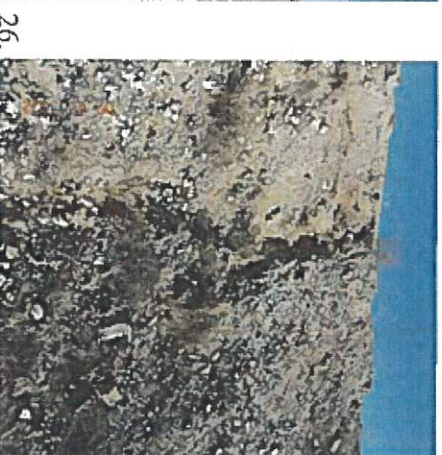
21. Images 21 through 23: Erosion gullies in need of repair on the upstream slope (Images 21 and 22) and more of the same on the downstream slope (Image 23).

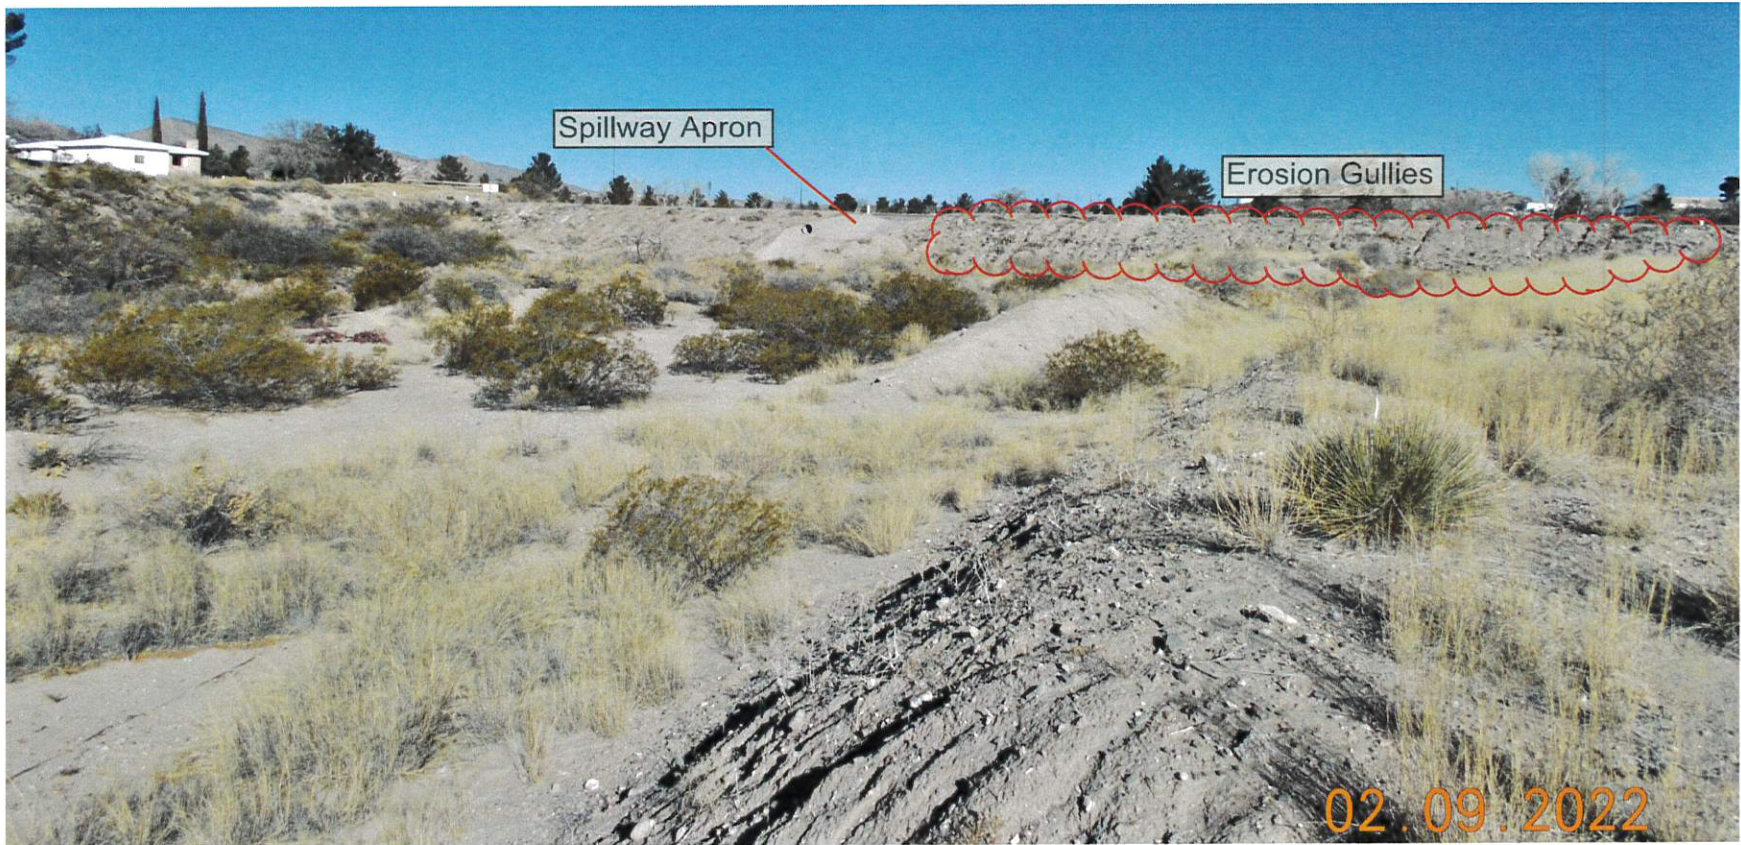
8. **Image 8:** Northerly view of the downstream slope with areas of erosion and spillway apron as indicated.

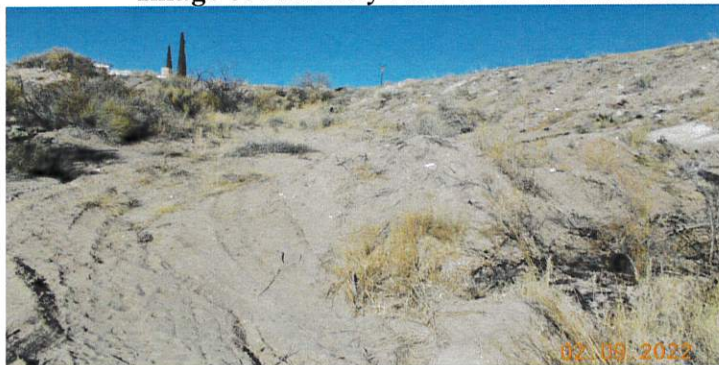
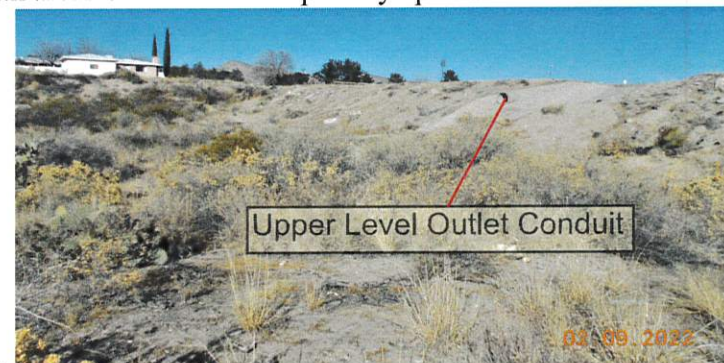
**Images 9 and 10:** Northerly views of the downstream slope at the right abutment with the location of the upper level outlet conduit as indicated.

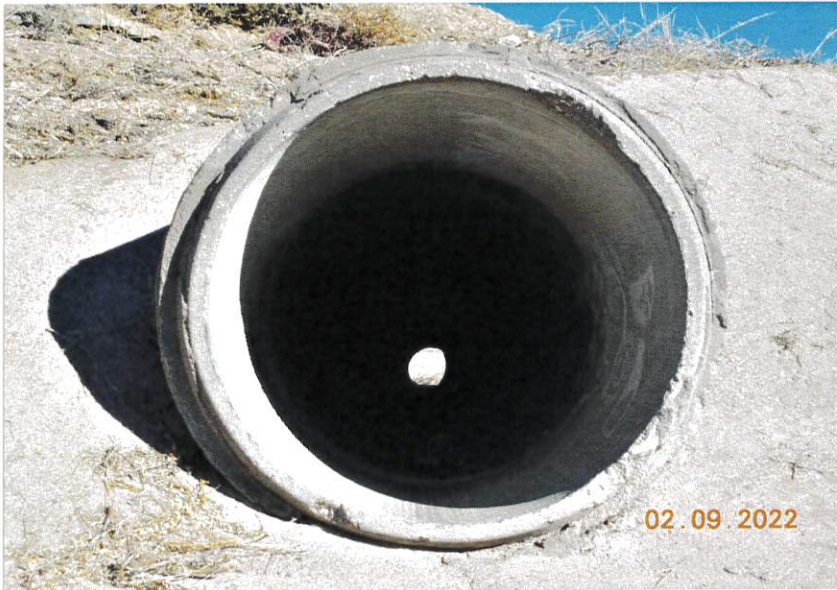
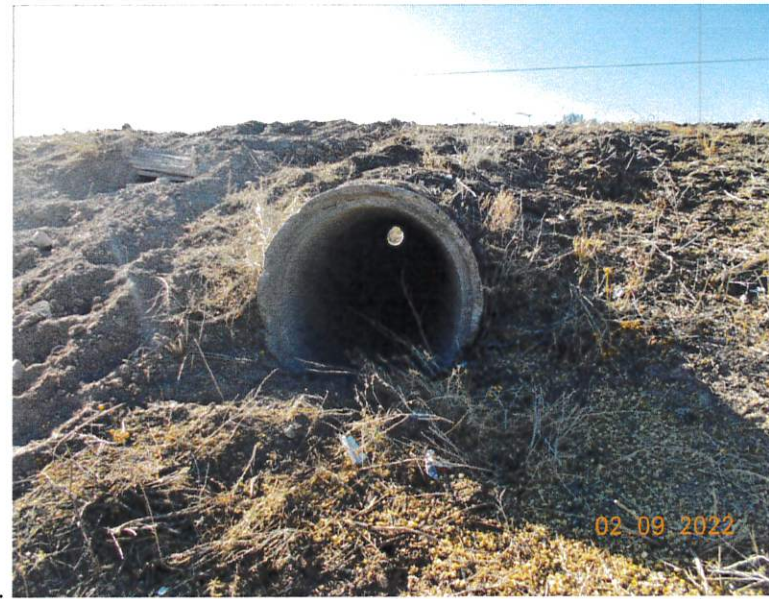
**Images 11 and 12:** Upstream and downstream views of the upper level outlet conduit beneath Marie Street (aka the dam crest).

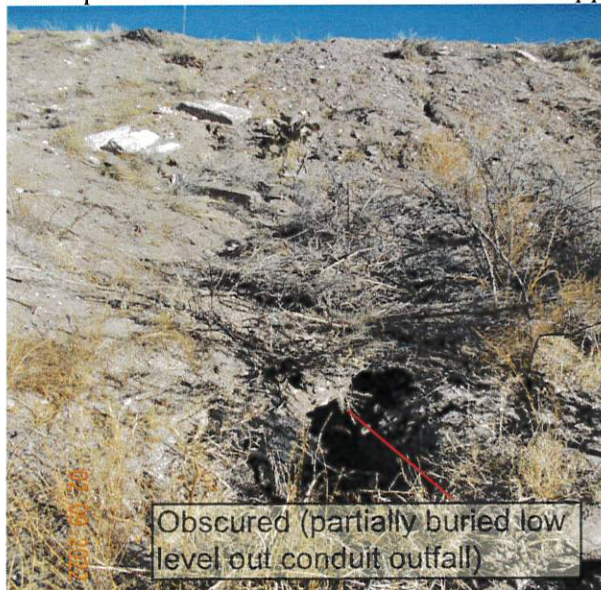
**Images 13 and 14:** Upstream views of the lower level outlet outfall in 2022 and 2015, respectively. The outfall is currently obscured and needs to be maintained in an exposed condition.

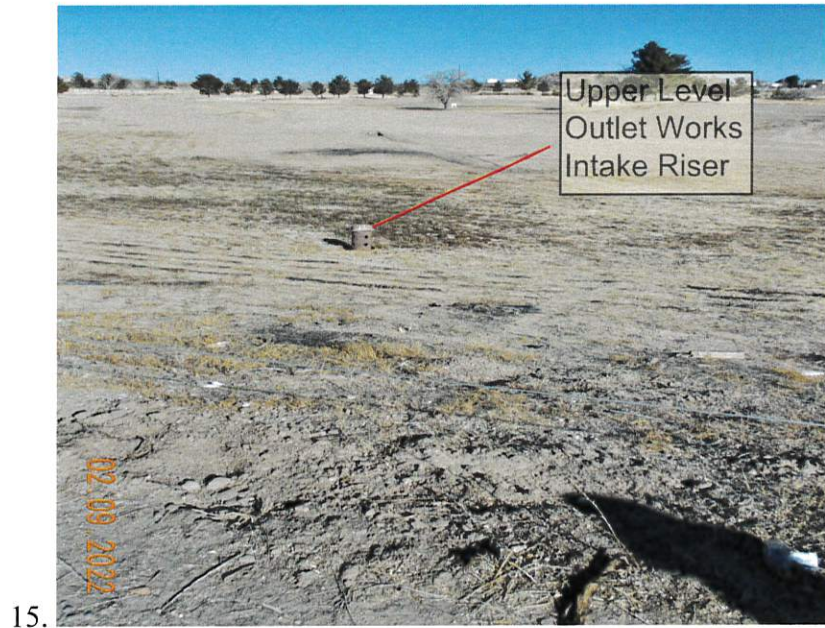
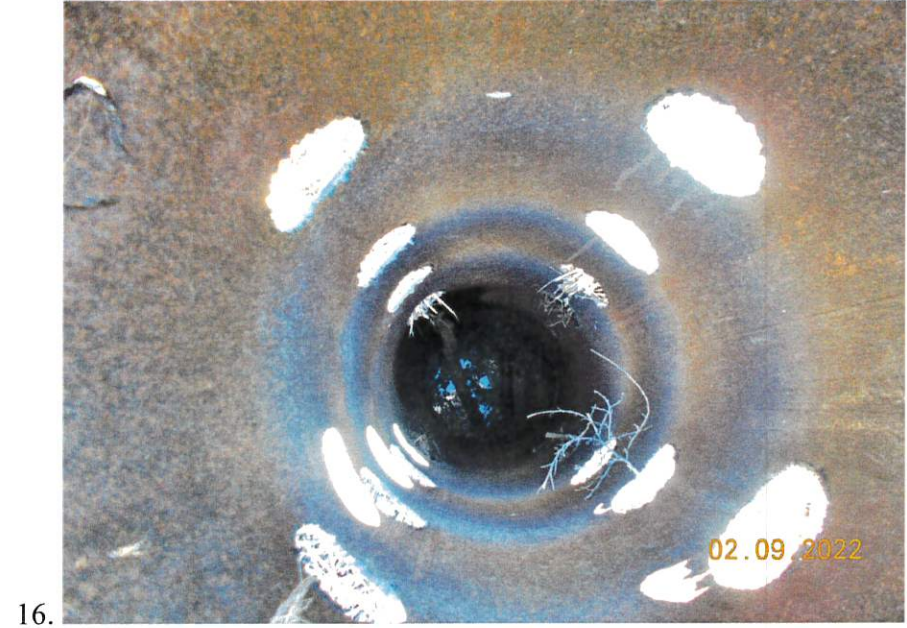
**Images 15 and 16:** Distant northerly view of the outlet works intake riser (Image 15) and interior view of the riser (Image 16).

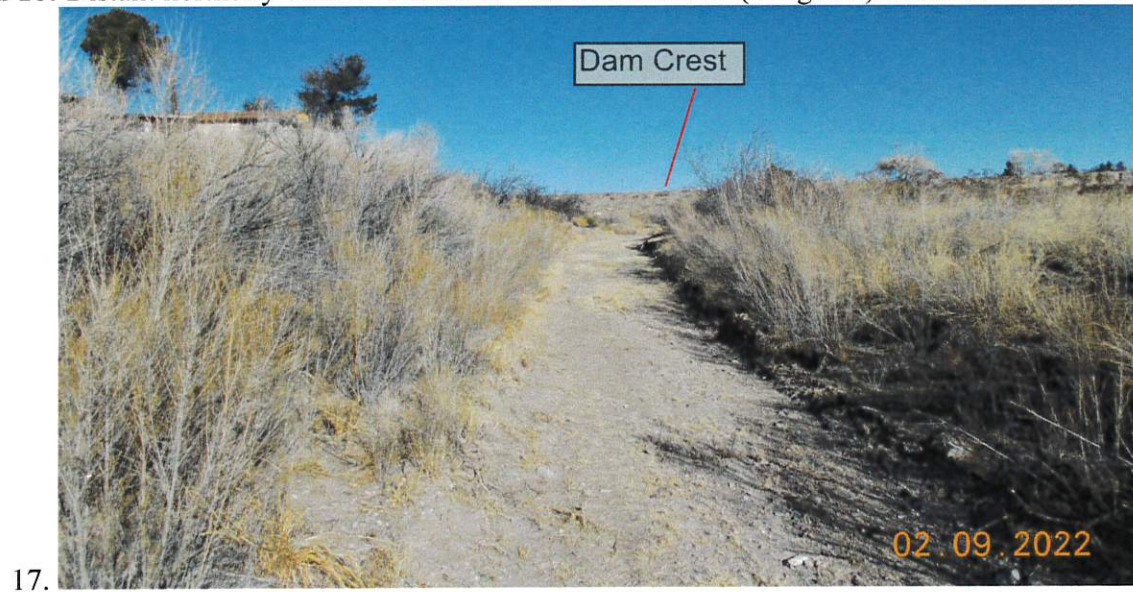
**Image 17:** Northerly (upstream) view of the combination outlet works / spillway exit channel with the dam crest as indicated.
