## REGULAR MEETING

THE REGULAR MEETING OF THE CITY COMMISSION OF THE CITY OF TRUTH OR CONSEQUENCES, NEW MEXICO, TO BE HELD IN THE COMMISSION CHAMBERS, 405 W. 3RD ST., ON WEDNESDAY, MARCH 27, 2024; TO START AT 9:00 A.M.

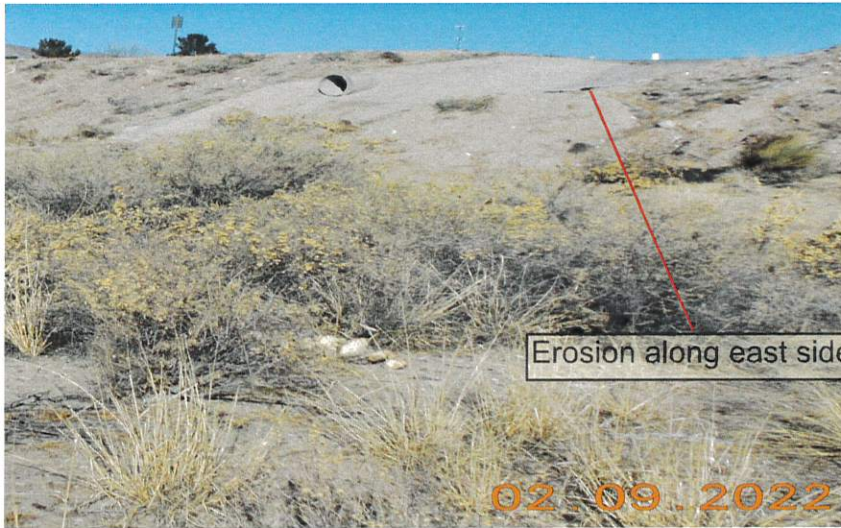
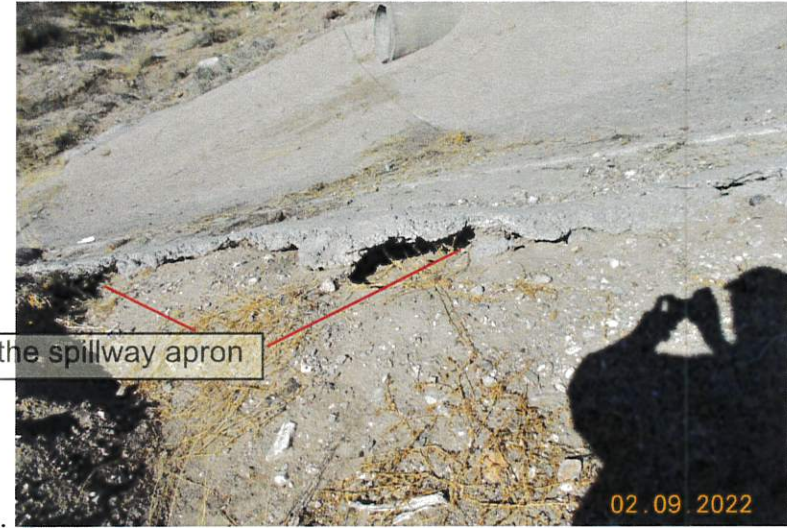
**Images 18 and 19:** Northwesterly view of the spillway apron on the downstream slope of the dam (Image 18) and erosion along the east side of the apron (Image 19). The flood discharge that occurred as a result of heavy rains in July 2020 overtopped the dam at the spillway and eroded the east side of the spillway apron. This area was apparently backfilled to some degree, but additional erosion or not enough backfill was placed to fill the eroded area that occurred in July 2020.

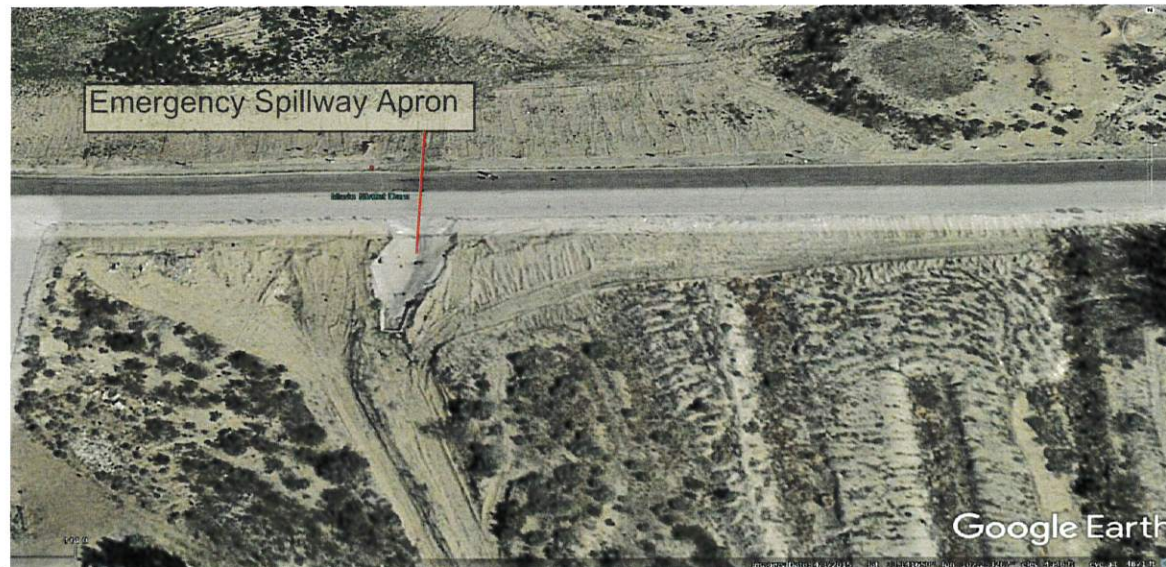
20.

**Image 20:** Overview of the overflow spillway (across Marie Street) with spillway apron as indicated.

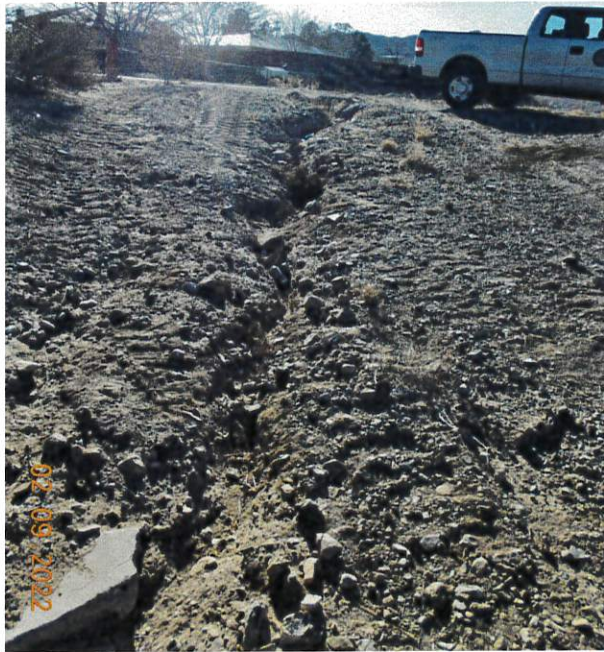
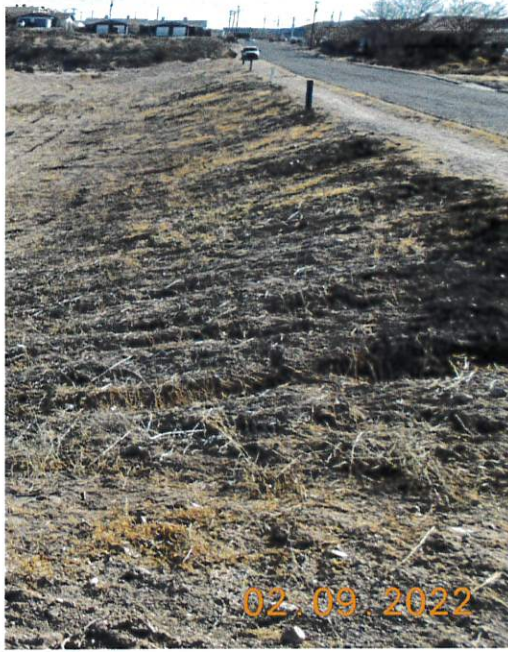
**Images 21 through 23:** Erosion gullies in need of repair on the upstream slope (Images 21 and 22) and more of the same on the downstream slope (Image 23).

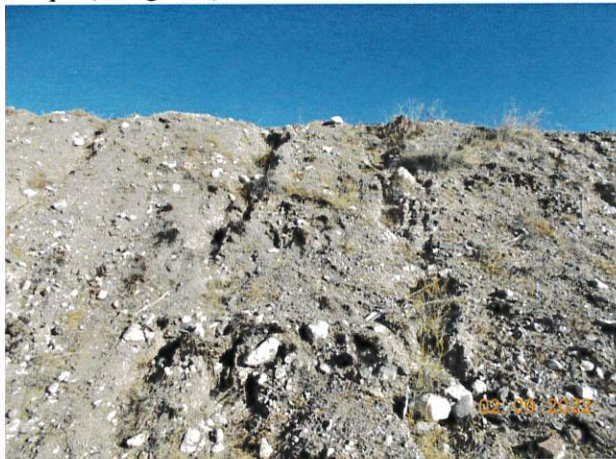
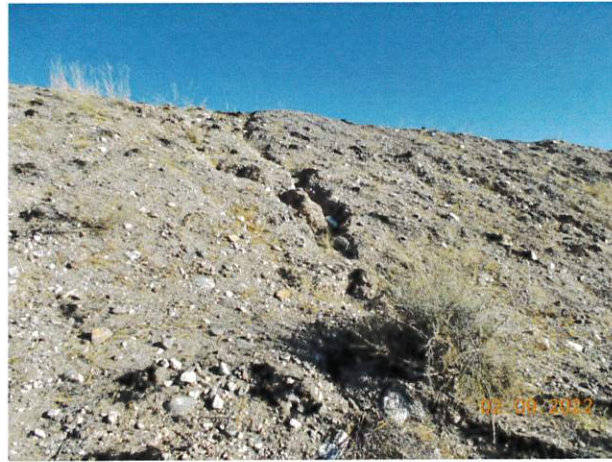
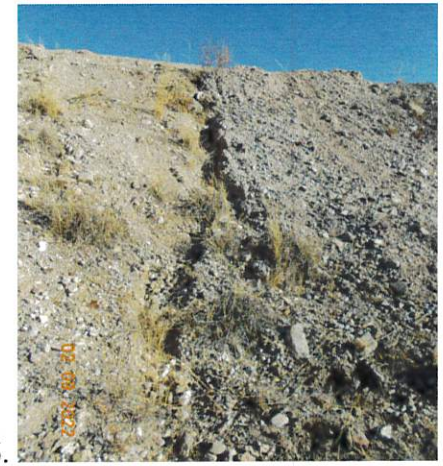
**Images 24 through 26:** Additional views of erosion on the downstream slope. A gravel/cobble mulch placed on the embankment slopes and abutment contacts at the upstream and downstream groins of the dam would serve well towards diminishing erosion.

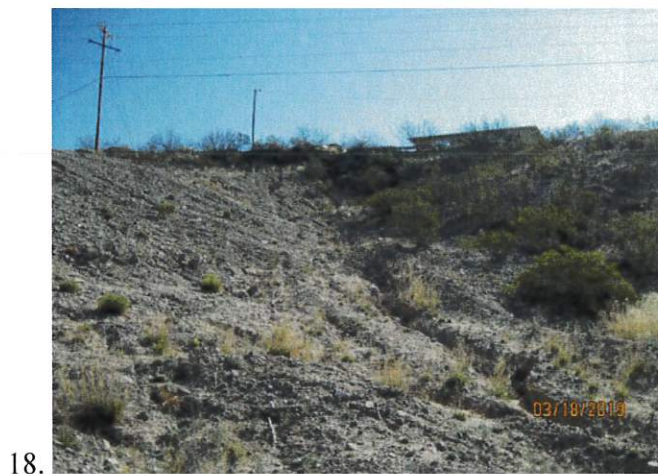
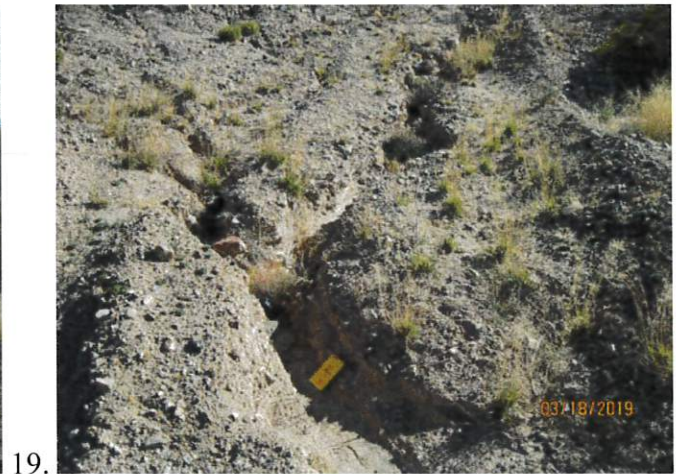
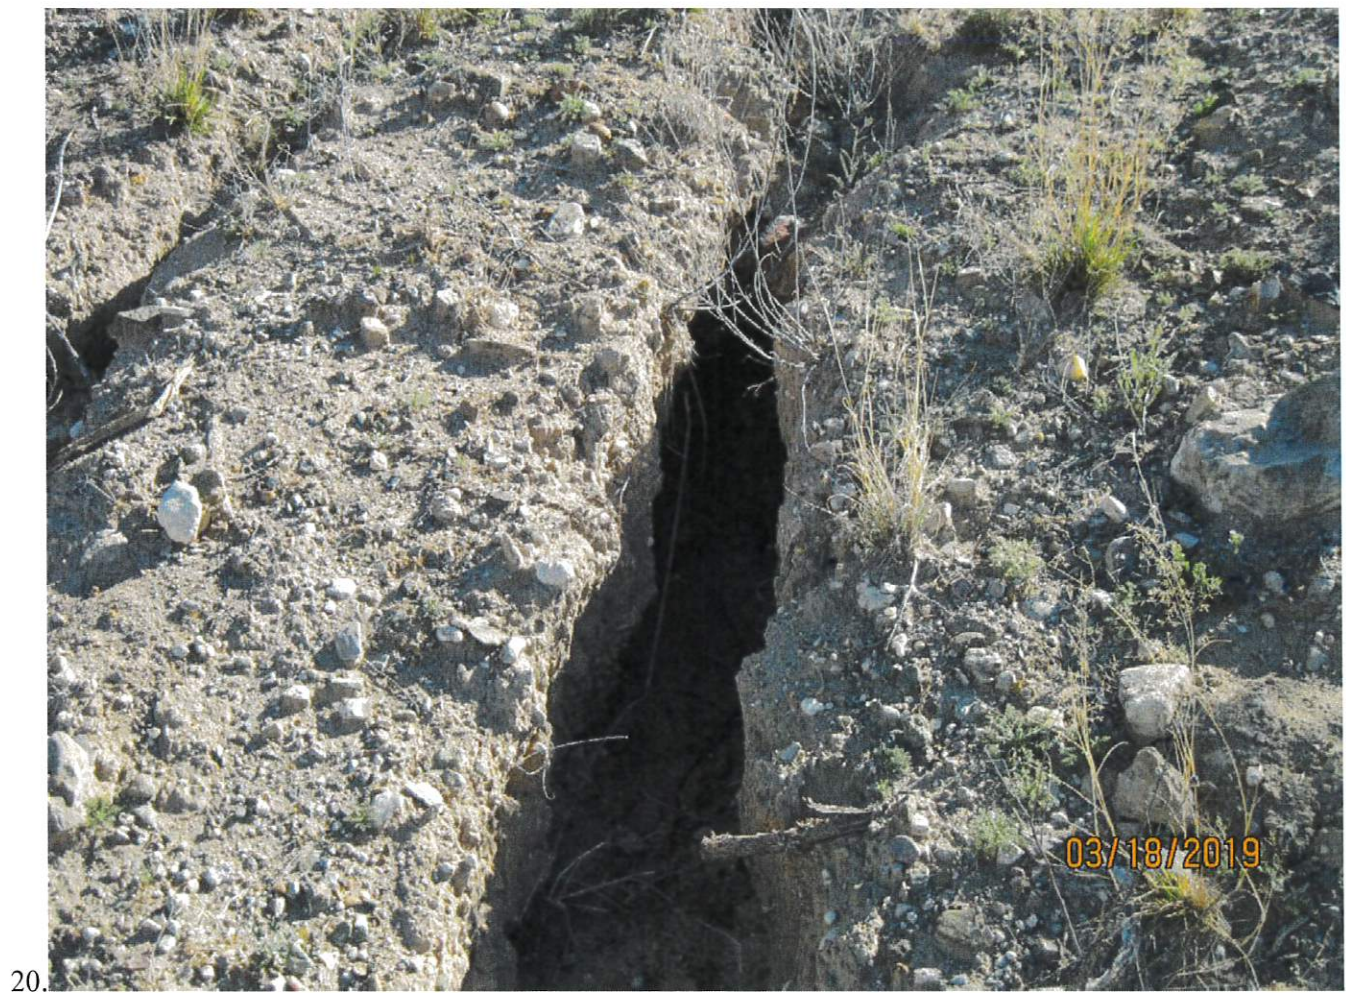
**Images 18 through 20:** Distant (easterly) view of erosion along the left downstream groin (Image 18), and close-up views of the same set of erosion gullies (Images 19 and 20).

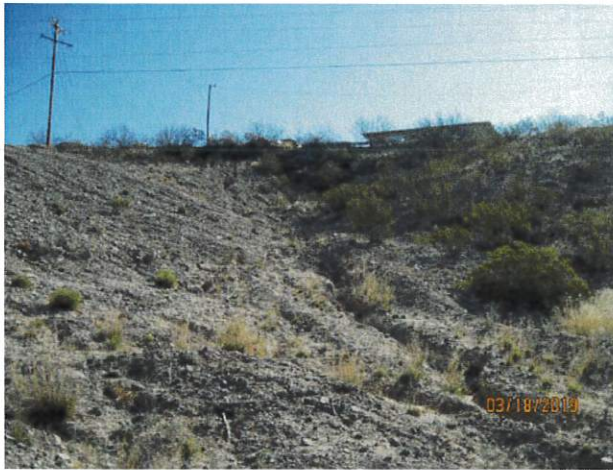
18.

**Images 18 through 20:** Distant (easterly) view of erosion along the left downstream groin (Image 18), and close-up views of the same set of erosion gullies (Images 19 and 20).

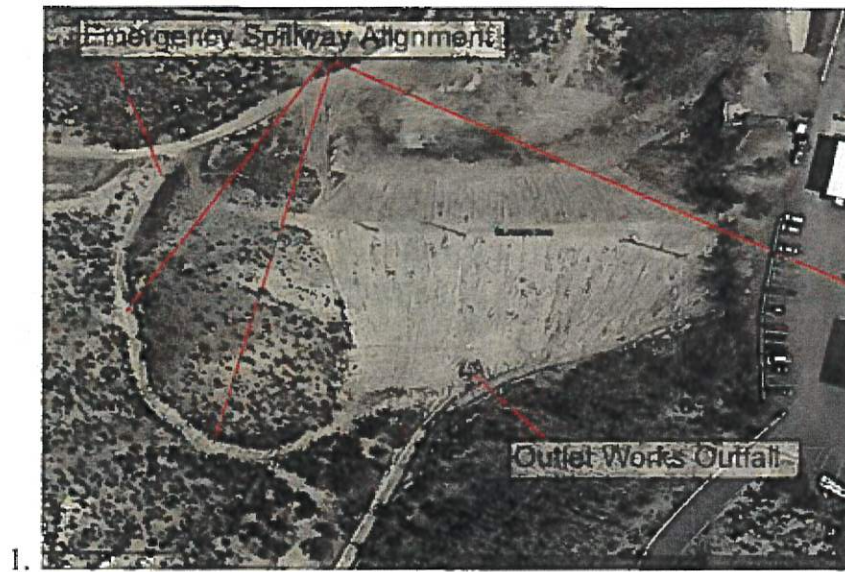
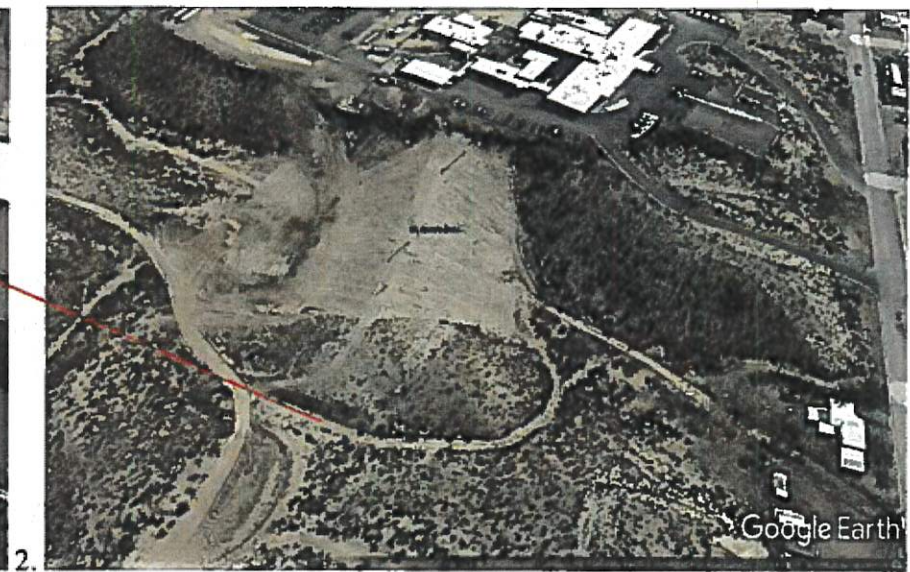
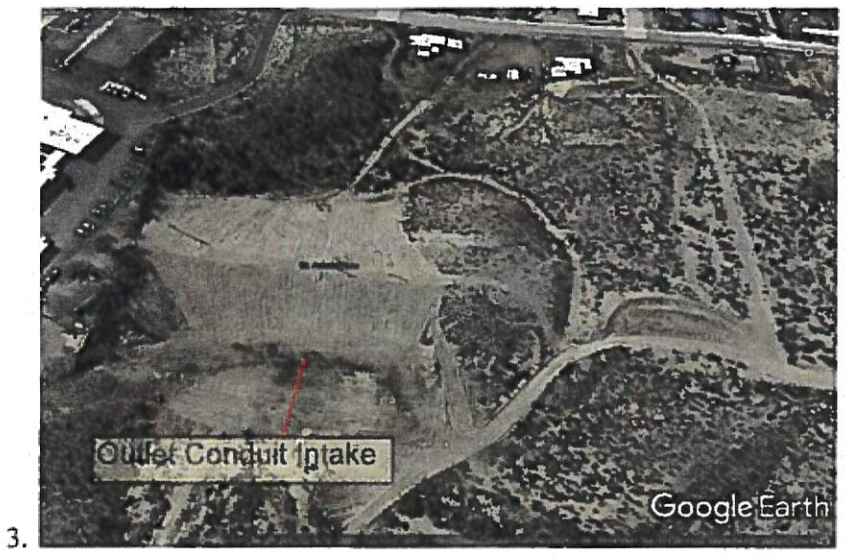
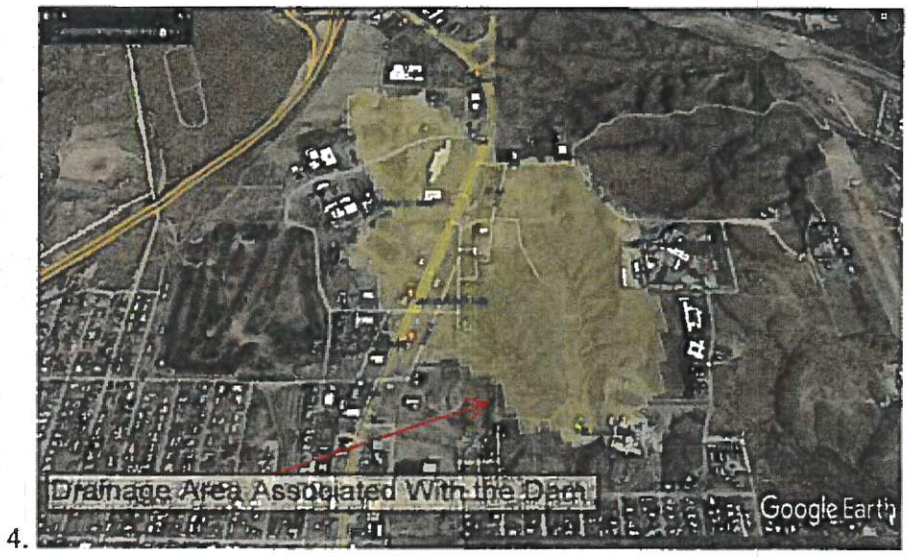
**Images 1 through 4 3:** Google Earth aerial overviews of the dam with drainage area from USGS Stream Stats as indicated. The drainage area for the dam as per USGS Stream Stats (Image 4) is on the order 0.33 square mile.

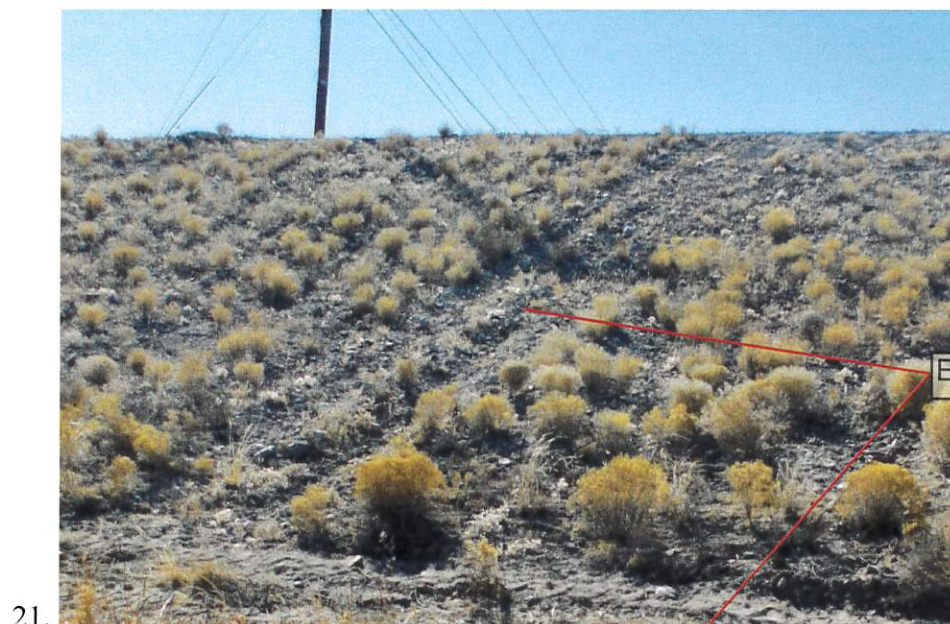
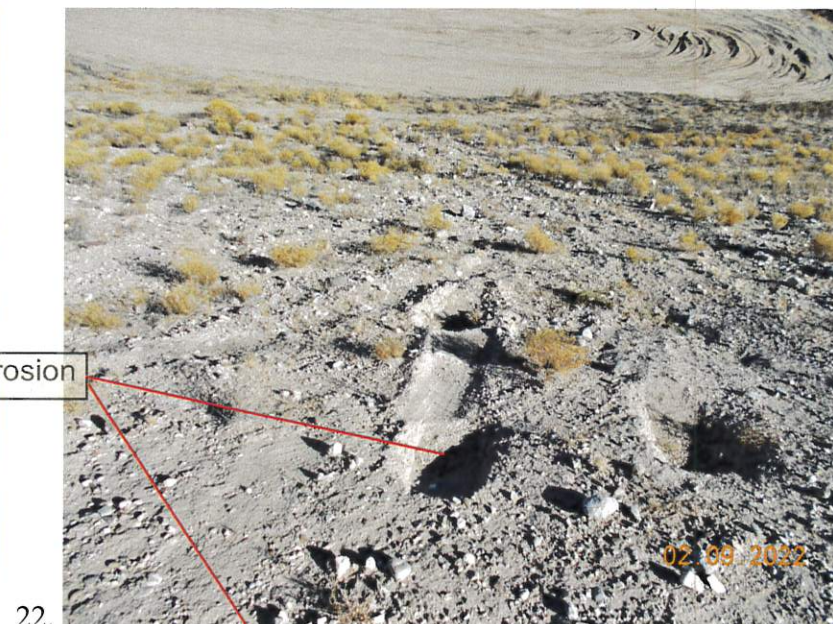
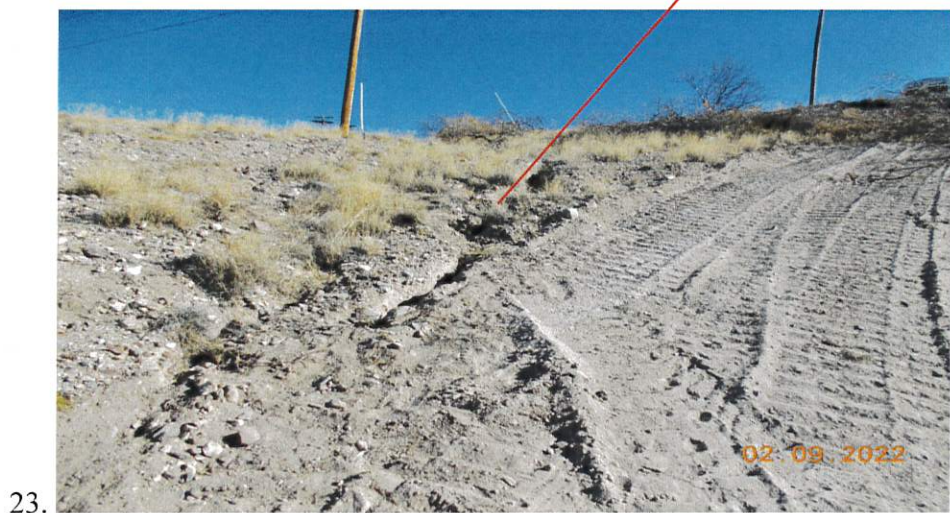
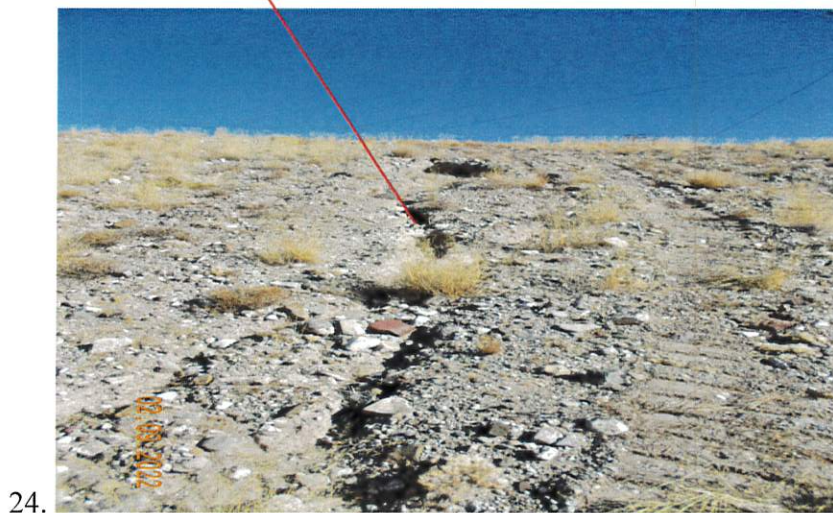
**Images 21 through 24:** Views of past off-road vehicle (ORV) traffic on the upstream slope (Images 21 and 22) and erosion gullies on the downstream slope (Images 23 and 24).
